## USING VISUAL INSPECTION NDT TO CHECK INTEGRITY OF TRIGA MARK I FUEL RODS

In more than 45 years of operation, CDTN's TRIGA IPR-R1 reactor may be considered a very safe nuclear research installation. As recommended by national and international regulatory organizations, all research and maintenance activities ever conducted have been continuously monitored. By the end of year 2000, a lot of actions and experimental jobs were established, concerning to its power increment to 250 kW. This paper describes the application of visual inspection non destructive tests in all fuel elements installed in that reactor. The electronic instrumentation and procedures applied to perform that task, as well as the operating details of the specially designed and constructed tools, which allowed an adequate handling of the fuel rods, are described. Furthermore, a set of photographs, digitally grabbed from the recorded data is presented. Additionally, some results obtained using an ordinary low cost water resistant surveillance camera are presented. A discussion, concerning to the actual integrity state of all installed fuel elements and the efficacy and limitations of such method to verify the occur

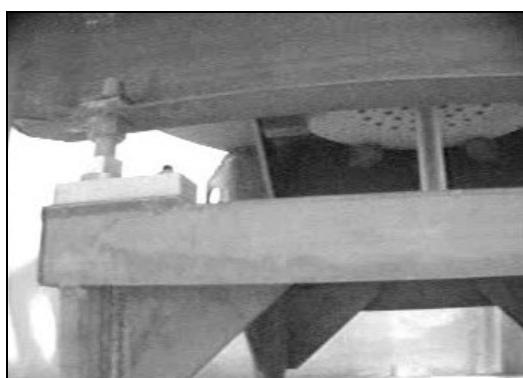
Within the limits of the method, the first inspection showed that all structural components, the core and the tank of the reactor were in good conditions. Concerning to the fuels, seven indications were pointed, as presented in Table 1. In the second inspection, the structural components, the core, the tank of the reactor and the fuels listed in Table 1 were re-examined. After 6 years of operation, none severe changing was verified. Six representative images, taken from the recorded video files, are presented in Fig. 6 to Fig. 11.

**Figure 6. View of the reactor structure.**

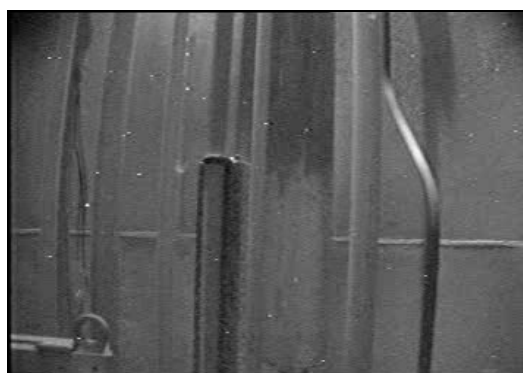
<b>Fuel Identification</b>	<b>Position in the core</b>	<b>Indicação</b>
1179	E-18	Deformation (kneading) in the lower termination pin
1314	B-1	Deformation (bending) in lower termination pin
1199	D-11	Corrosion pit
1220	D-13	Oxide film color difference in the active/inactive zone
1147	E-23	Oxide film color difference in the active/inactive zone
1188	B-2	Corrosion pits
1205	E-6	Deformation (kneading) in the lower termination pin

**Figure 8. Fuel 1220 color difference.**

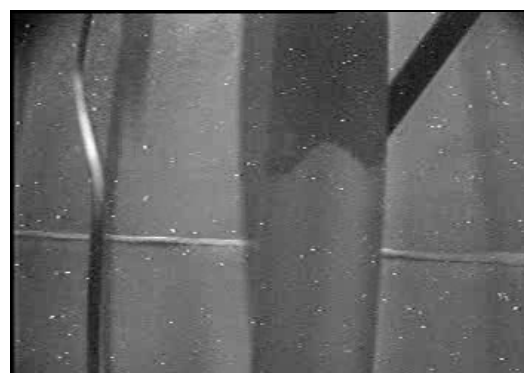
**Figure 9. Fuel 1147 color difference.**

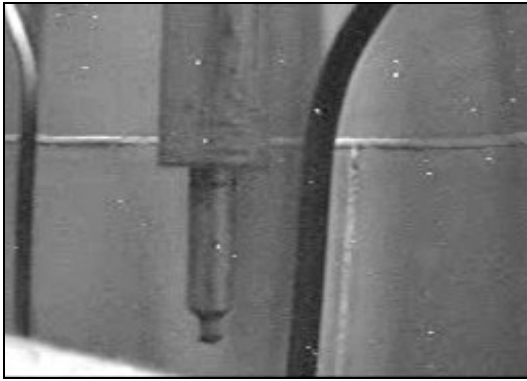
**Figure 10. Fuel 1179 kneaded pin.**

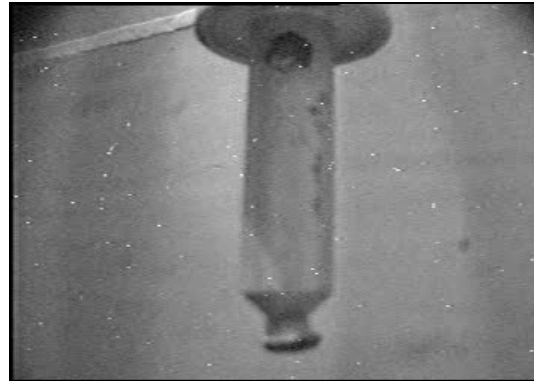
**Figure 11. Fuel 1205 kneaded pin.**
