Radiological Protection Performance in Radiopharmaceutical Facility

Abstract. The Radiopharmaceutical Facility (RF) of the IPEN-CNEN/SP has processed and handled several radionuclides and compounds, in unsealed form, in amounts that require specific procedures to avoid contamination, intake and unexpected exposures of the workers, in order to do not resulting doses over of the waited standards. The (RF) is committed to good work area management of all its potential risks, minimizing risks to the work area, and anticipating and addressing potential problems before they pose a threat to the quality of the local areas. The radiological protection team has established a radiological protection program whose purpose is to provide an adequate occupational worker protection system in agreement to national and international radiological protection standards. The main objective of this study is to correlate the unusual events occurred in the (RF), over the years, that in some way contributed with failure in the process that led to an intake and or an external exposure, or contamination in the workplace. For the analysis, the reports from the radiation protection supervisor, complemented by

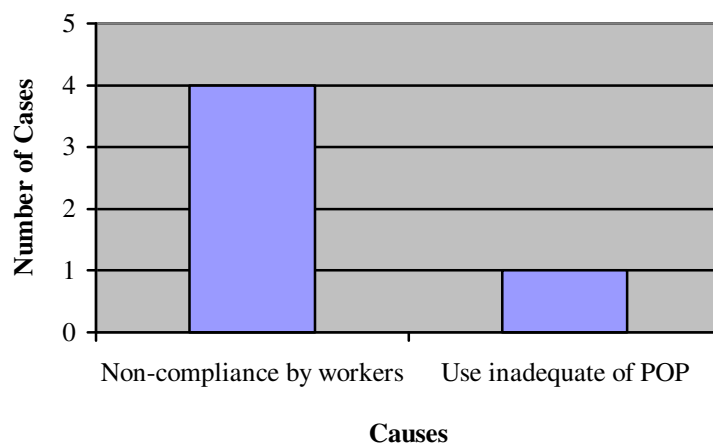
Figure 2: Causes of unusual events occurrences.

The causes of these unusual events are illustrated in Fig. 2 and in Fig. 3 are presented the solutions adopted to prevent or reduce the unusual events.

A systematic critical review of the nature and magnitude of the unusual events occurrence was made and the data analyze showed that 80% of these events are consequences of non-compliance with operating procedures and improperly knowledge by workers. This resulting gave rise in contamination of individuals and the workplace, emphasizing that in any case there was not contamination outside facility.

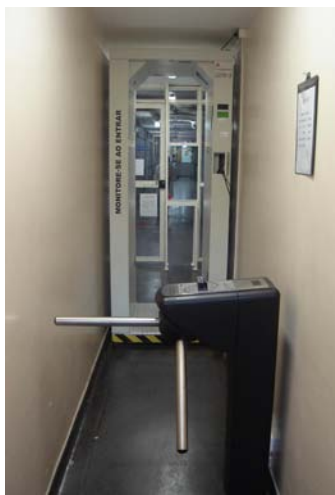
Figure 4: Portal monitor and barrier arm turnstiles.

(a) Portal monitor and magnetic badge Bi-directional Barrier Arm Turnstiles for access control system - entry.

In Fig. 4, is illustrated a portal monitor of compulsory use in entry and exit of the workplace was installed to provide an additional control measures.

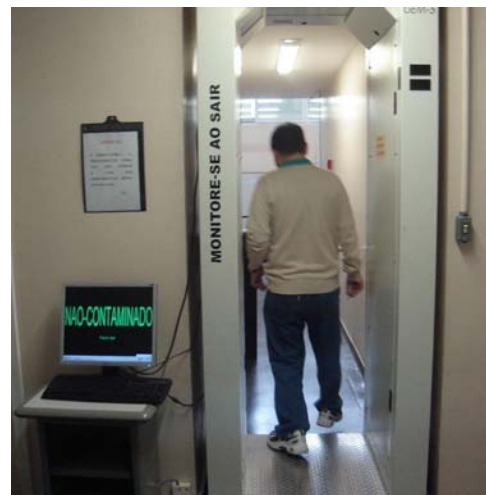
(b) Portal monitor and magnetic badge Bi-directional Barrier Arm Turnstiles for access control system - exit.
