EFFECT OF COUPON ORIENTATION ON CORROSION BEHAVIOR OF ALUMINIUM ALLOY COUPONS IN THE SPENT FUEL STORAGE SECTION OF THE IEA-R1 RESEARCH REACTOR

O.V.Correa, R.M.Lobo, S.M.C.Fernandes, G.Marcondes and L.V.Ramanathan
Materials Science and Technology Center,
Instituto de Pesquisas Energéticas e Nucleares (IPEN),
Av. Prof. Lineu Prestes, 2242, Cidade Universitária
05508-000 – São Paulo – Brazil
lalgudi@ipen.br

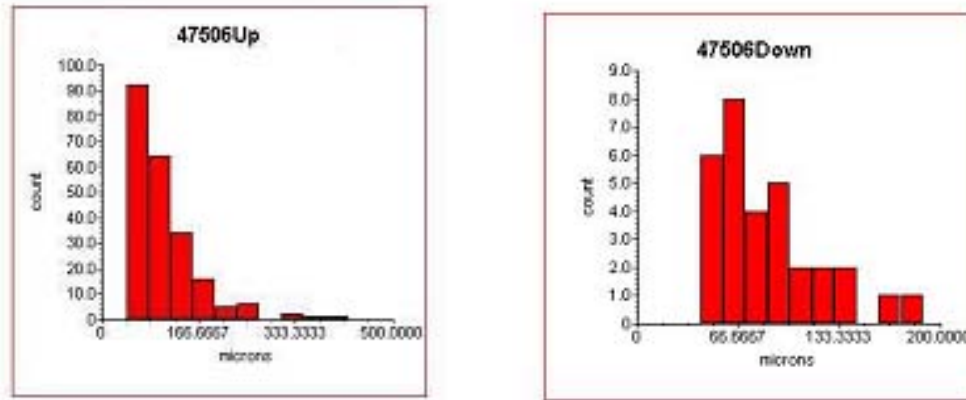
Figures 2a and 2b reveal the histograms of pit count versus pit size on the upward facing and the downward facing surfaces of the individual AA 1050 coupon respectively. The upward facing surface revealed a large number of pits, ~90, in the size range 40-50 μm while the downwards facing surface revealed only 6-8 pits in the same size range. The shape of the pits on this coupon varied from irregular to round. (figure 3).

Figure 2. Histograms of pit count versus pit size on the upward facing (47506Up) and downward facing (47506Down) surfaces on horizontally oriented AA 1050 coupon.

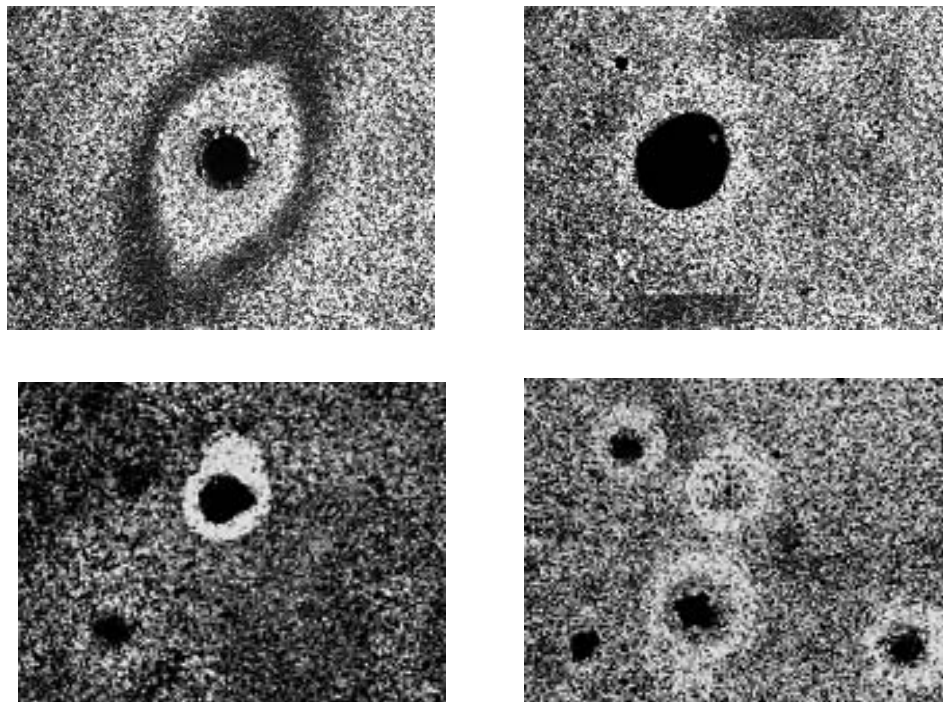
Figure 3. Micrographs showing pits and bright regions on horizontal AA 1050 surfaces.

Most of the pits revealed a bright region around the pit, characteristic of a cathode region around a localized anode region. The shape of this bright region also varied from circular to elliptical. (figure 3) On the exposed surfaces of the other AA 1050 coupons, similar round and irregular shaped pits were observed. On the AA 1050 coupon surface, in contact with the AISI 304 stainless steel

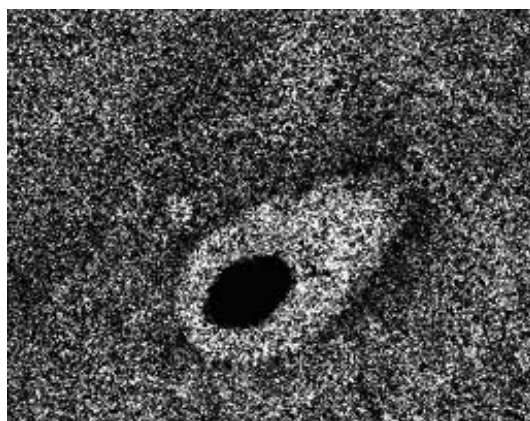
On the surfaces of the individual AA 1050 coupon, round and irregularly shaped pits were observed. Many pit clusters were also observed. The bright cathode areas associated with pits were shaped like a comet with a tail giving a clear indication of the top and bottom of the vertically oriented coupons. (figure 4)

Figure 4. Optical micrograph of vertically oriented AA 1050 surface revealing comet shaped bright region around a pit.

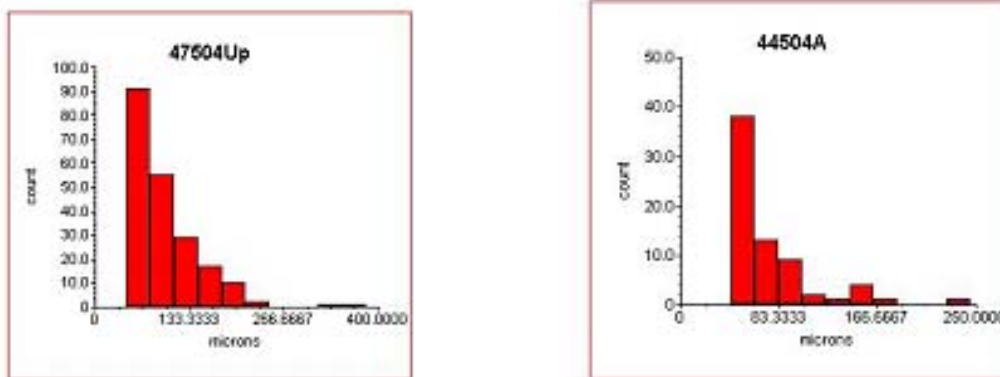
Comparison of pit histograms obtained for the horizontally oriented top surface of AA 1050 with that obtained for one of the surfaces of the same alloy oriented vertically (Figure 5) reveals that twice as many pits (size range 40-50 μm) form on the horizontal coupon as compared to that on the vertical coupon.

Figure 5. Histograms of pit count versus pit size on the upward facing surface (47504Up) and vertical surface (44504A) of AA 1050 coupon.
