A RATIONAL APPROACH TO EVALUATE A STEAM TURBINE ROTOR GRABBING AND LOCKING EVENT

Miguel Mattar Neto

Carlos Lueska

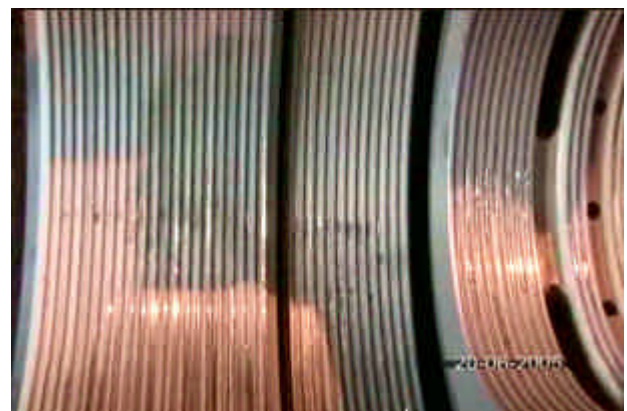
- [i] Damages in the sealing strips and labyrinths in the sealing regions.
- [ii] Scratches and rubs in the cover of some rotor blade stages.
- [iii] Damages in the end covers (small diameter) do stationary blades (axial rubs).
- [iv] Rubs in the journal bearings pads and in the back stop flange.

Figure 1: Damage in stationary parts

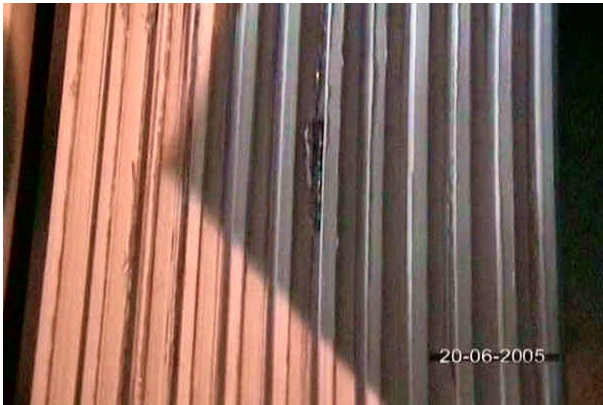
Figure 2: Damage in stationary parts

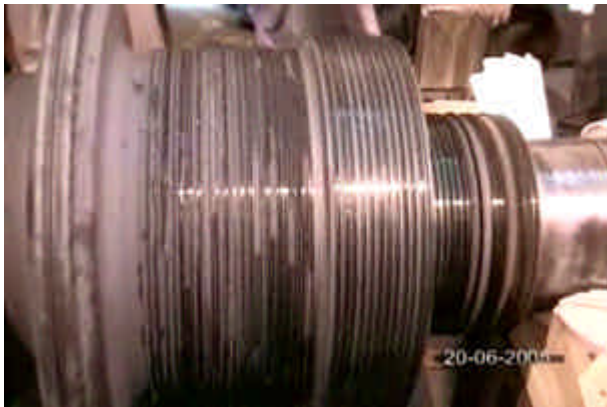
Figure 3: Damages in rotating parts

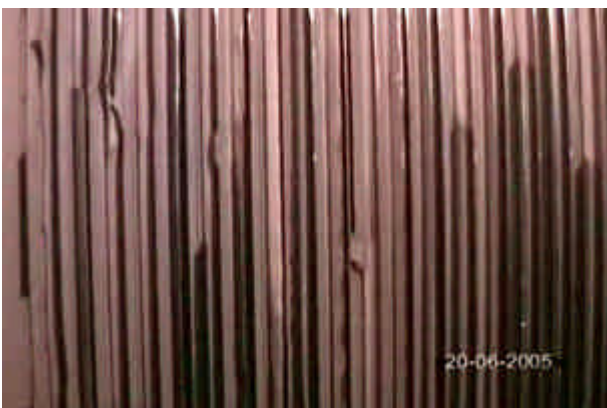
Figure 4: Damage in sealing parts

From the damaged condition of the rotor and the turbine casing, the evaluation of the visual inspections records revealed that the rotor grabbing in the turbine casing occurred in speeds greater than the low speed rotation. Further, from the rotor sealing strips conditions e from the damage in the labyrinth it was evident that the grabbing occurred at relatively high speeds. The rotor sealing strips and labyrinths were, in some positions, and almost completely destroyed. In other places, the sealing strips were crushed and broken.
