## CRACKS CAUSED BY INCLUSIONS ON AISI 409 WELDED TUBES FOR CARS EXHAUST SYSTEMS

Bôrro Jr. , A., Buso, S.J., Monteiro, W.A., Vatauvuk, J.

Depto. de Eng. de Materiais, IPEN – USP, CP 11049, CEP 05422-970 – São Paulo, Brasil

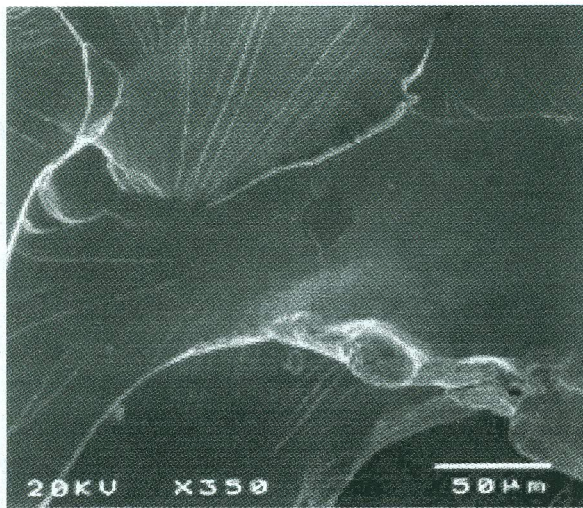
Samples showing longitudinal cracks have been investigated. First of all, surfaces were separated and submitted to ultrasonic cleanness. Cracks observed on SEM, have revealed cleavage mechanism, typical from brittle fractures, and mainly chevron marks pointing to the origin of fracture. Figure 1 (a) presents area pointed as failure initial region, figure 1 (b) shows in detail particle which is responsible for cracking mechanism in the welded zone. Arrow indicates the 20  $\mu\text{m}$  precipitate and figure 2 EDS from that precipitate.

Figure 1: (a) SEM image, initial crack area., (b) arrow pointing to particle responsible for cleavage mechanism development. Precipitate about 20 μm large.

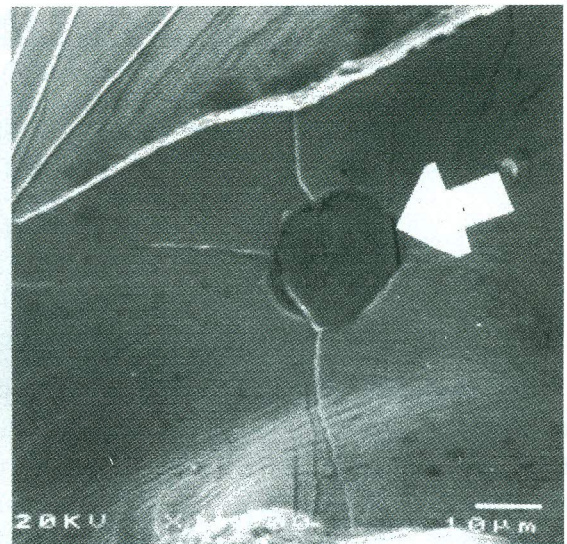
- Ca rich particles can be responsible for cracking developments on AISI 409 welded tubes. They appeared as exogenous inclusions, 15 a 20  $\mu\text{m}$  size.
- Fracture analysis techniques lead to those precipitates as responsible for cleavage mechanism.

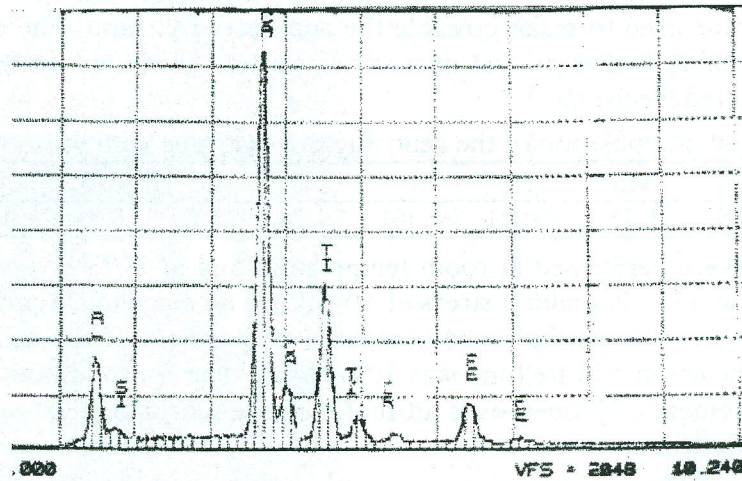
Figure 2: Particle (arrow figure 1.(b)) EDS analysis. Ca rich particle.
