# **Corrosion of Research Reactor Aluminum Clad Spent Fuel in Wet Storage**

**Lalgudi V. Ramanathan**

**Instituto de Pesquisas Energéticas e Nucleares – IPEN- CNEN/SP  
(The Energy and Nuclear Research Institute)  
Av. Prof. Lineu Prestes 2242, Cidade Universitária,  
05508-000 São Paulo. Brazil.**

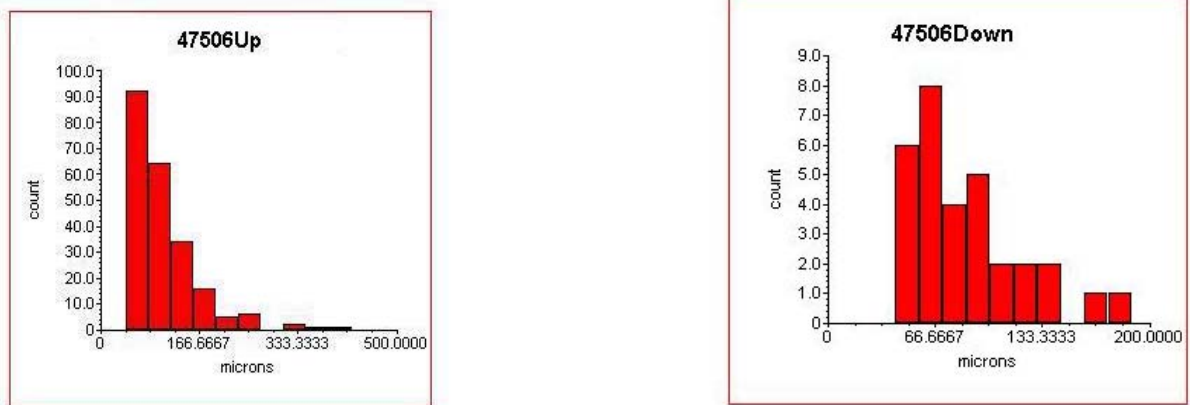
Figures 2a and 2b reveal the histograms of pit count versus pit size on the AA 1050 alloy coupon surface facing upwards and downwards respectively. The surface facing upward revealed a large number of pits, ~90, in the size range 40-50  $\mu\text{m}$  while the surface of the same coupon facing downwards, revealed only 6-8 pits in the same size range. The shape of the pits on this coupon varied from irregular to round. (figure 3).

Figure 2. Histograms of pit count versus pit size on the surface facing upwards (47506Up) and the surface facing downwards (47506Down) on a horizontally oriented AA 1050 coupon exposed for one year to the IEA-R1 SFSS.

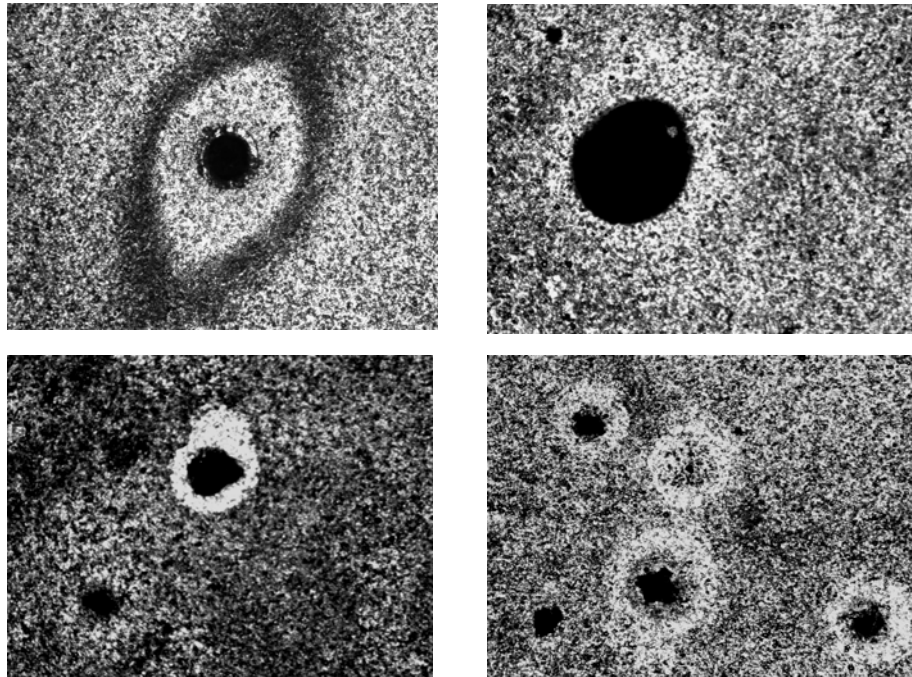
Most pits revealed a bright region around them, characteristic of a cathode region around a localized anode region. The shape of this region varied from circular to elliptical. (figure 4) On the AA 1050 alloy coupon surface in contact with the AISI 304 stainless steel coupon, larger pits were observed, revealing the deleterious effect of a bimetallic contact. The two surfaces of the pre-oxidized and scratched AA 1050 alloy coupon revealed few small pits and no bright regions around the pits. Also, no pits were observed along the scratch.

Figure 3. Micrographs revealing pits and bright regions on horizontal AA 1050 alloy coupon surfaces.

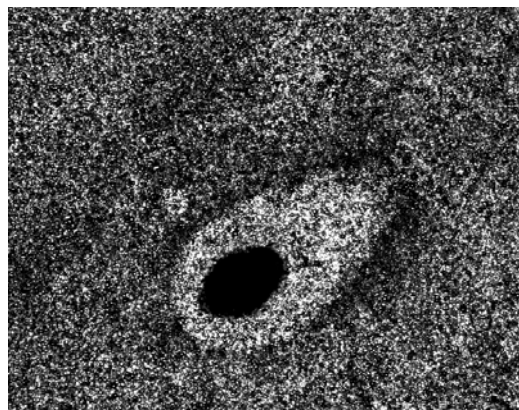
On the surfaces of individual AA 1050 alloy coupons, round and irregularly shaped pits were observed. Many pit clusters were also observed. The bright cathode areas associated with the pits were shaped like a comet with a tail, giving a clear indication of the top and bottom of the vertically oriented coupons. (figure 4)

Figure 4. Optical micrograph of vertically oriented AA 1050 alloy coupon surface revealing the comet shaped bright region around a pit.

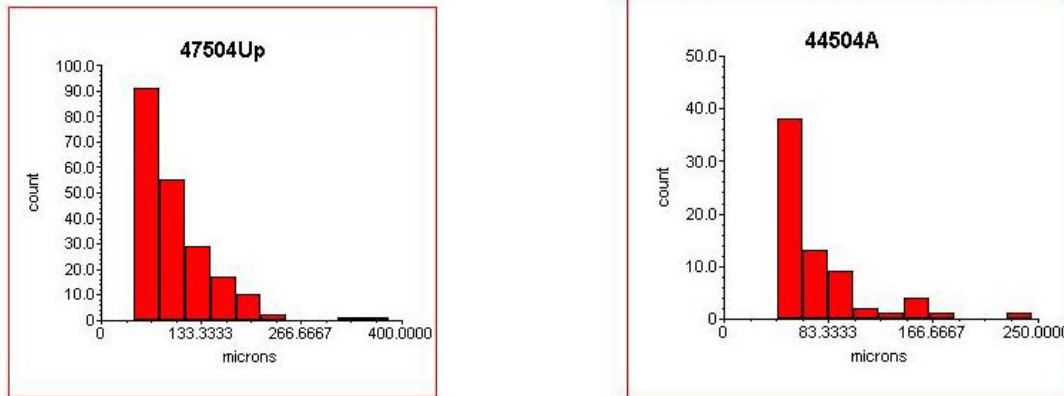
Comparison of pit histograms of the horizontally oriented surface of AA 1050 coupon facing upwards exposed for one year, with that of the surface of the same alloy oriented vertically (Figure 5) revealed that twice as many pits (size range 40-50  $\mu\text{m}$ ) form on the horizontal coupon as compared to that on the vertical coupon.

Figure 5. Histograms of pit count versus pit size on the AA 1050 alloy coupon surface facing upwards (47504Up) and a vertically oriented surface of the same alloy (44504A)

Comparison of pit histograms of vertically and horizontally oriented AA 6061 alloy as well on coupons of both alloys exposed for 2 and 3 years also revealed similar behavior. This indicated that among the many parameters that control pit formation, such as alloy composition, metallurgical state and water parameters, settled solids contribute to pit initiation and formation.

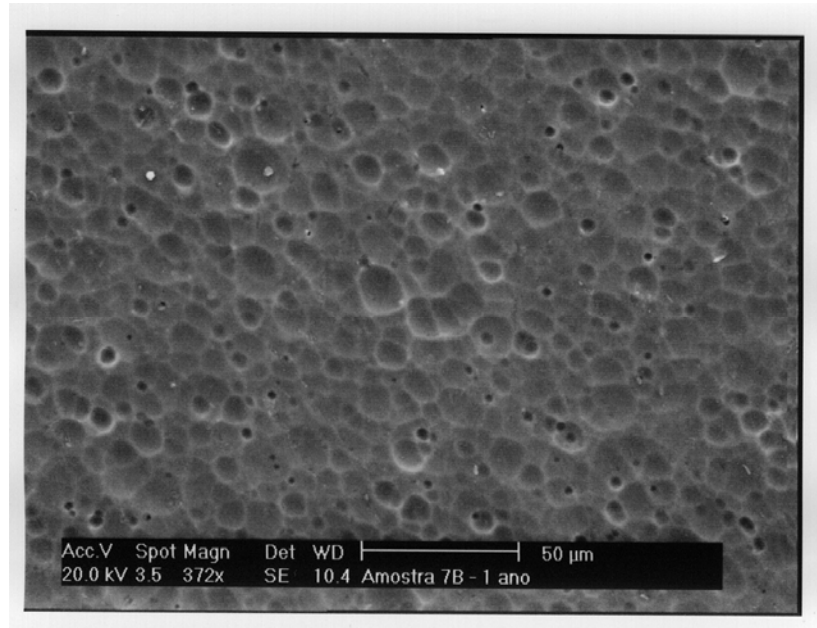
Figure 6. Scanning electron micrograph of AA 1050 alloy coupon surface exposed for 12 months in the IEA-R1 SFSS.

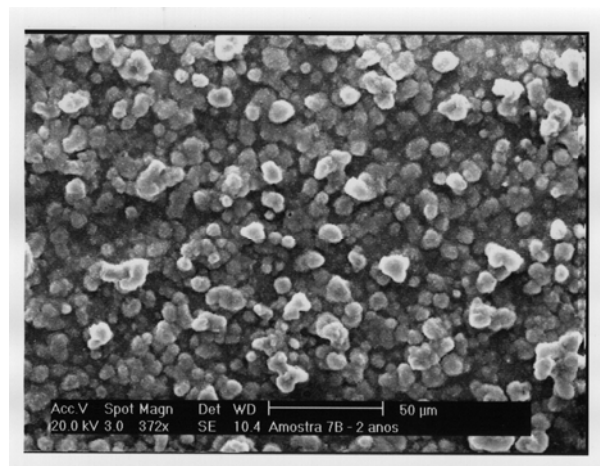
This part of the study was initiated when IEA-R1 reactor operations reported greying of all Al surfaces inside the reactor pool. Consequently some racks were withdrawn after 22 months of exposure instead of the planned 24 months. The surfaces of coupons exposed for 22 months (nominal 2 years) were darker and stained compared to those exposed for 12 months. These stains obscured the pits from being observed in an optical microscope. The stained regions were analyzed by SEM and XRD and found to be the aluminium oxide Bayerite, as shown in the micrographs in figures 6 and 7. This oxide forms at temperatures below 70° C. The pool water temperature was reported to be 10° C higher than normal during a six month period. The rack with coupons exposed for 12 months were withdrawn prior to the increase in reactor water temperature. This six months period also coincided with reactor operation at 5MW. The increase in pool water temperature was attributed to insufficient cooling capacity of the heat exchanger. The reactor power has subsequently been reduced to 4MW awaiting installation of a new heat exchanger. This exemplifies the added advantage of conducting a corrosion surveillance program.

Figure 7. Scanning electron micrograph of AA 1050 alloy coupon surface exposed for 22 months in the IEA-R1 SFSS.
