TECHNICAL REPORTS SERIES NO. 418

Corrosion of Research Reactor Aluminium Clad Spent Fuel in Water

International Atomic Energy Agency

This report documents the work performed in the IAEA Co-ordinated Research Project (CRP) on Corrosion of Research Reactor Aluminium Clad Spent Fuel in Water. The project consisted of the exposure of standard racks of corrosion coupons in the spent fuel pools of the participating research reactor laboratories and the evaluation of the coupons after predetermined exposure times, along with periodic monitoring of the storage water. The project was overseen by a supervisory group consisting of experts in the field, who also contributed a state of the art review that is included in this report.

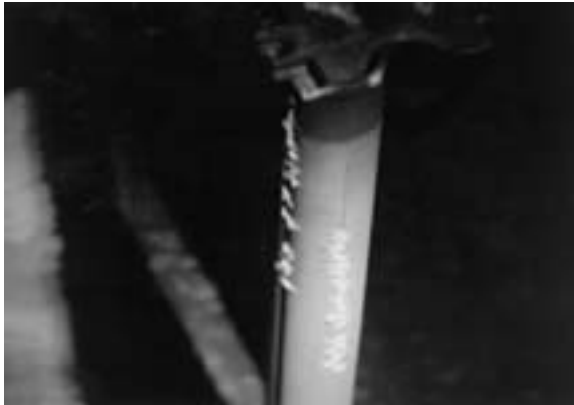
FIG. 1.3. Nodular corrosion on aluminium clad U-Al alloy fuel.

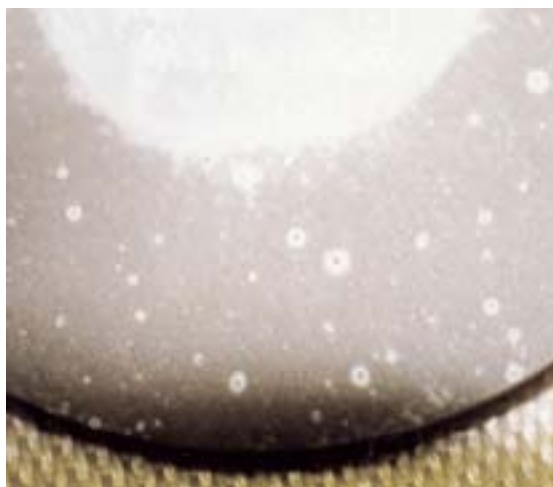
A total of six racks were withdrawn from the two basins during 1996–1997. These racks were withdrawn after six and 12 months of exposure. Out of the 360 individual coupons examined during the first year of exposure, pitting was observed on four coupons, as shown in Fig. 1.6. Further detailed investigations on these coupons using scanning electron microscopy showed iron filings embedded on the surface of the aluminium. These iron particles were cathodic with respect to the aluminium coupon, causing localized attack on the aluminium and shallow pitting. Once a pit developed in the aluminium, the iron particle dropped out, leaving a round, shallow pit. Subsequent

FIG. 1.6. Pitting caused by embedded iron filings.

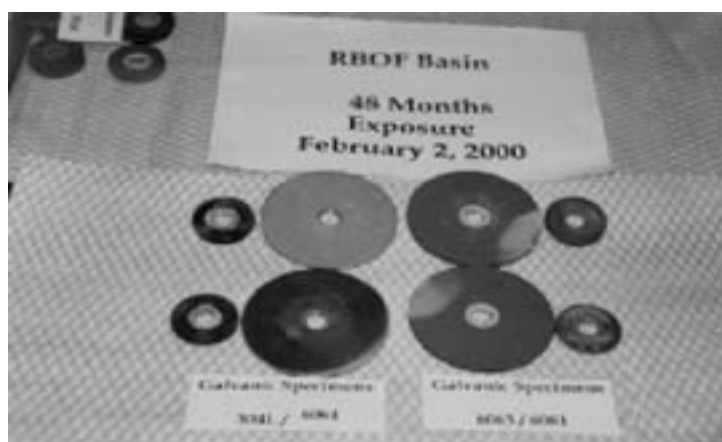
FIG. 1.7. Possible biofilm passivation on aluminium top external surfaces.

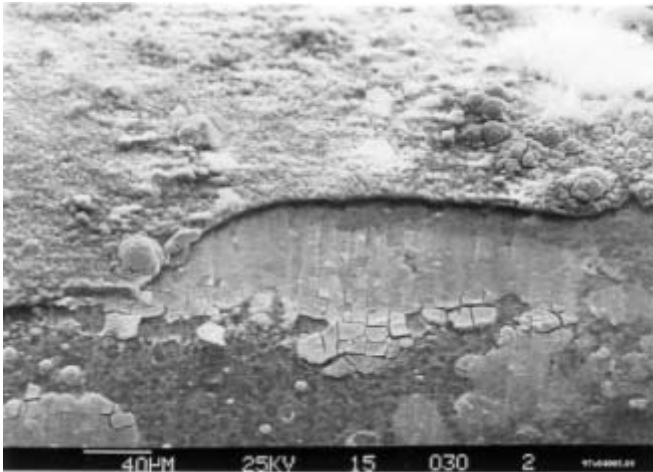
FIG. 1.8. Biofilm on aluminium alloy in high purity water.

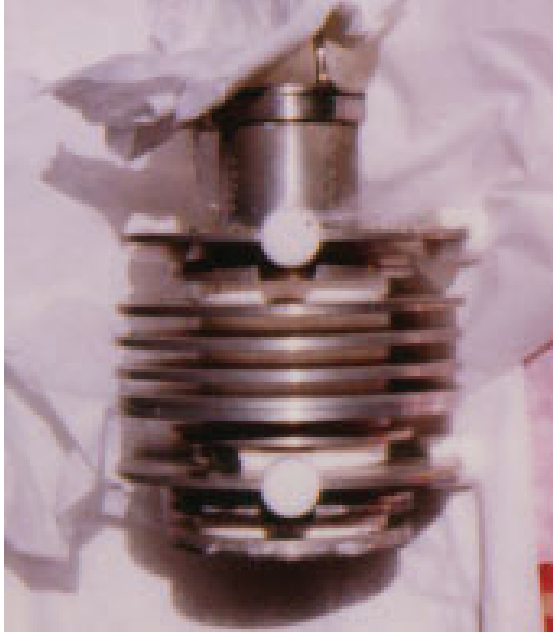
FIG. 5.3. Side view of rack 1 after extraction. Corrosion products can be seen emerging from inside the two galvanic couples at the bottom of the assembly.

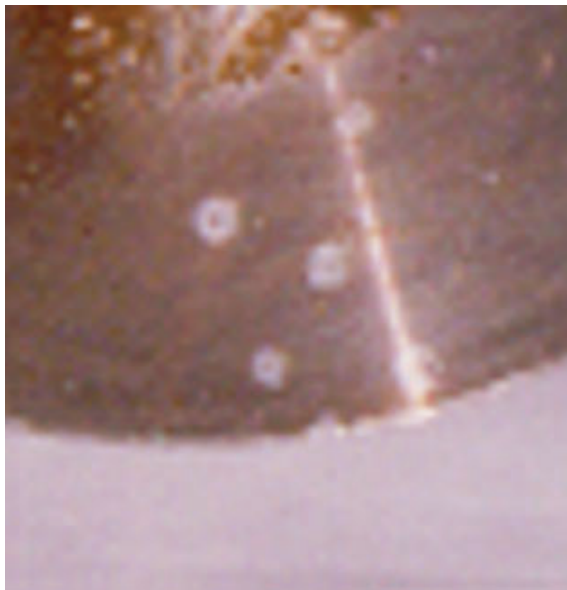
FIG. 5.4. Pits in the middle of the zone where white blisters were found.

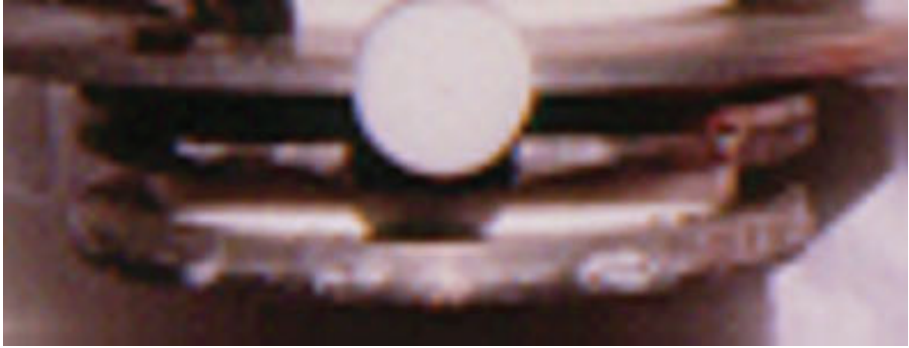
FIG. 5.5. Corrosion products emerging from inside the galvanic couples.

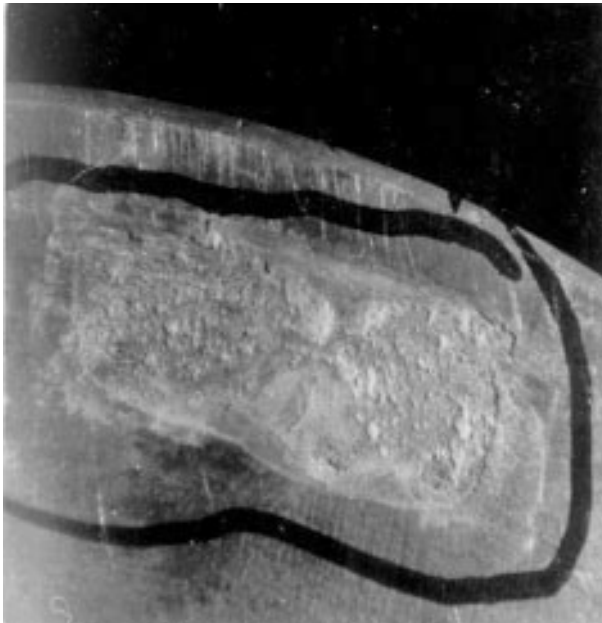
FIG. 5.6. Coupon 6061/77. Attack under Teflon separator (6 ×).

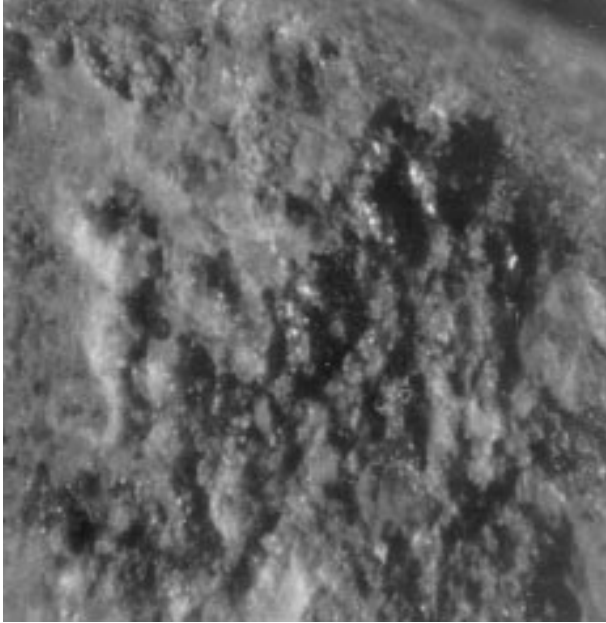
FIG. 5.7. Higher magnification of Fig. 5.6, showing pitting (50 ×).

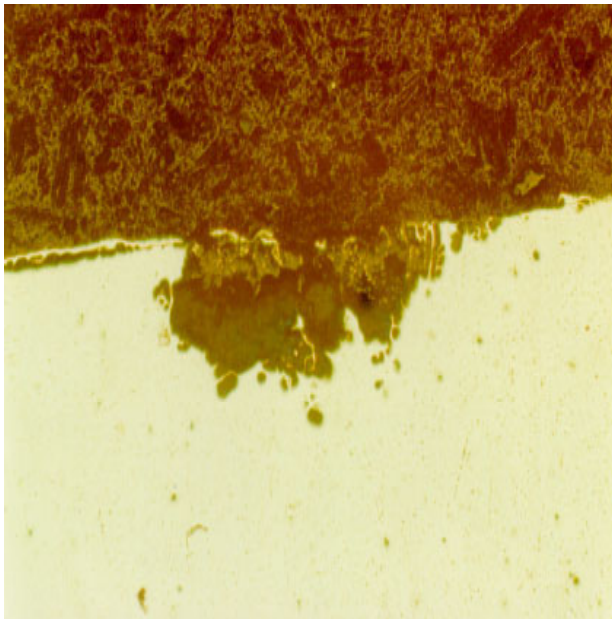
FIG. 5.8. Cross-section of isolated pit (50 ×).

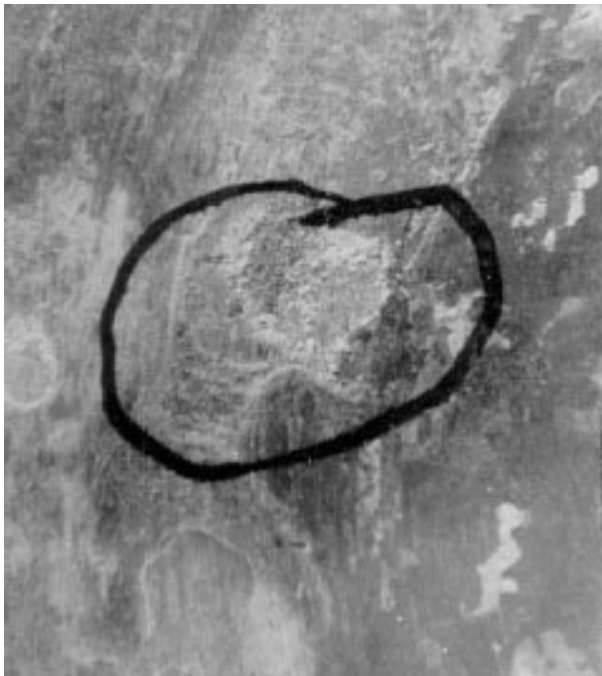
FIG. 5.10. Coupon 6063/64, crevice corrosion (6 ×).

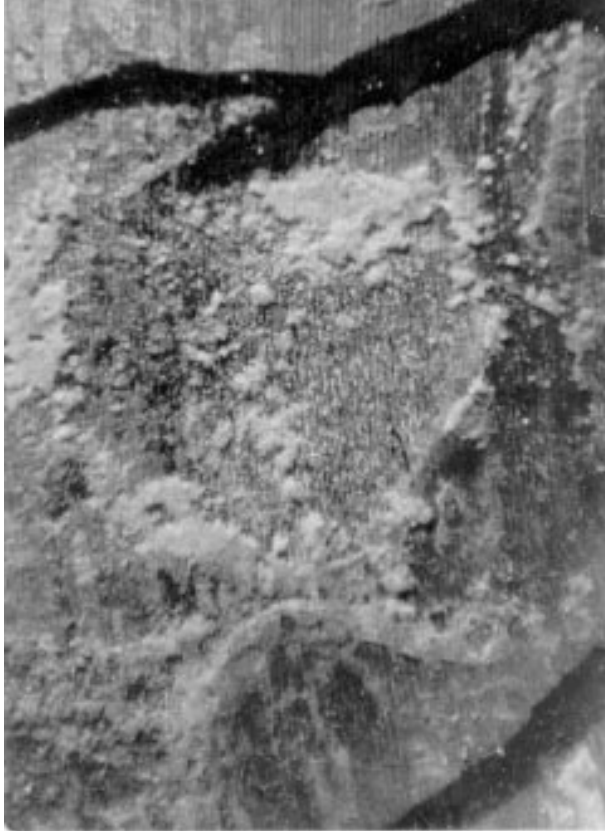
FIG. 5.12. Coupon 6064/64, crevice corrosion (18 ×).

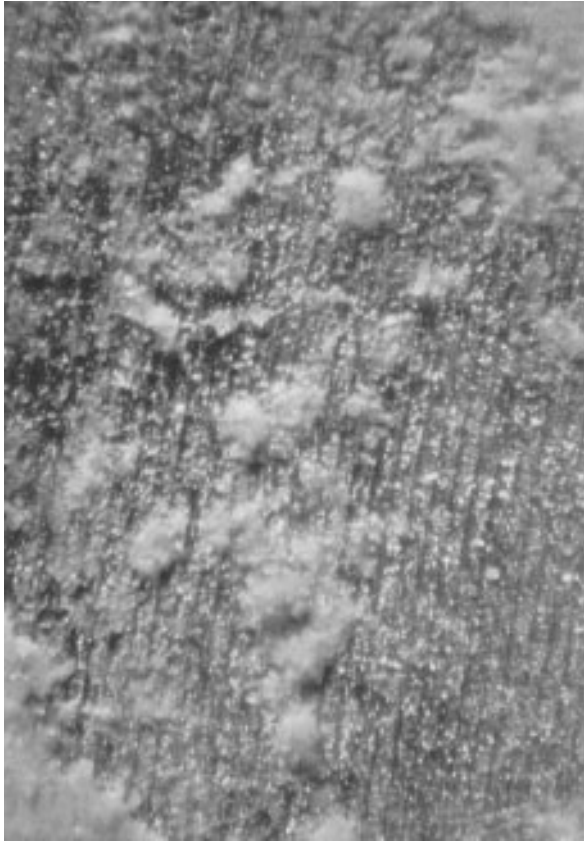
FIG. 5.13. Coupon 6064/64, crevice corrosion (50 ×).

magnifications, whereas Fig. 5.13 shows the outer surface of the same sample, which is virtually clean. In Figs 5.14 and 5.15, massive pitting produced on sample 6061/08 at the inner side of the galvanic couple can be seen at two magnifications, whereas in Fig. 5.16 the clean outer surface of the same coupon can be seen.

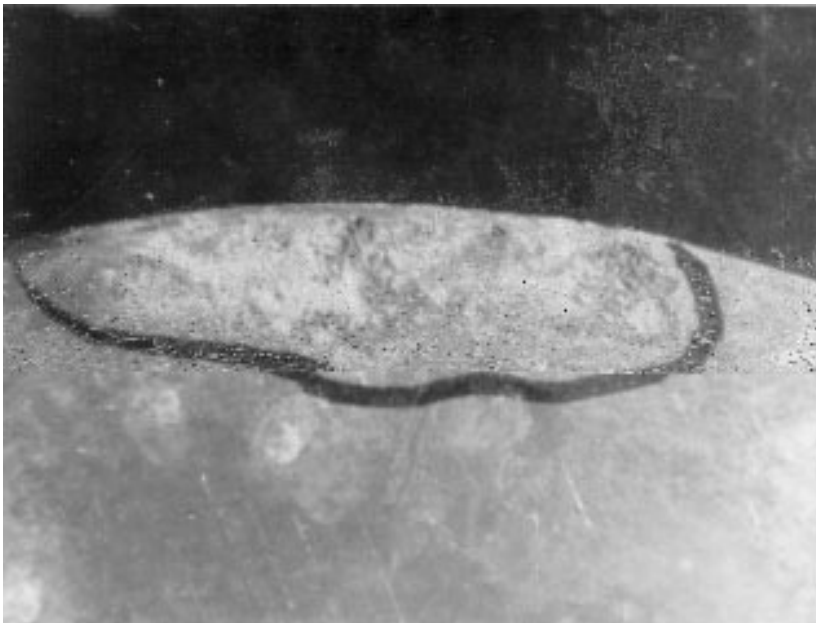
FIG. 5.14. Coupon 6061/08, galvanic corrosion (6 ×).

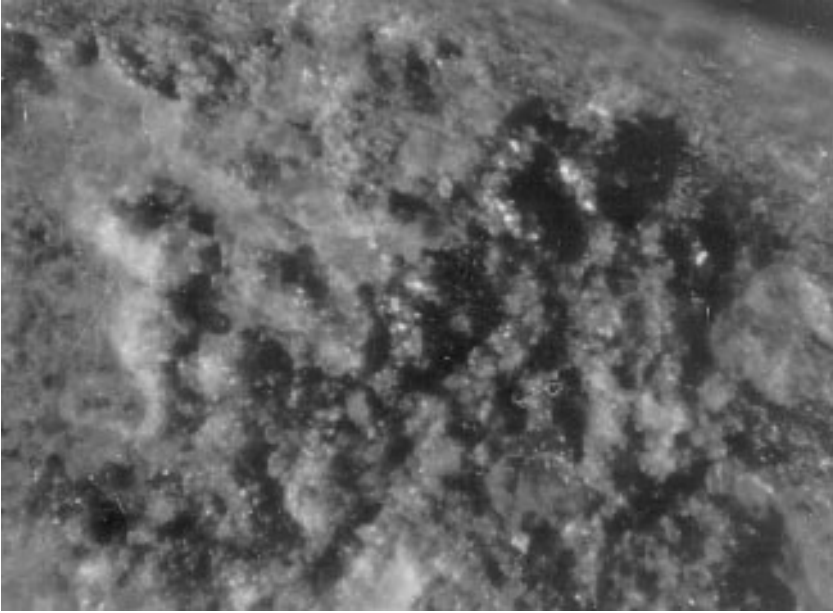
FIG. 5.15. Coupon 6061/08, galvanic corrosion (50 ×).

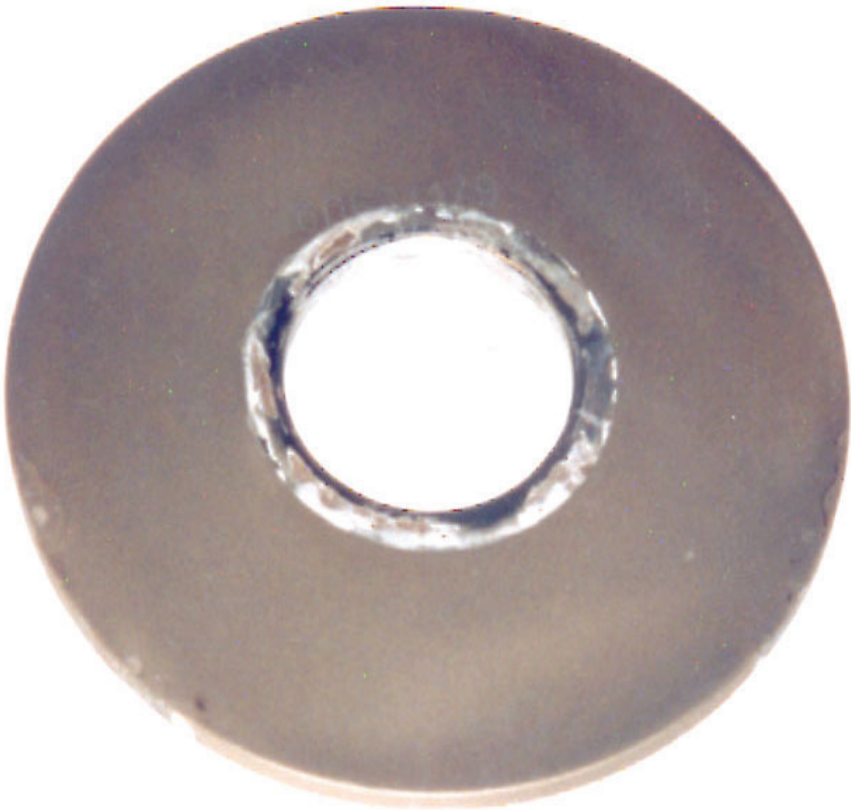
FIG. 5.26. Thick oxide covering surface of sample (1 ×).

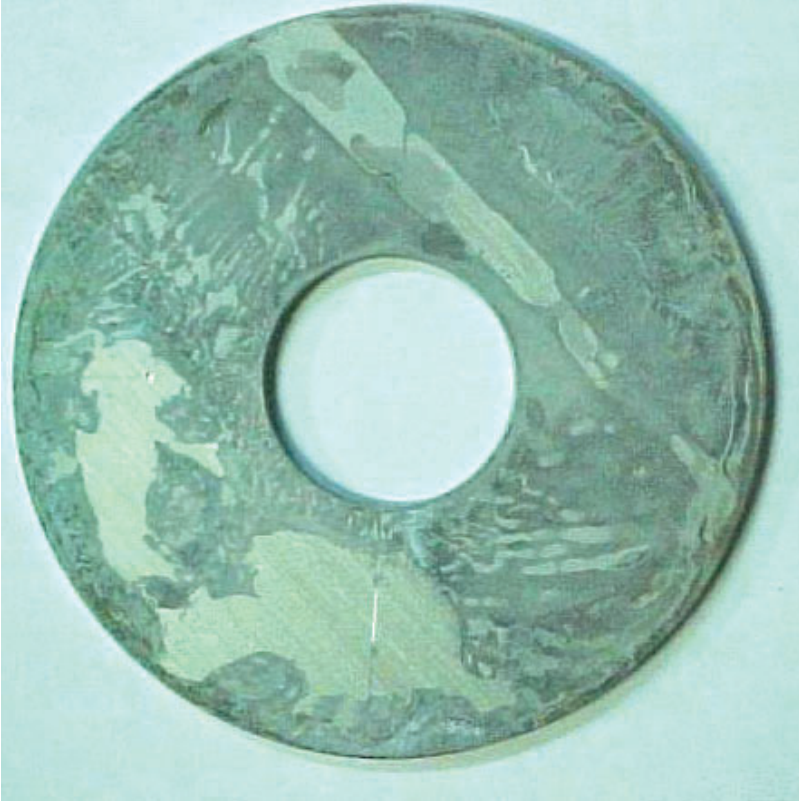
FIG. 5.27. Uneven oxidation (1 ×).

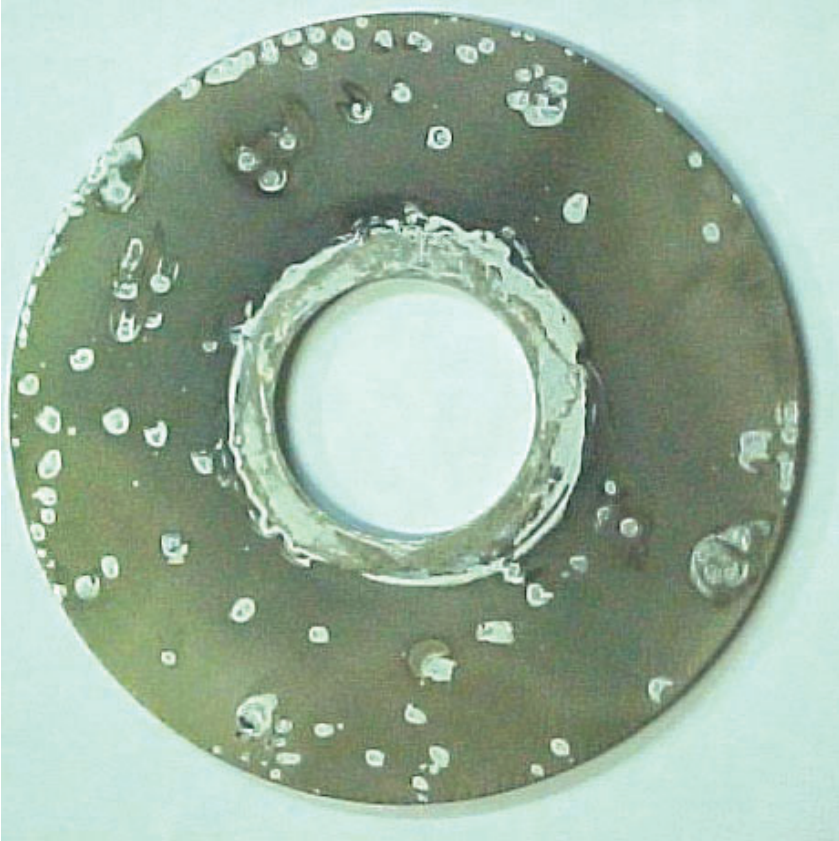
FIG. 5.28. Pitted surface (1 ×).

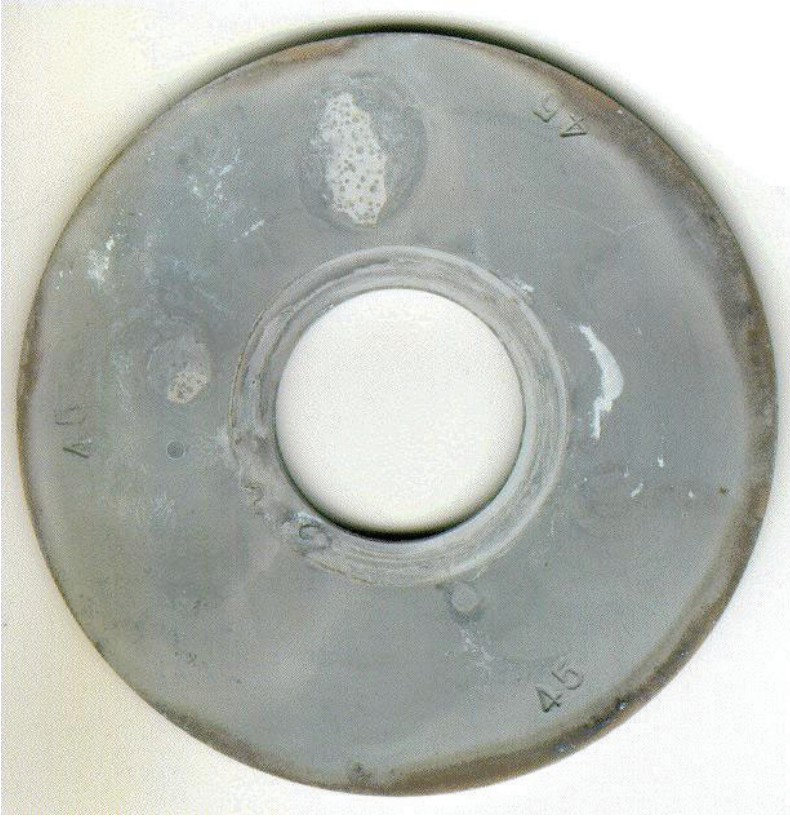
FIG. 5.29. Islands of pits on an otherwise intact sample (1 ×).

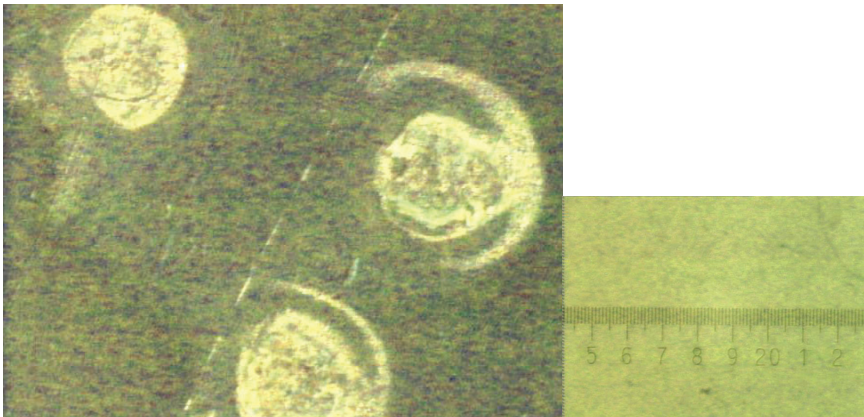
FIG. 5.33. Large pits. One main division equal to 100 μm.

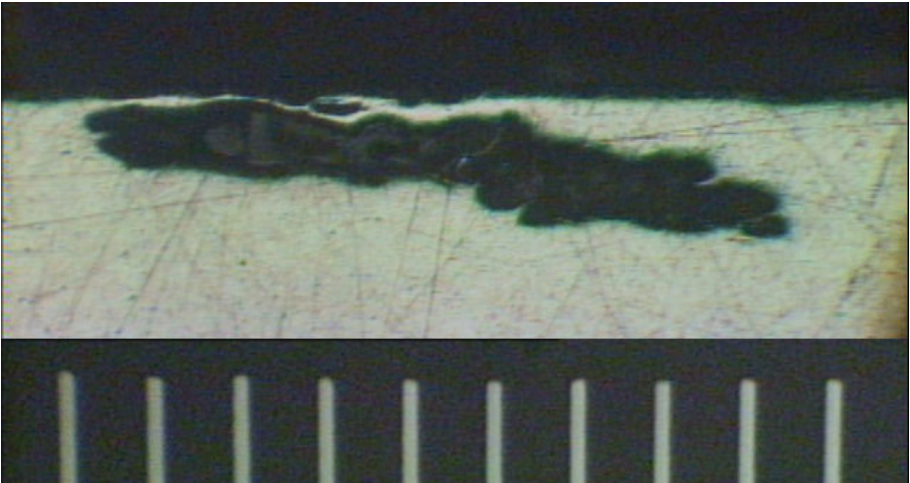
FIG. 5.35. Magnification of pit A. One division equal to 100 μm .

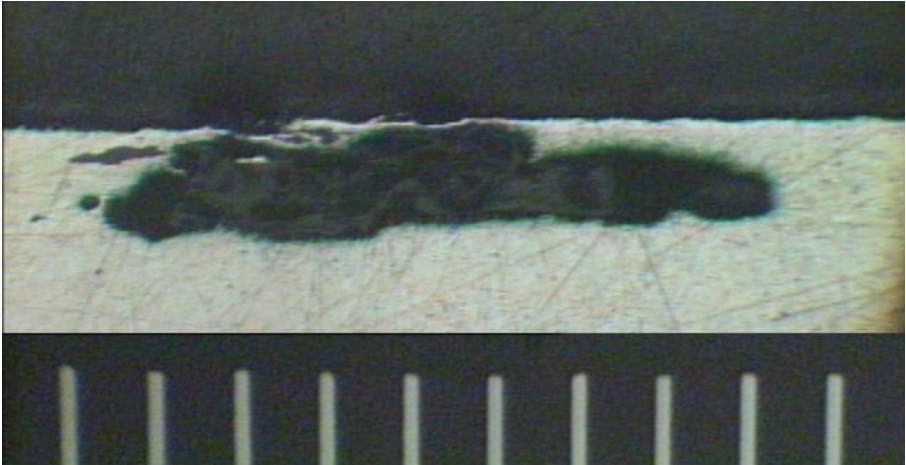
FIG. 5.36. Magnification of pit B. One division equal to 1 μm .

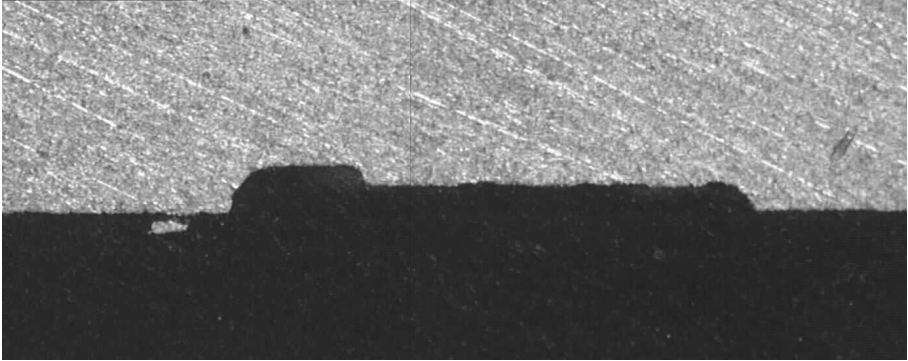
FIG. 5.37. Shallow attack on external face of crevice sandwich. Dimensions of the attack 5.5 mm × 0.5 mm.

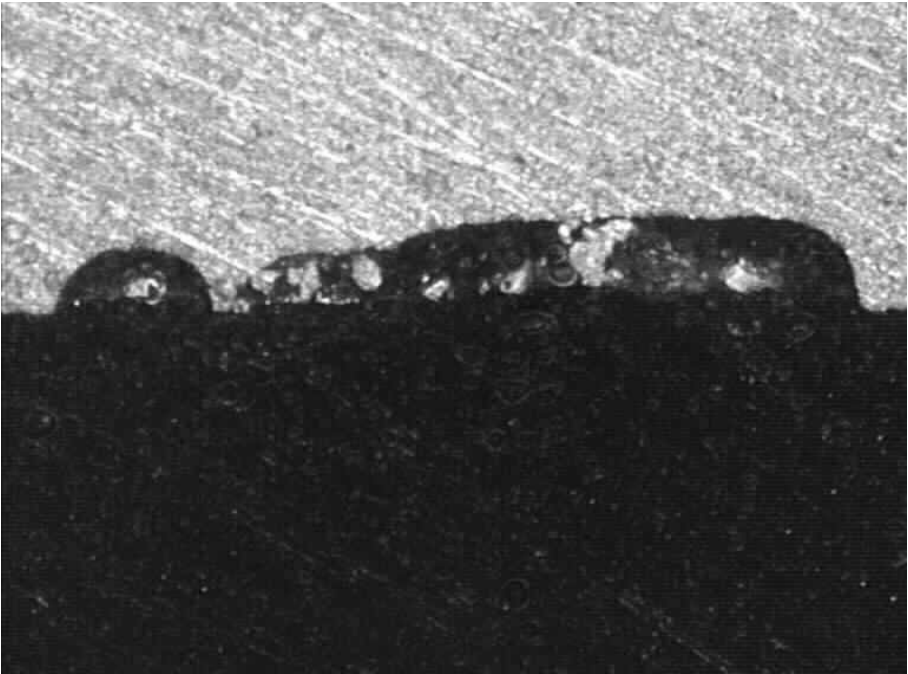
FIG. 5.38. Particle pitting on coupon 11. Size of area pictured 5.4 mm × 4 mm.

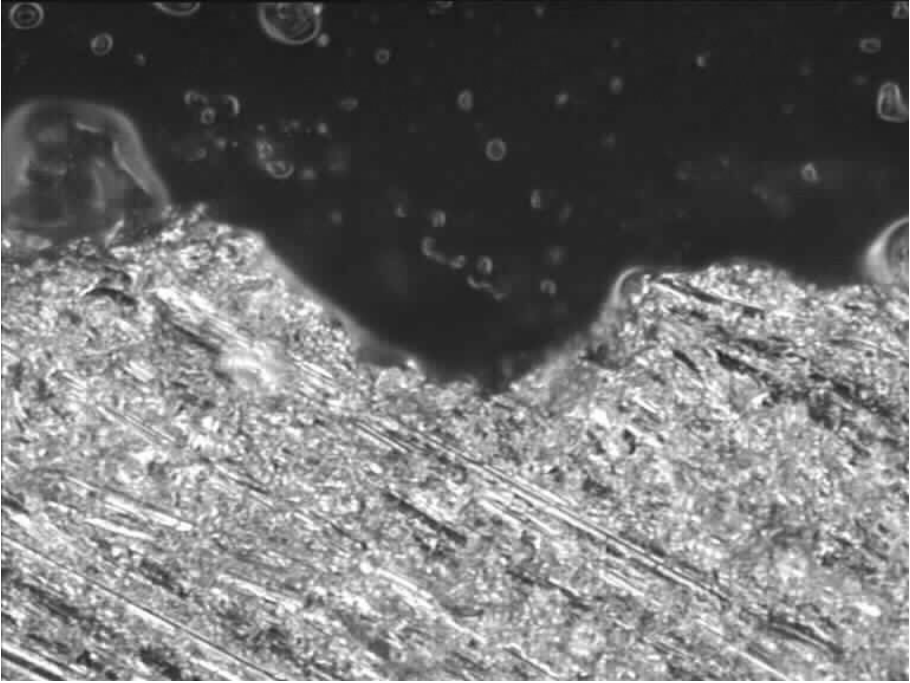
FIG. 5.39. Small pit on inner side of crevice. Size of area pictured 1.35 mm \times 1 mm.

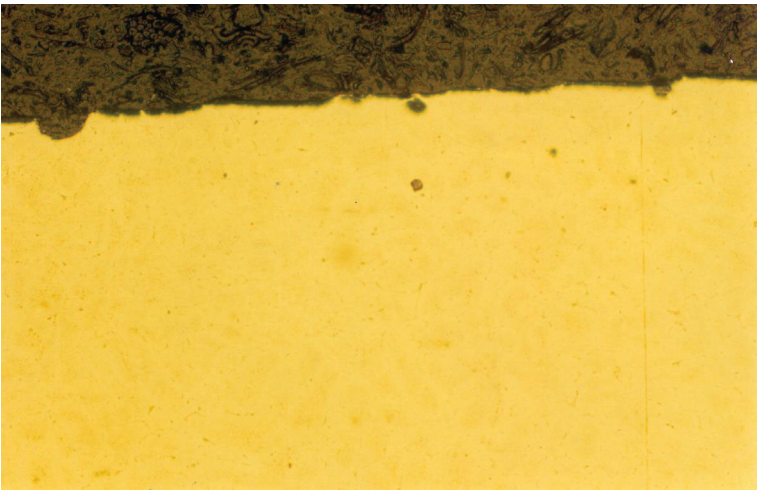
FIG. 5.40. Small pits on inner side of crevice. Size of area pictured 750 μ m \times 500 μ m.

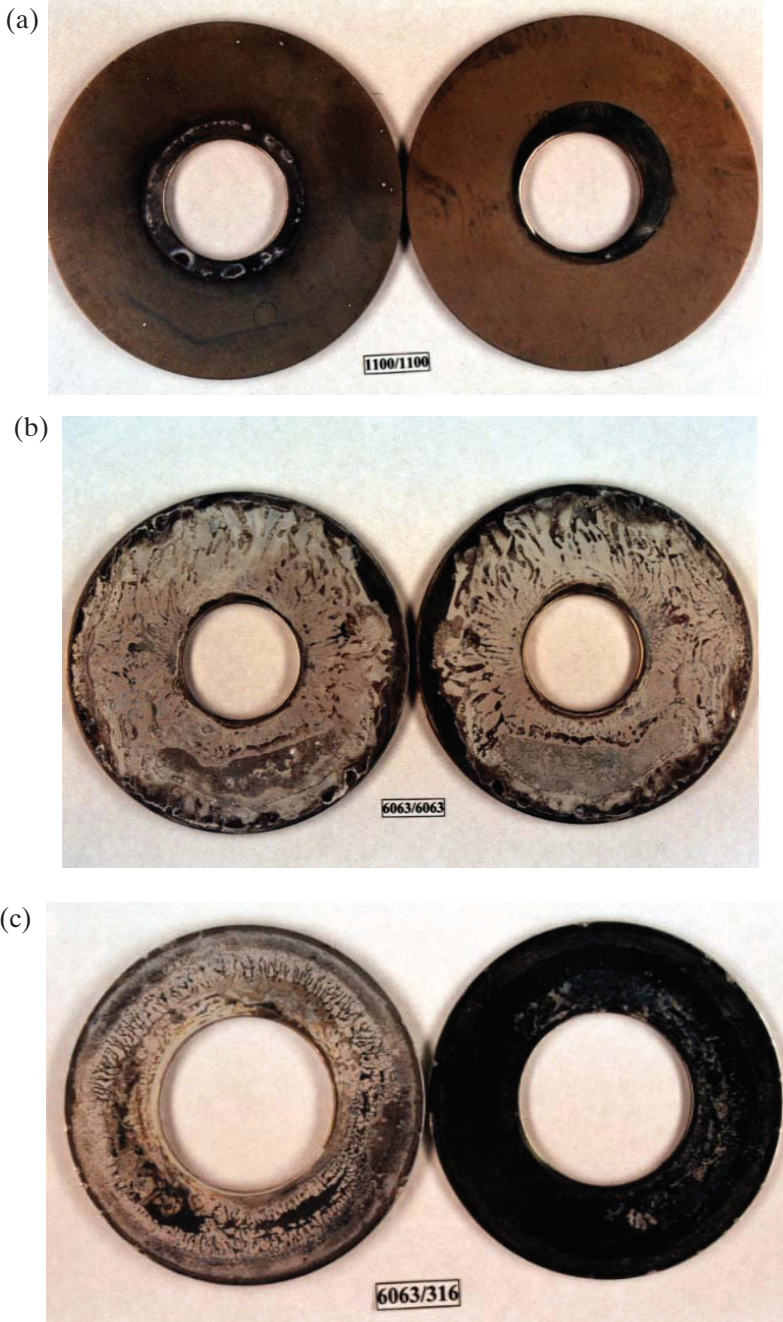
FIG. 6.1. Surface features on (a) an 1100–1100 crevice couple, (b) a 6063–6063 crevice couple, and (c) a 6063–SS 316 galvanic couple from rack 2A.

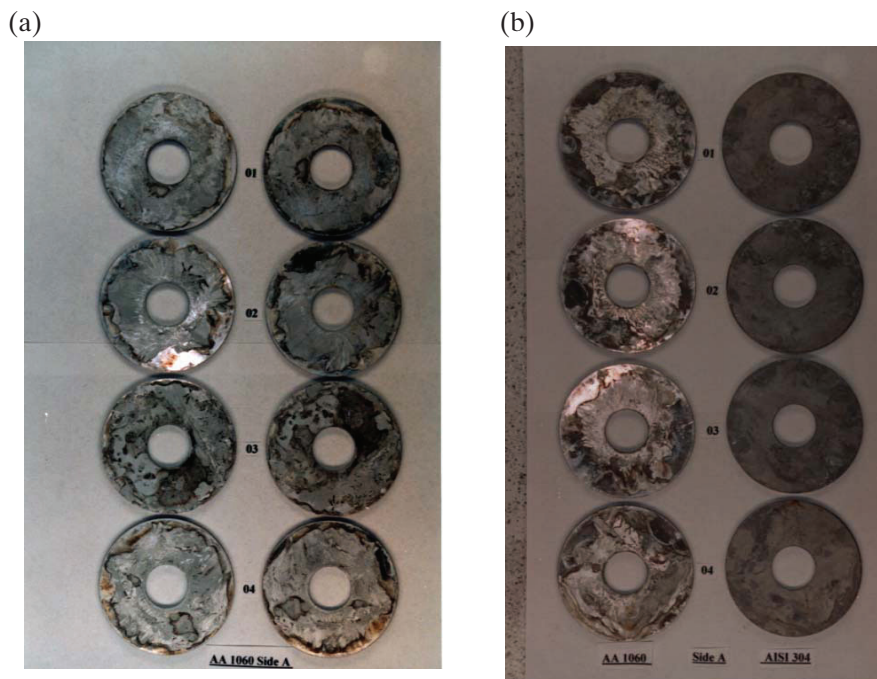
FIG. 6.3. Surface features on the facing surfaces of (a) 1060–1060 crevice couple coupons and (b) 1060–SS 304 galvanic couple coupons.

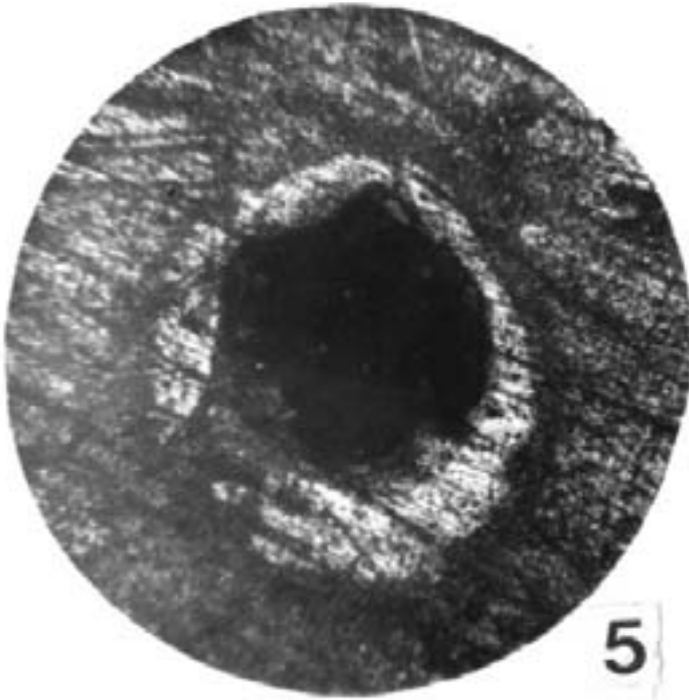
FIG. 7.3. Pits on coupon surface from rack 5.

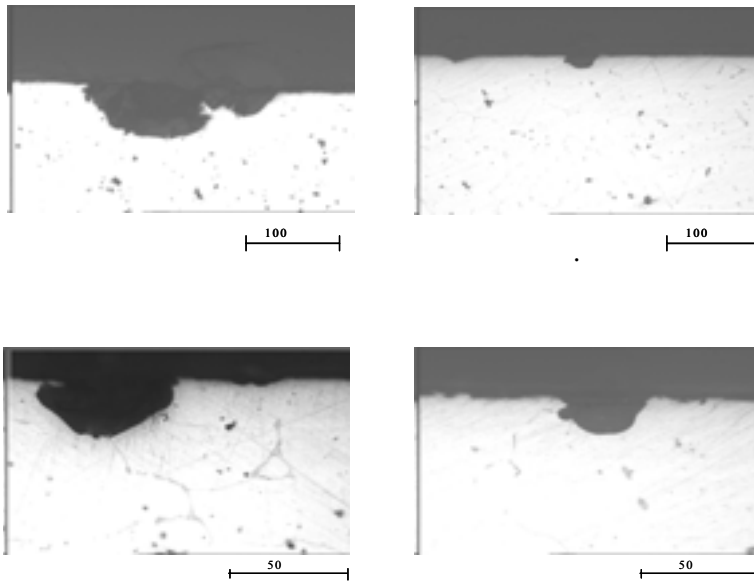
FIG. 8.1. Pits on SZAV surfaces exposed to the basin water.

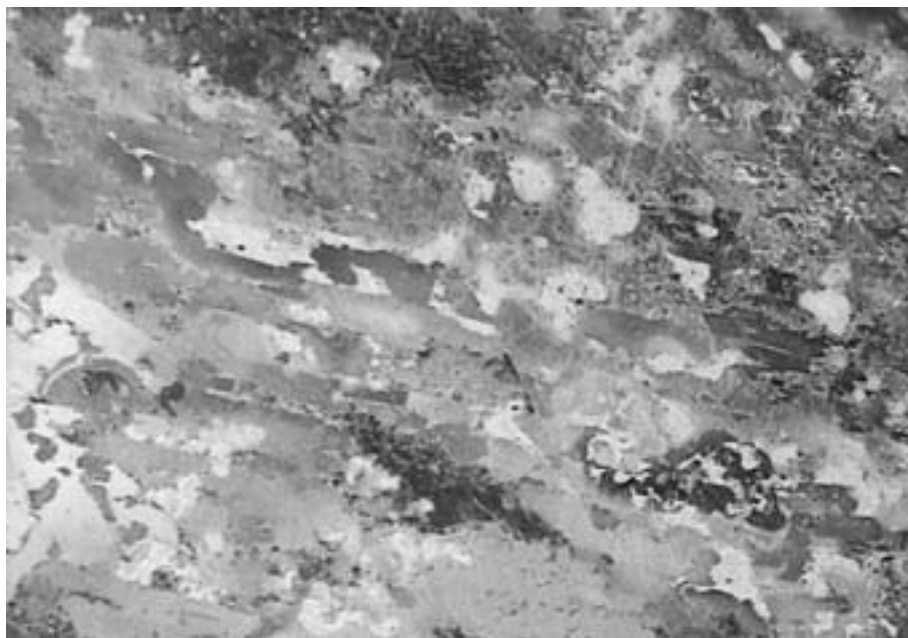
FIG. 8.2. Deposit on a 6063 coupon from rack 2 after exposure to the basin water for one year.

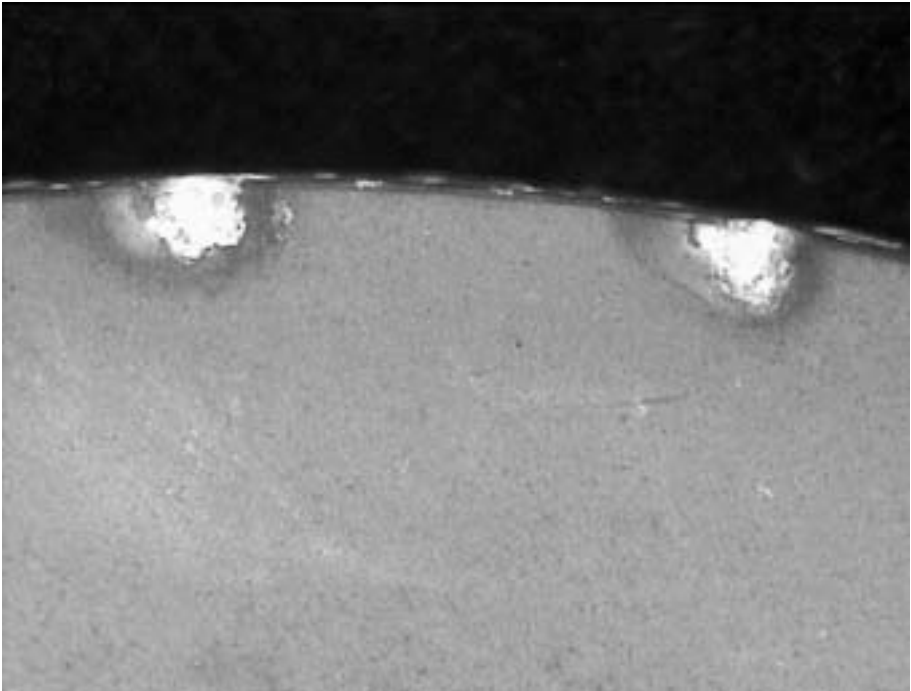
Some pits were seen on the surfaces of the coupons (Fig. 8.5). A few seemed deeper than the others. To study this in detail, metallographic coupons were prepared (polished) to examine the pits. All the coupons were carefully evaluated. These pits were neither deeper nor larger than those observed on coupons from rack 1. Hence no pictures of these pits have been presented.

FIG. 8.5. Surface of a 6063 coupon from rack 2.

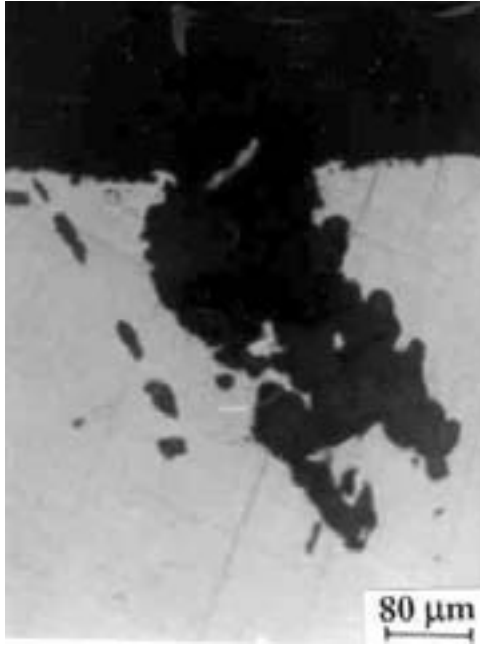
FIG. 9.4. Coupon surface showing a pit.

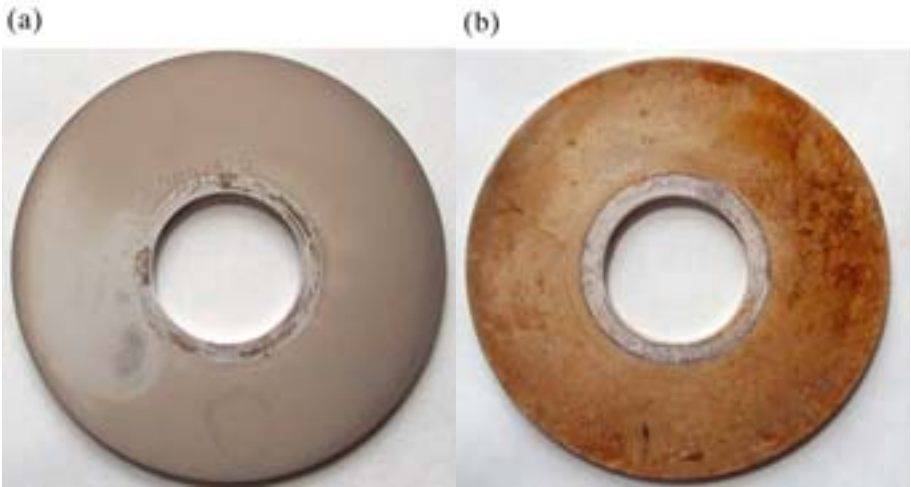
FIG. 11.2. Coupon surfaces (a) without film and (b) with red and brown film.

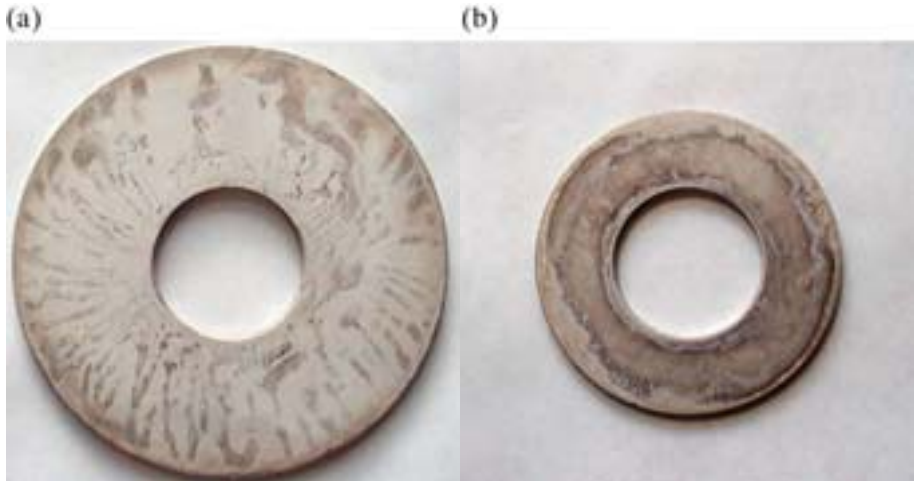
FIG. 11.4. Surface of coupons from racks 2 and 3 in contact with (a) an alloy of the same grade, and (b) SS 316.

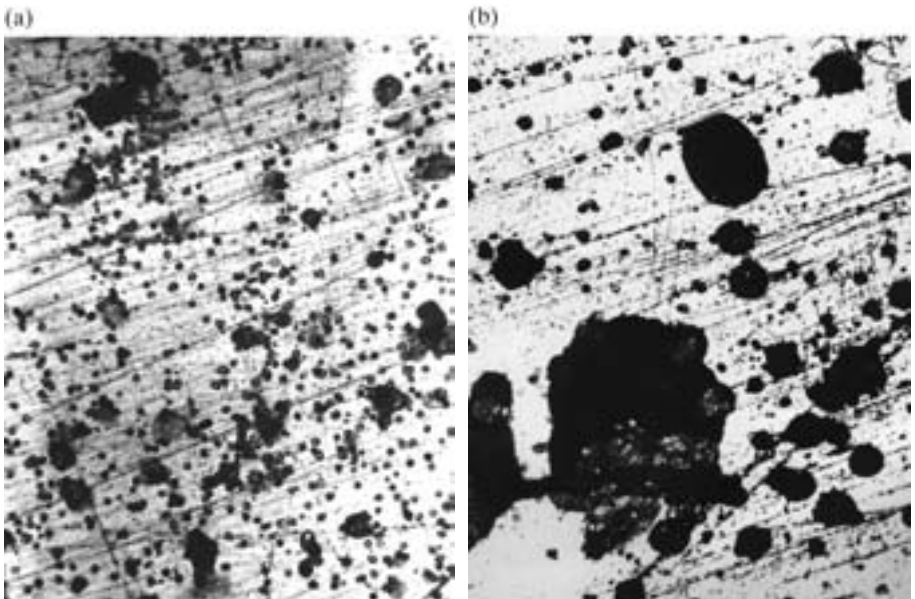
FIG. 11.5. Contact surfaces on coupons with different degrees of damage: (a) one year of exposure, and (b) two years of exposure ($100\times$ magnification).

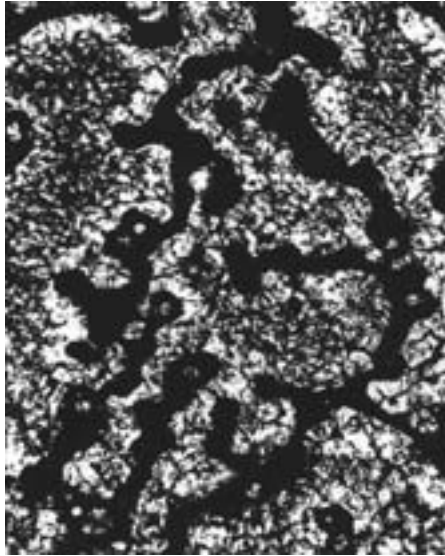
FIG. 11.6. Coupon surface in contact with steel (100 × magnification).

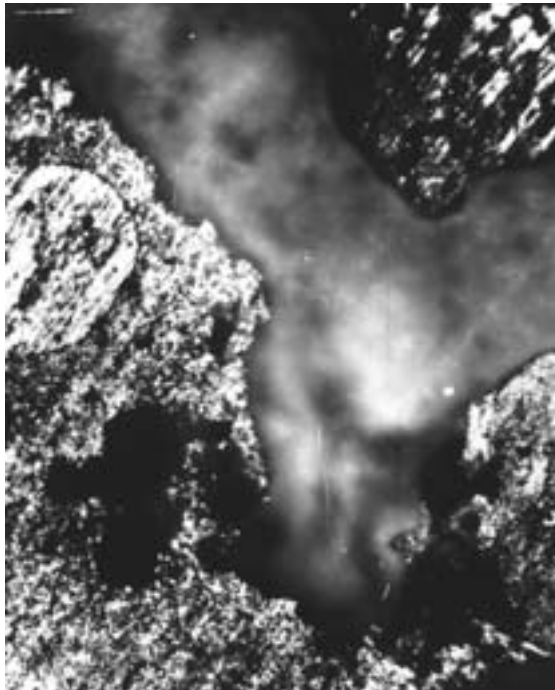
FIG. 11.7. White film region on coupon of rack 1 (100 × magnification).

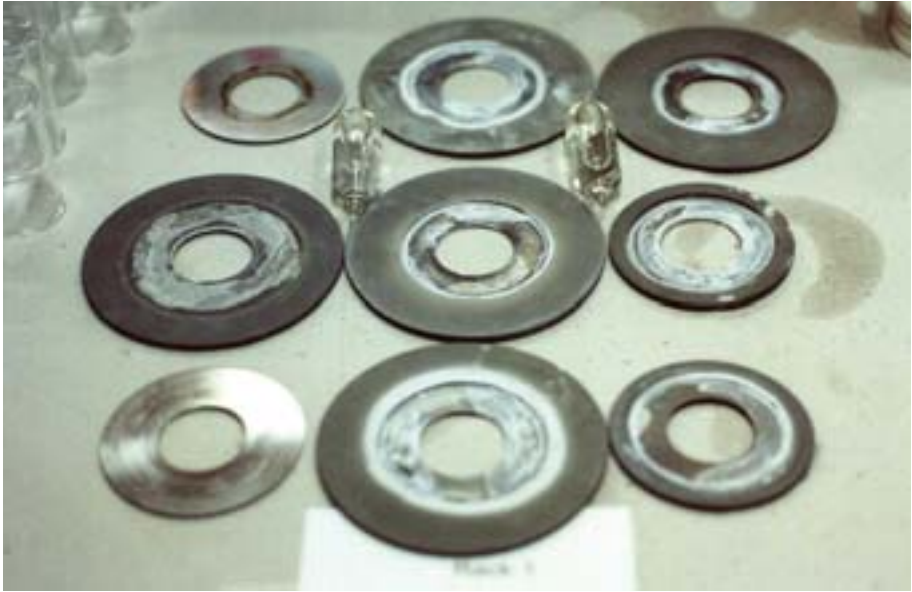
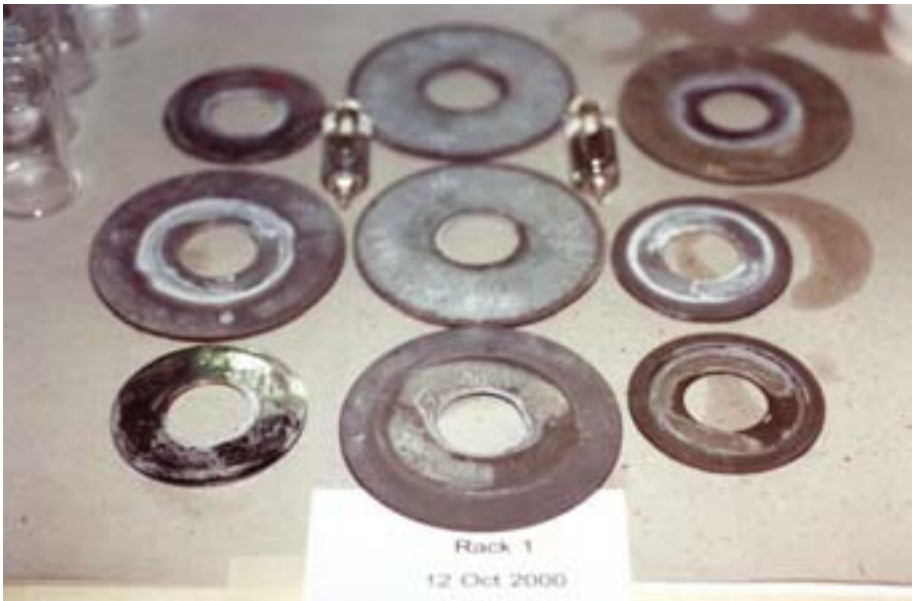
FIG. 13.1. Coupons of rack 1. (a) Non-contact side; (b) contact side.

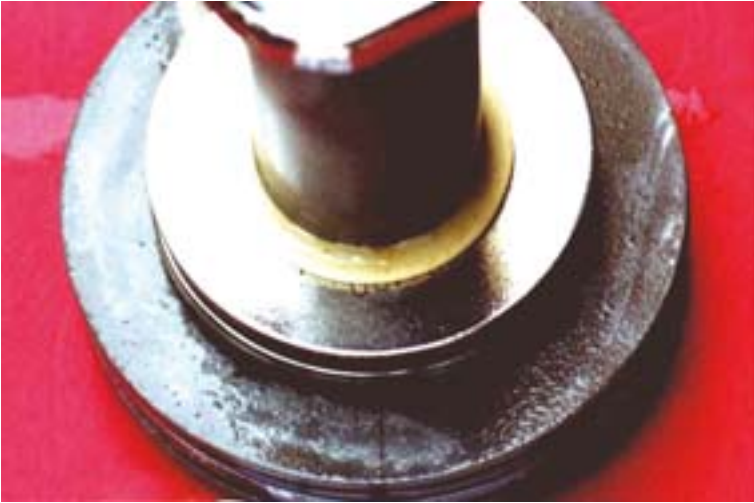
FIG. 13.4. Rack 2. Scratch mark on the 6063 alloy after 24 months of immersion.

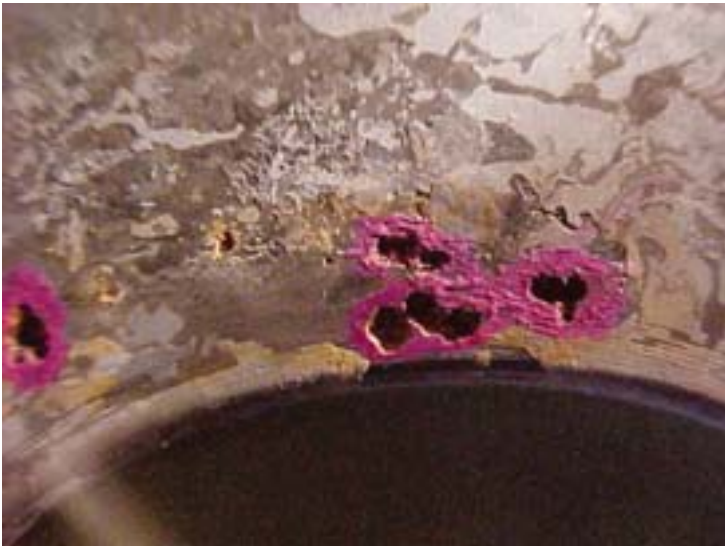
FIG. 13.5. Pits on the contact side of the crevice couple from rack 2.
