Analysis of the criticality of flaws found in trunnion of grinding ball mills used in mining plants

M.D.M. Neves*, A.H.P. Andrade, D.N. Silva

IPEN – Instituto de Pesquisas Energéticas e Nucleares, São Paulo, Brazil

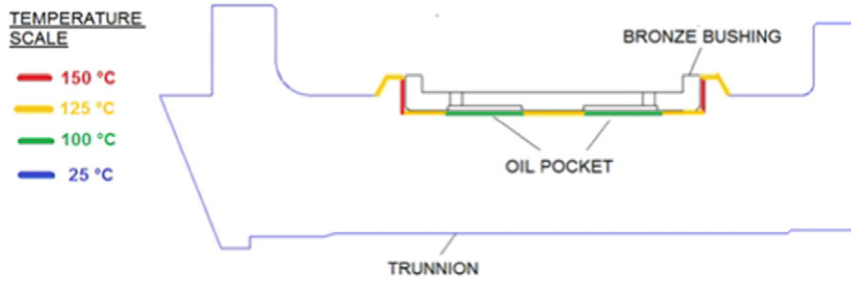
Fig. 5. Surfaces temperatures simulation for thermal stresses.

were found at the ends of the trunnion shoulder. There is no clearance between the bushing and the trunnion shoulder from an axial direction. Different thermal expansion between the trunnion and the bushing led to higher contact, and consequently heating as assumed in Fig. 5.

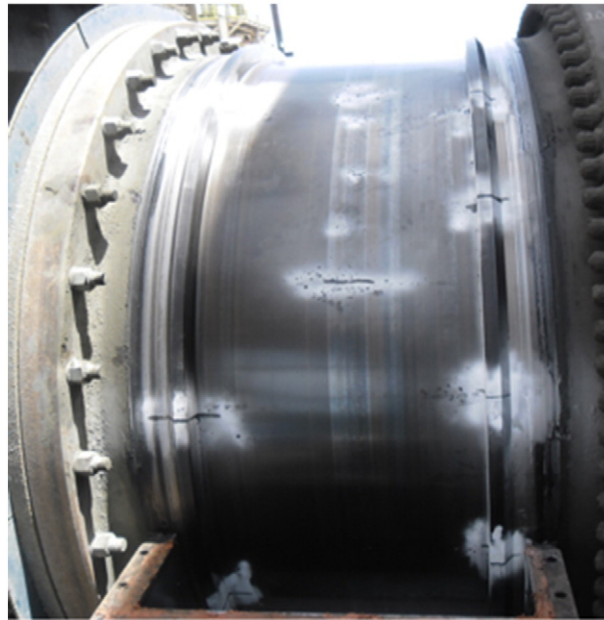
The cracks to be analyzed in this study appeared in a trunnion of a ball mill in the region of axial and radial contact with the bearing bushing of the mill. Those cracks were caused by a lack of lubrication, which allowed the metal to metal contact between the trunnion and the bushing. This contact led to a heating in the trunnion, inducing thermal stresses that culminated in the appearance of cracks in various regions of the trunnion.

Fig. 6. Cracks location overview.

The condition of the trunnion and trunnion bearing bronze bushing immediately after the metal-metal contact are shown in Figs. 9 and 10 respectively. The cracks were not visually detected, however after a dye penetrant test, cracks shown up as indicated in Fig. 6. It was realized there were some dark marks on both components. There were also some light marks which are coincident to oil pockets location, where the oil film is formed, which resulted in less contact between trunnion and bushing, because of residual oil on them. In Fig. 10 it is also shown that the oil inlet holes, where the oil coming from the lubrication system achieved the bushing.

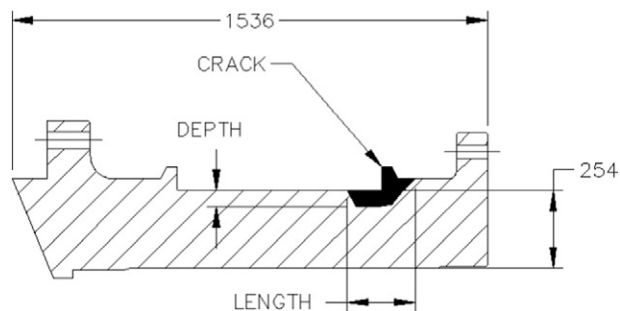
Fig. 7. Location of most critical crack.

Fig. 8 showed the stress range calculated by Ansys software, version 12.1 for a 30% ball charge, where it was noted that the maximum stress range at the trunnion journal is 40.8 MPa, which was quite below the yield strength indicated in the Table 1. Looking at Fig. 7, considering the location of the most critical size, the stress range at this crack location was even lower, close to 31 MPa. This means there should not have appeared any crack at this location, called trunnion shoulder, which was supposed to be a low stress region. Moreover, the presence of longitudinal cracks meant the stresses to cause those that were circumferential.

Table 2 indicated the measured length and depth obtained by the periodical inspection of the most critical crack. The number of cycles was based on mill speed of 12.19 rpm. According to the standard BS7910 after 645 days, crack size theoretically should have been 55.46 mm and per ASME Section XI, Appendix A, it should have been 71.88 mm. BS7910 standard result was closer to actual depth value and ASME Section XI was more conservative (Table 3).

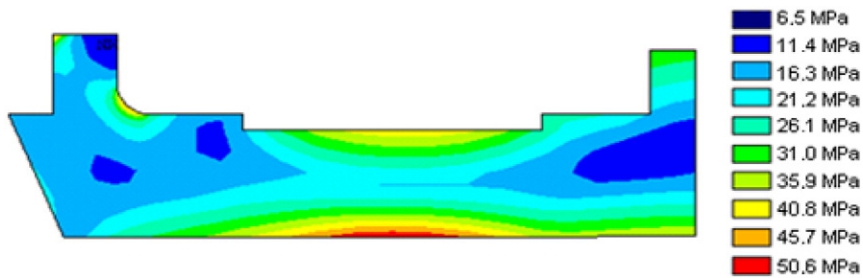
Fig. 8. Trunnion finite element analysis.

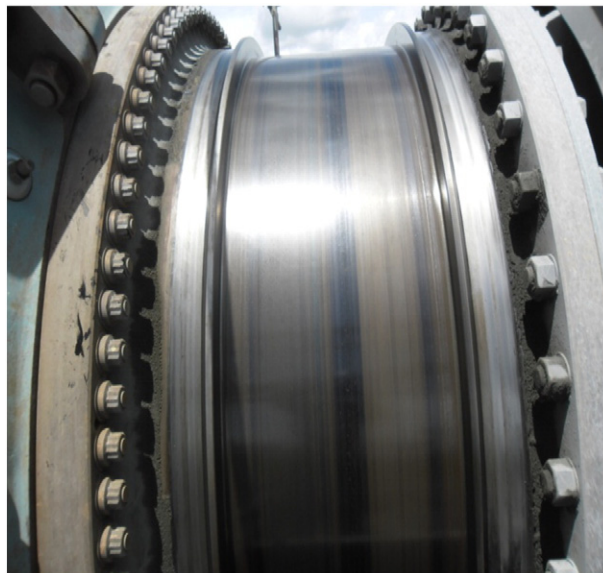
Cracks nucleation was related to an incident caused by lack of lubrication which led to a metal–metal contact between the trunnion and the bronze bushing of a hydrostatic bearing. The lack of lubrication was originated by a logic failure which allowed the mill to start and run over the trunnion bearing bushing without the lubrication system to be turned on, that is, without oil film. The logic failure was caused by an operator fault. The maximum trunnion temperature during a normal operation is 57 °C. There is a heat exchange device in the lubrication system that always tries to keep the oil to the mill at 40 °C. The metal–metal contact generates heat, therefore temperature raise and since the lubrication unit was shut down, the root problem was not oil temperature, but oil not reaching the bushing.

Fig. 9. Detail of trunnion marks.

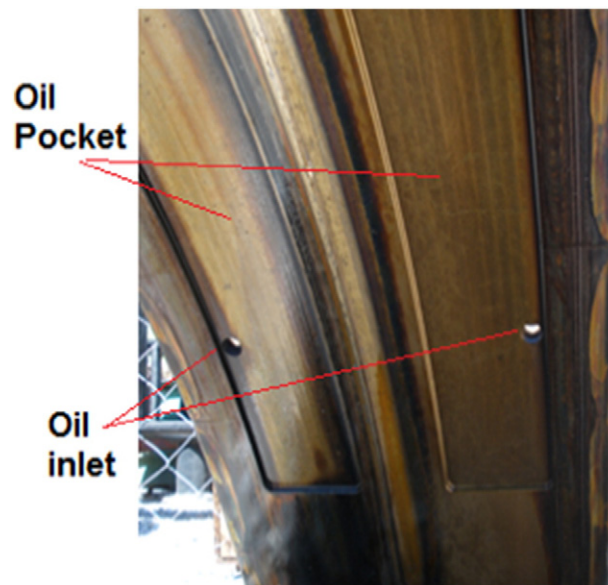
Fig. 10. Detail of bushing marks.

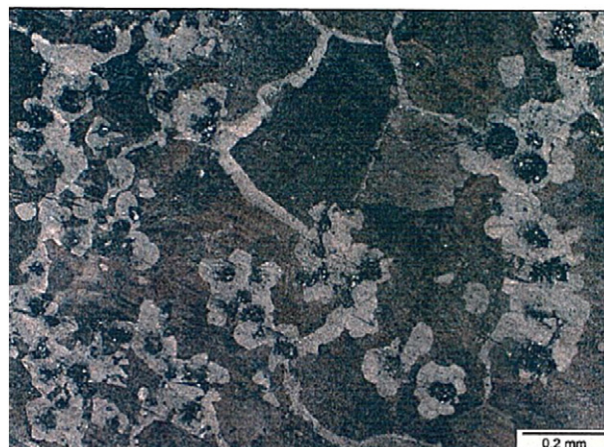
Fig. 11. Micrography obtained by metallographic replica of trunnion region. Region with light marks from Fig. 7. Zoom 100×.

In Fig. 11 is observed the microstructure of the region from Fig. 9 with light marks, while in Fig. 12 is realized the microstructure of the trunnion region with dark marks from Fig. 9. Note the similarity of both microstructures, indicating that the contact temperature between the trunnion and the bushing did not achieve high values, enough to occur a phase transformation.

The trunnion surface micrographies prove the contact temperature between the trunnion and the bearing bushing did not achieve high temperature values to cause phase transformation.

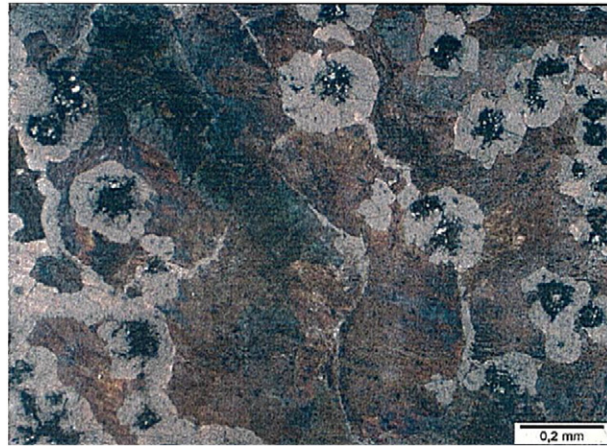
Fig. 12. Micrography obtained by metallographic replica of trunnion region. Region with dark marks from Fig. 7. Zoom 100 \times .

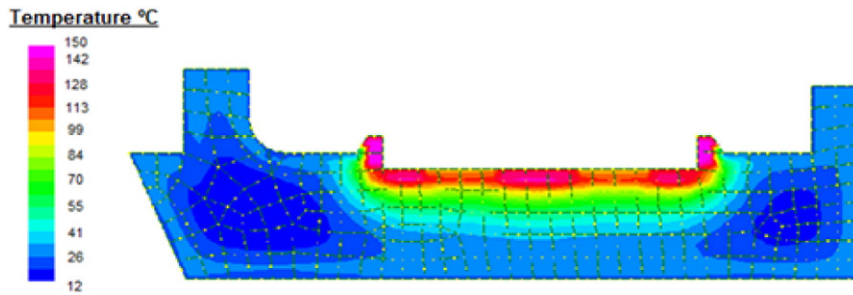
Fig. 13. Temperature gradient distribution.

Fig. 13 indicated the temperature through the trunnion cross sectional, based on the methodology considered in Fig. 5 and in the contact marks seen in Figs. 9 and 10. Fig. 14 showed that the thermal stresses distribution along the trunnion where it was observed the maximum stress was 344 MPa, corresponding to a stress higher than yield strength of the material. Therefore, 150 °C at trunnion surface could generate stresses, which combined to the normal duty load were enough to nucleate longitudinal cracks in the trunnion.

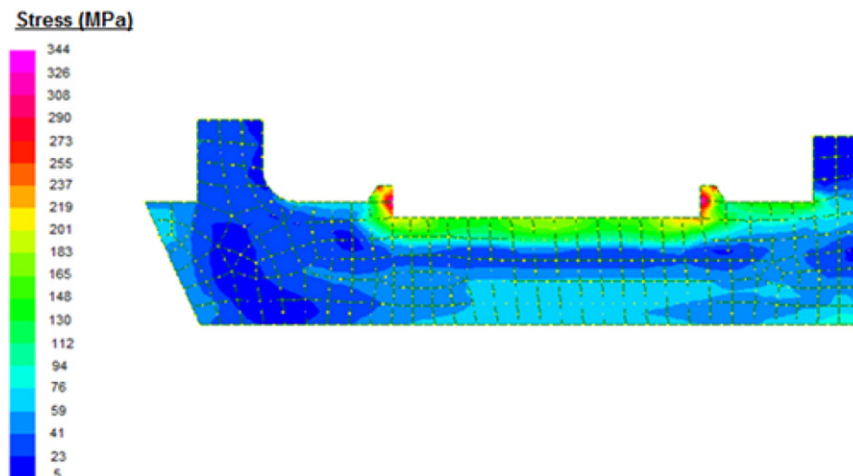
Fig. 14. Stress gradient distribution.

A temperature of 150 °C is enough to meet a stress over the yield strength of the material. Therefore, 150 °C at trunnion surface could generate stresses, which combined to the normal duty load were enough to nucleate longitudinal cracks in the trunnion.
