Inspection of an artificial heart by the neutron radiography technique

The neutron radiography technique was employed to inspect an artificial heart prototype which is being developed to provide blood circulation for patients expecting heart transplant surgery. The radiographs have been obtained by the direct method with a gadolinium converter screen along with the double coated Kodak-AA emulsion film. The artificial heart consists of a flexible plastic membrane located inside a welded metallic cavity, which is employed for blood pumping purposes. The main objective of the present inspection was to identify possible damages in this plastic membrane, produced during the welding process of the metallic cavity. The obtained radiographs were digitized as well as analysed in a PC and the improved images clearly identify several damages in the plastic membrane, suggesting changes in the welding process. © 1999 Elsevier Science B.V. All rights reserved.

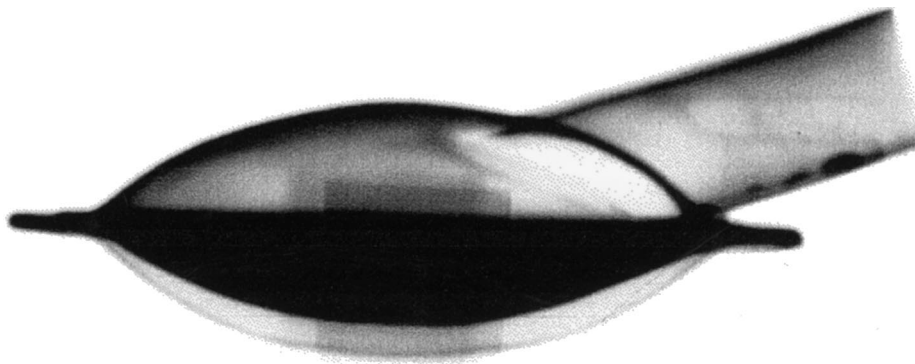
Figs. 3 and 4 show radiographs obtained by positioning the artificial heart parallel to the blood movement plane, with respect to the neutron beam. These radiographs show the two titanium tubes employed for blood circulation (the third is visible in Fig. 5) and the polyurethane membrane in the position down and up respectively. In the former, the membrane is in its initial position and in the latter, it is air compressed.

Fig. 3. Digital neutron radiography: heart membrane in its initial position.

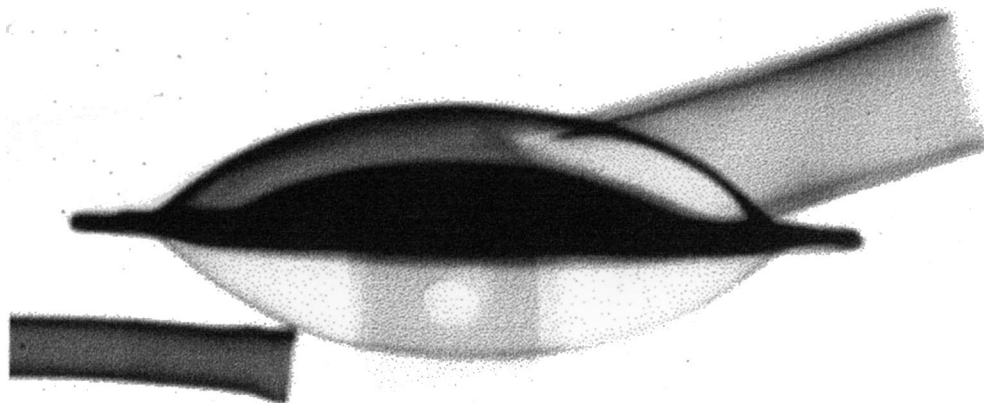
Fig. 4. Digital neutron radiography: heart membrane pressurized.

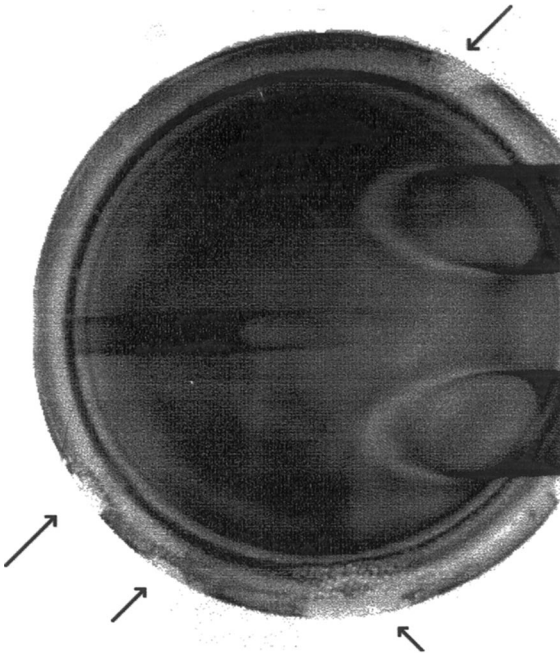
Fig. 5. Digital neutron radiography showing the damages in membrane, indicated by arrows.

Fig. 5 is the radiograph of the same original heart positioned perpendicularly to the blood movement plane. Several damages in the polyurethane membrane could be identified at the membrane extremity which acted like small holes that caused blood leakage, from the upper to the lower part of the cavity, when the membrane was

air compressed. These membrane damages occurred due to the high heating during the cavity welding process. Some welding experiments in lower heating conditions were also tried but all of them were not approved by the neutron radiography inspection. Presently a laser based welding system is being used and high quality prototypes are being obtained.
