# RETRIEVAL AND CONDITIONING OF RADIUM SOURCES-CONTAINING PACKAGE IN PANAMA

A team of CNEN experts successfully conducted an operation in Panama to recover and condition disused radioactive sources stored in an unsafe condition. The sources, containing the Ra-226 isotope, were used in the past to treat tumors using the technique known as brachytherapy and were immobilized in a complex package buried in an old hospital wing destined for demolition. The compartment where the package stayed for decades, built under the floor of a hospital laboratory, was contaminated with radon and daughters, including Pb-210, responsible for the contamination found. The operation consisted of extracting the package from this compartment, placing it in a cylindrical metal overpack, transporting it to the temporary storage site and carry out site decontamination. Besides the package with the sources, three 200L drums containing contaminated debris from the demolition of walls and floor were generated. No relevant event of radiological protection, such as occupational dose above the established limits, contamination of personnel or place, etc, was observed. The package produced, together with those con

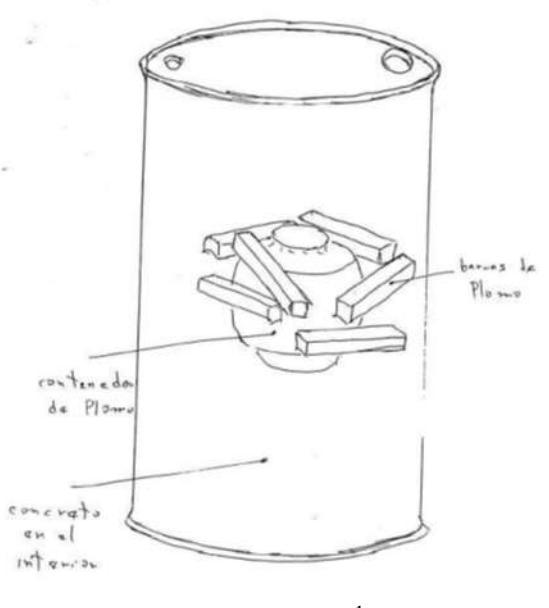
Main components<sup>1</sup> [2]

The package to be treated consisted of an external 200-liter metallic drum, a centralized lead shielding device, twelve lead bars surrounding this device to improve the package's shielding capacity and a block of high-density concrete filling the void space (Figure 2, left side). The radium sources were immobilized inside the shielding device by molten lead poured into the device's cavity. A pipe coming from inside the concrete block stood out by the upper surface of the block. The drum cover was missing.

<sup>&</sup>lt;sup>1</sup> The following parts are identified in Figure 2, left side: shield container (*contenedor de plomo*); lead bars (*barras de plomo*); concrete inside (*concreto en el interior*).

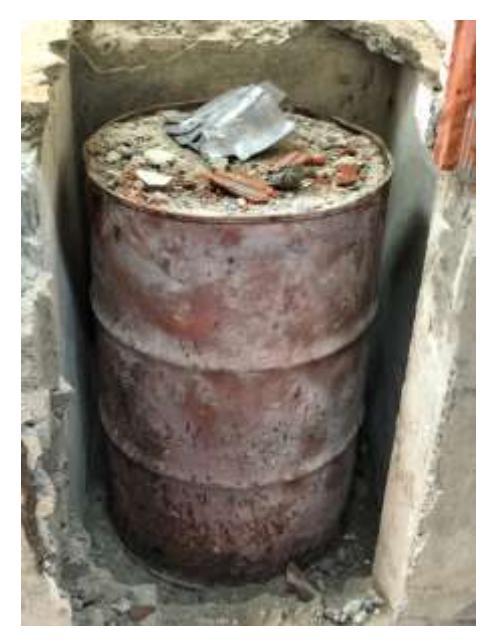
The package thus constituted was buried under the floor in one corner of the Physics Laboratory of the Santo Tomás Hospital (Figure 2, right side), and the burial site was marked by a different type of ceramic applied to the floor. The package construction and burial occurred in the 1970s.

Package in burial site, after floor and wall removal

The visual inspection of the package after its exposure revealed that the metal drum and the concrete block were in good state, without corrosion or noticeable signs of deterioration. A metallic tube emerging from the inside of the block, probably for radon venting, was detected in the inspection. The maximum surface dose rate measured on the surfaces accessible before the removal of the package from its original position was 143  $\mu$ Sv/h.

A decision was made not to destroy the concrete matrix and recover the shielding device but, alternatively, to condition the original package in a metallic overpack. This decision was based on the information that the sources had been immobilized in solidified liquid lead, and on the absence of damage to the package. Also the high dose rate expected if the concrete matrix were to be broken in order to recover the lead shielding with the sources was taken into account, as well as the presence of surface contamination in the concrete by the radon by-products with longer half-life (e.g. Pb-210,  $T_{1/2} = 22.2$  years),

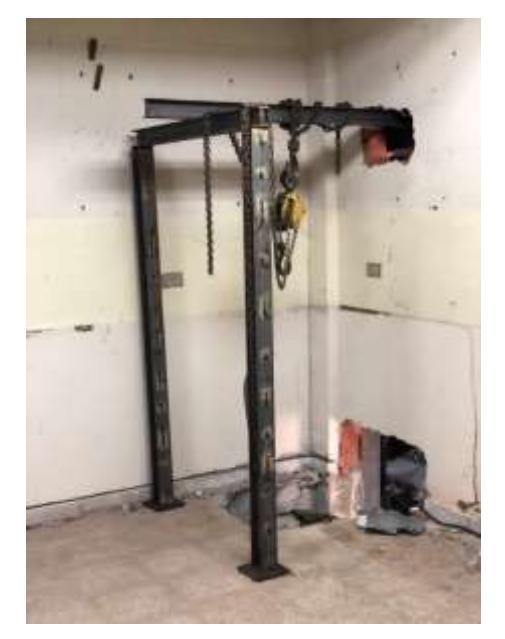
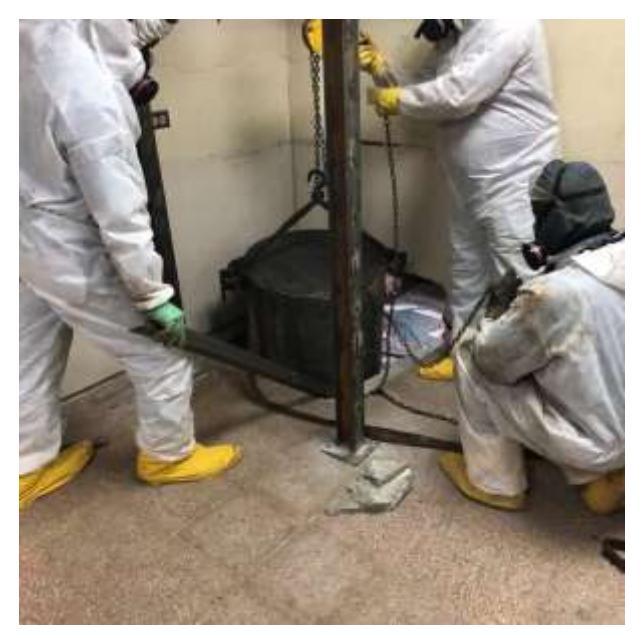
# Figure 4: Package handling

Hoisting frame

Lifting the final package

The next steps were the manufacture of the overpack and the setup of a structure to hoist the package to the Laboratory floor level. The metal structure for hoisting the final package was mounted on the floor of the room and fixed to the floor and to the side wall (Figure 4).

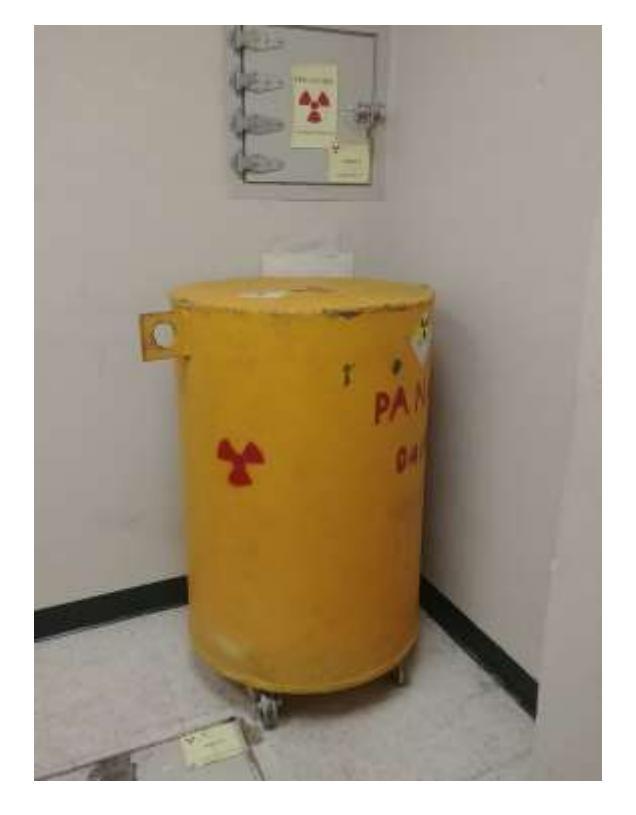
Figure 5: Final package after painting and marking

The cylindrical overpack was manufactured in carbon steel, provided with eye plates and wheels for handling and had the following measures: thickness 6.35 mm, diameter 64 cm, height 90 cm (Figure 5).
