EXPERIENCE ON WET STORAGE SPENT FUEL SIPPING AT IEA-R1 BRAZILIAN RESEARCH REACTOR*

J. A. PERROTTA, L. A. A. TERREMOTO and C. A. ZEITUNI

Instituto de Pesquisas Energéticas e Nucleares (IPEN/CNEN-SP), Divisão de Engenharia do Núcleo (REN), Travessa R, 400, Cidade Universitária, Caixa Postal 11.049, CEP 05422-970, São Paulo-SP, Brazil

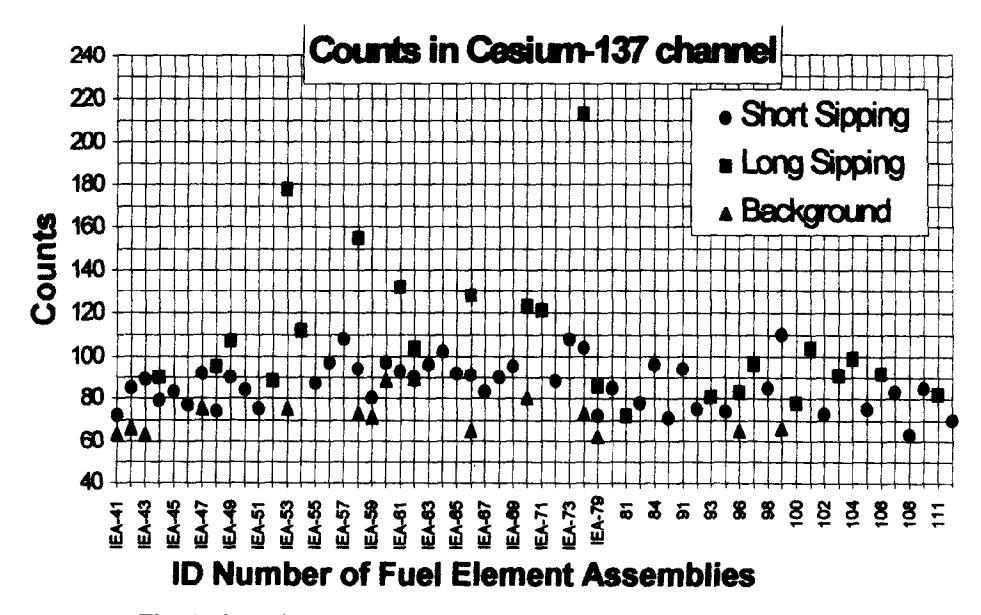
Fig. 6. Counting results for sipping water samples of fuel assemblies.

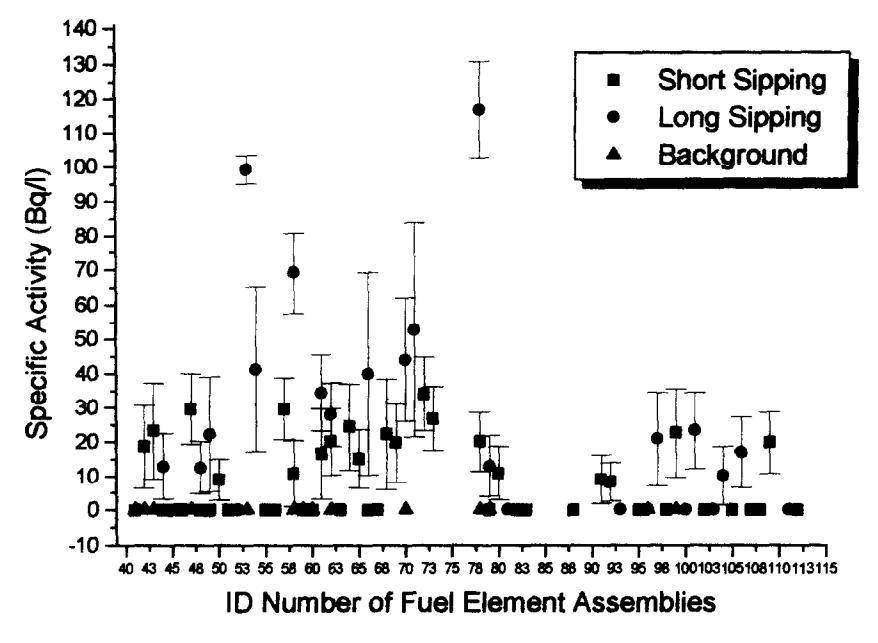
Fig. 7 shows the specific activity calculated for each fuel assembly sipping test. It can be seen that some fuel assemblies show a leaking pattern, and that most of the fuel assemblies have specific activities lower than 30 Bq l^{-1} (for sipping resting time of 4 h).

Fig. 7. Specific activity results for sipping water samples of fuel assemblies.

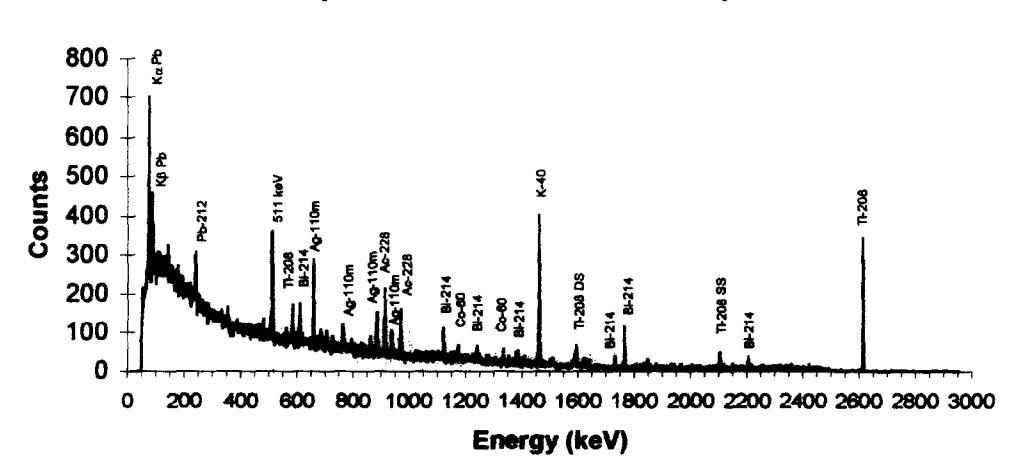
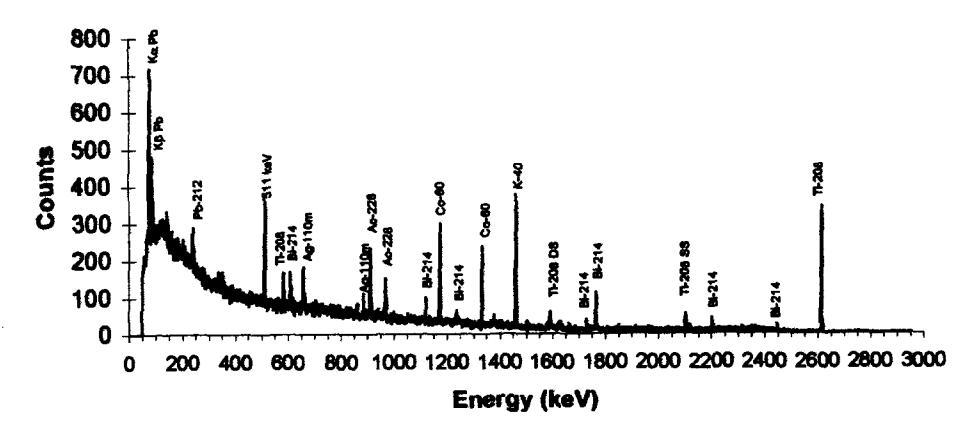
Figs 8-11 show the gamma-ray spectra for one non-leaking fuel assembly and one leaking fuel assembly.

Fig. 8. Gamma-ray spectrum of the first sipping water sample of the fuel element assembly IEA-49.

Fig. 9. Gamma-ray spectrum of the second sipping water sample of the fuel element assembly IEA-49.

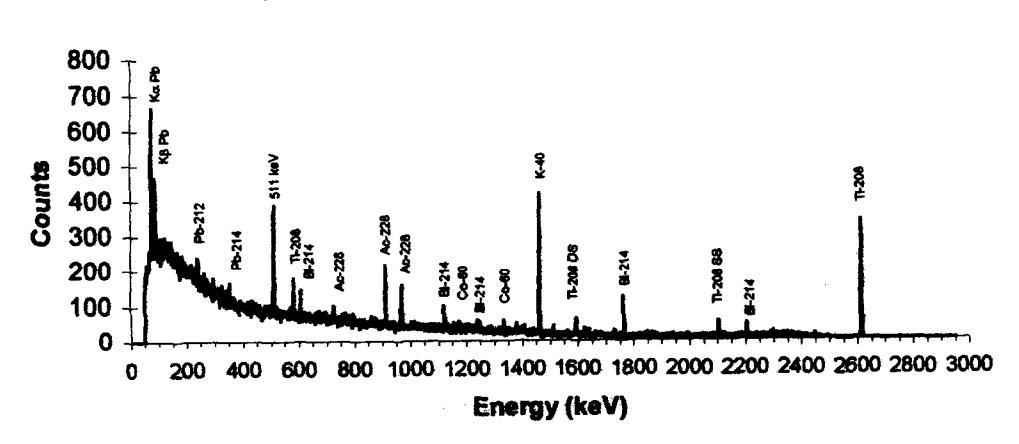
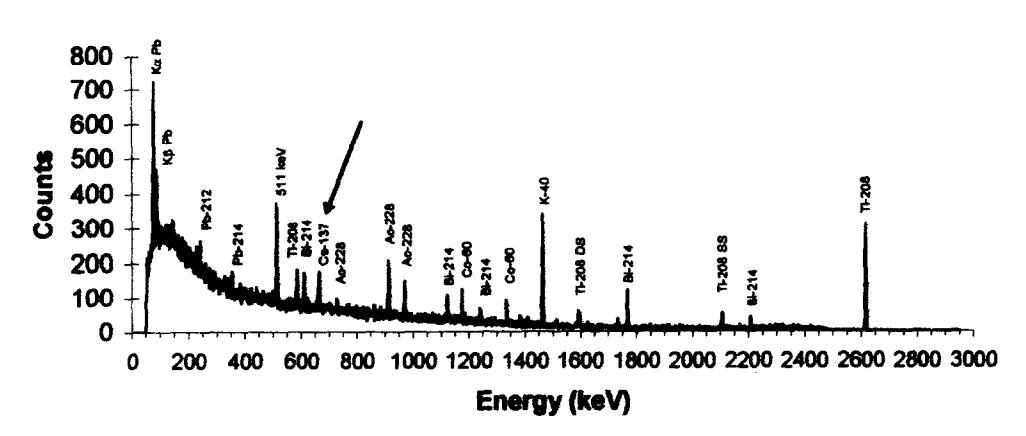
Fig. 10. Gamma-ray background spectrum of the fuel element assembly IEA-53.

Fig. 11. Gamma-ray spectrum of the sipping water sample, collected after long resting time of the fuel element assembly IEA-53. The arrow indicates the 661.6 keV photopeak.

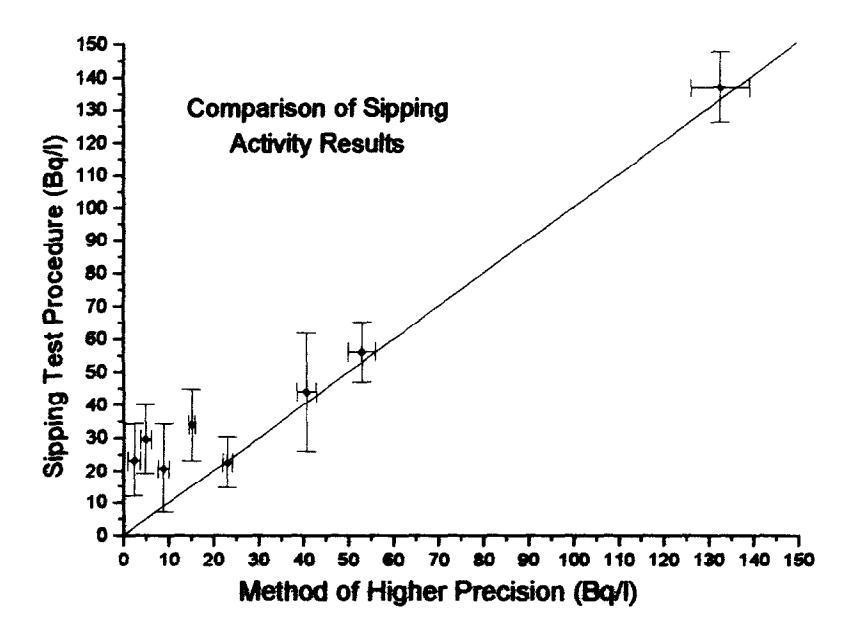
Fig. 12. Comparison of measured specific activities.

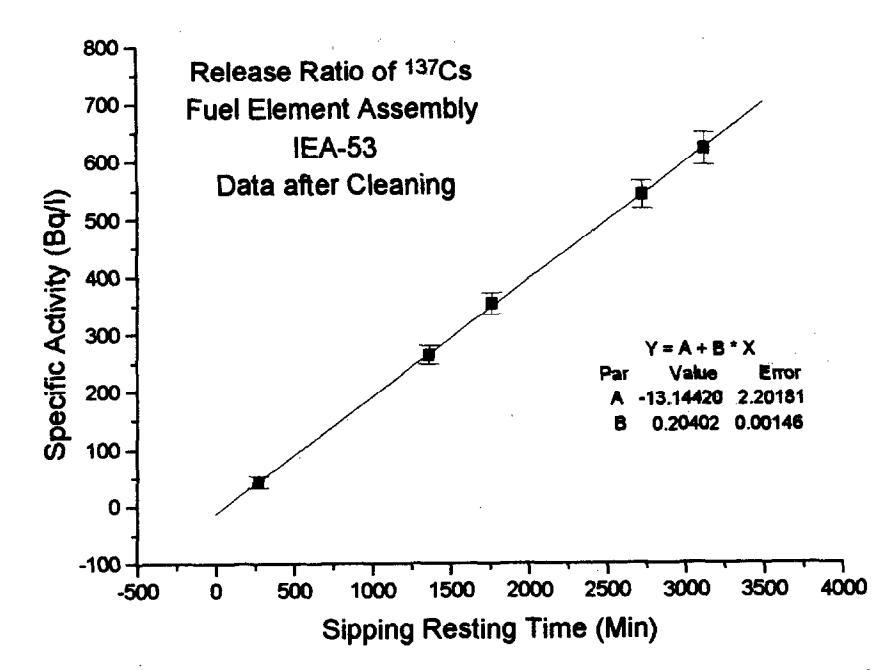
One can also see from Table 7 the results for fuel assembly IEA-53. Fig. 13 shows the specific activity along sipping resting time. The results show a straight line with a constant leaking rate of $\sim 0.2 \text{ Bq } l^{-1} \text{ min}^{-1}$ or $\sim 14 \text{ Bq min}^{-1}$. Fig. 14 compares the rate before and after cleaning and one can see that there is almost no difference.

As fuel assembly IEA-53 was the one with the highest leakage rate, this value of $14 \text{ Bq} \text{min}^{-1}$ can be compared to the criteria established by DOE-SRS (staff communication, July 1996) for canning leaking fuel assemblies.

The value obtained at IPEN/CNEN-SP fuel assembly sipping, correcting to the volume of DOE-SRS criteria, is 0.64 pCi ml⁻¹ h⁻¹ (0.4 Bq l⁻¹ min⁻¹), which is far below the criteria limit.

Fig. 13. ¹³⁷Cs leaking rate determination for the fuel element assembly IEA-53, considering only data obtained after cleaning.

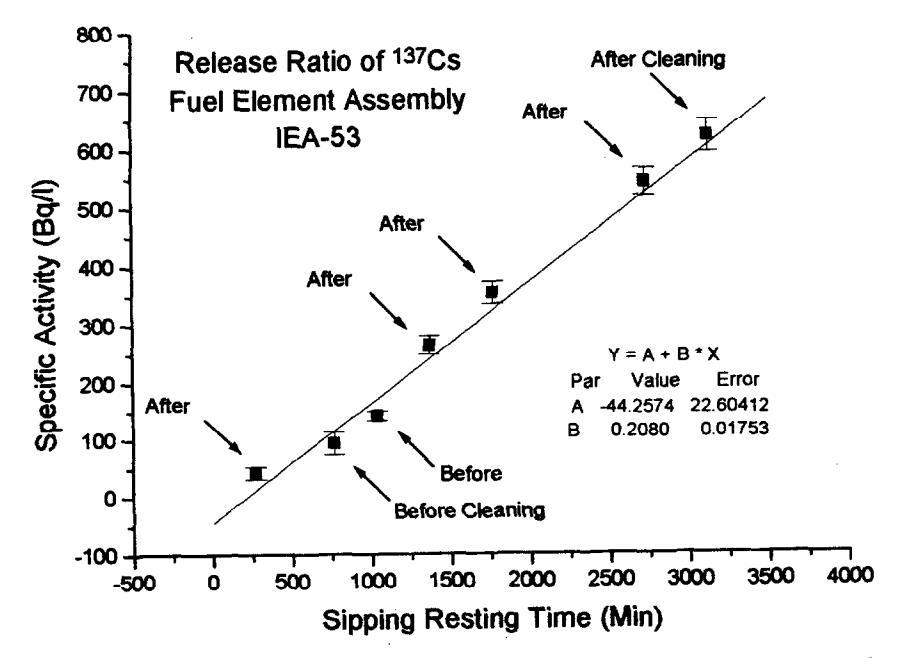
Fig. 14. ¹³⁷Cs leaking rate determination for the fuel element assembly IEA-53, considering data obtained before and after cleaning.

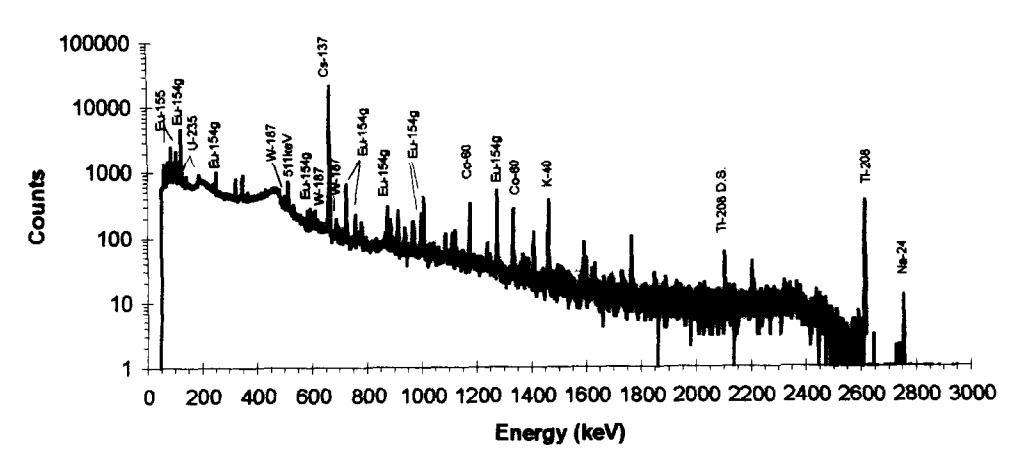
A sample of a pitting corrosion nodule obtained from a fuel plate of fuel assembly IEA-53 was taken to perform gamma-ray spectrometry analysis. Fig. 15 shows the gammaray spectrum obtained. One is able to find a high level of 137 Cs activity and also 235 U, 155Eu, and 154 Eu activities. This indicates that the pitting corrosion nodule penetrates through the cladding up to the plate meat where there is uranium and fission products. It also indicates that besides 137 Cs, U and Eu isotopes are migrating from the meat to the

nodule. U and Eu are not migrating (or migrating in a very small rate) to the water, although these elements were not found in the gamma-ray spectrometry of the sipping water. The mechanism of migration of U and fission products from the plate meat through the corrosion pit to water has to be studied in more depth.

The activity of ${}^{137}Cs$ in the pitting corrosion nodule sample was determined to be 2400 Bq or 5600 Bq g^{-1} . It is interesting to compare this activity with the meat activity and the sipping water activity.

Fig. 15. Gamma-ray spectrum of a pitting corrosion nodule removed from the fuel element assembly IEA-53.

Gamma-ray spectrometry of a pitting corrosion nodule shows the presence of Cs, U and Eu isotopes. The ¹³⁷Cs activity is much higher than the sipping water activity and U and Eu isotopes were not detected in water. This confirms that it is a thru-clad pit.
