Title: Laser Decontamination of the Radioactive Lightning Rods

Abstract: Brazil has experienced an expressive market of radioactive lightning rods in the 70's and 80's. These apparatuses are constituted by an air terminal to which one or more Americium-241 sources are fixed aiming at ionizing the surrounding air and enhancing the attraction of the atmospheric discharges. In 1989, the Brazilian National Nuclear Energy Commission (CNEN) lifted the authorization for manufacture and installation of radioactive lightning arresters, because their inefficacy was technically demonstrated. It also determined that replaced radioactive lightning rods were sent immediately to one of the centralized radioactive waste storage facilities for treatment as radioactive waste. Although the sources can easily be removed, some contamination is found all over the remaining metal scrap, requiring decontamination to allow its release as non-radioactive waste. Decontamination using various chemicals proved to be inefficient and generates large amounts of secondary wastes. Laser ablation is being evaluated as an alternative for decontamination. A Nd:YAG nanosecond laser is used with energy 300 mJ and resul

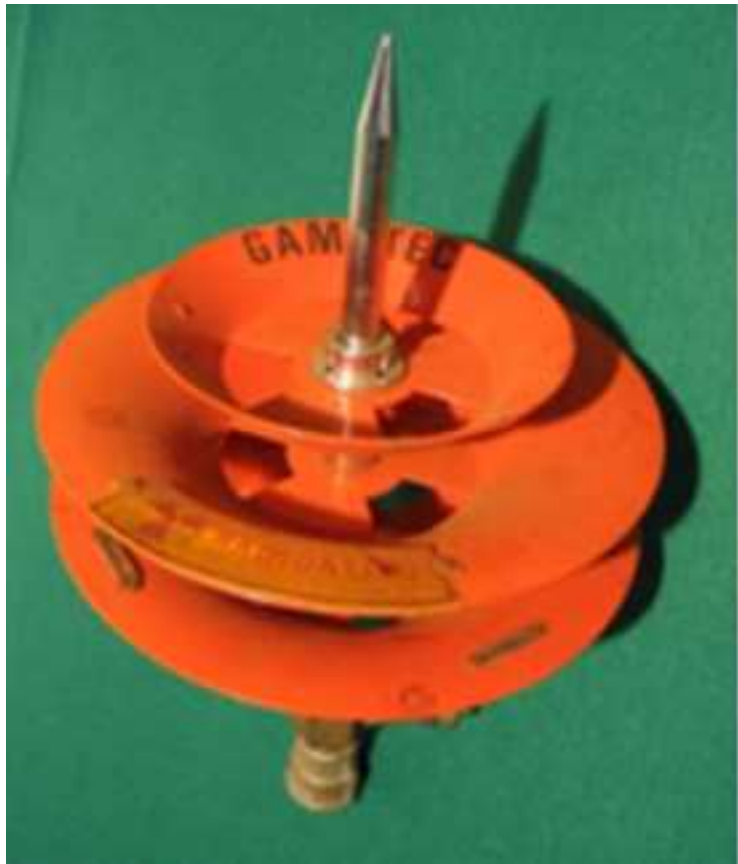
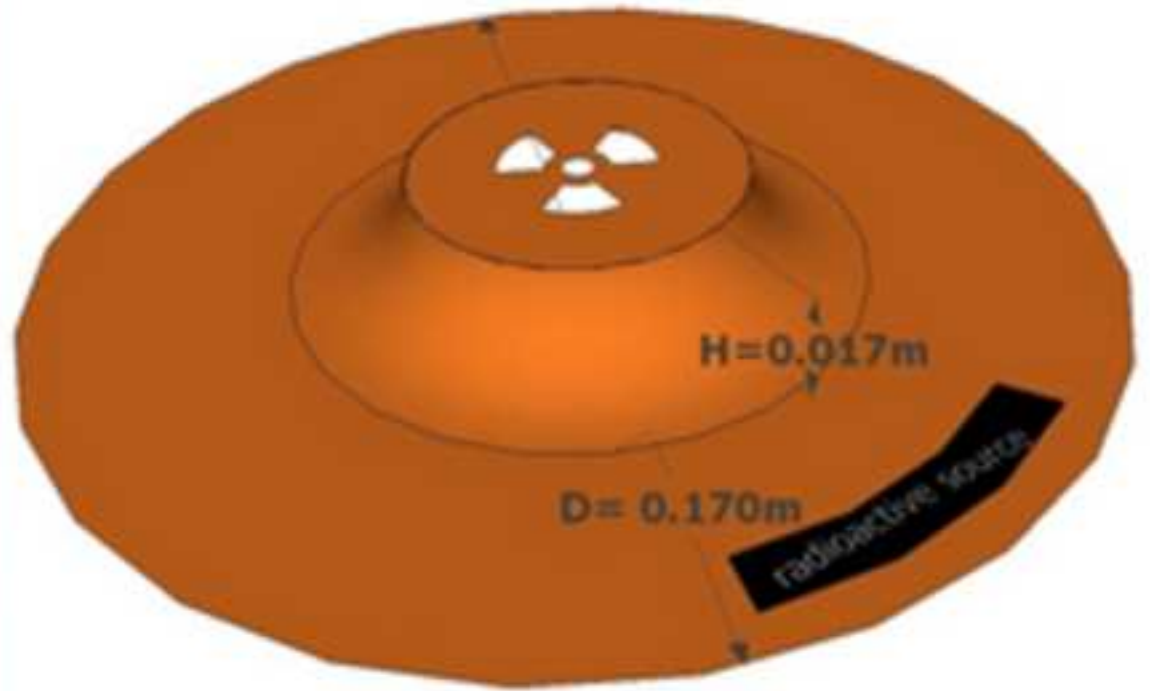
Figure 1
[Click here to download high resolution image](#)

Figure 1 - RLR plate (left) and schematic RLR (right).

16 The radioactive source used in the RLR was a strip of americium oxide covered with a layer
17 of a gold alloy that encapsulated the radioactive material and avoided its dispersion. The
18 americium sources were mounted over a sheet of stainless steel which was in turn riveted to
19 the plates of the terminal. Two of such sources are visible in the upper surface of the bottom
20 plate of the RLR shown in the left picture of Fig. 1. Rivets visible in the top plate are evidence
21 of other sources attached to the RLR shown.

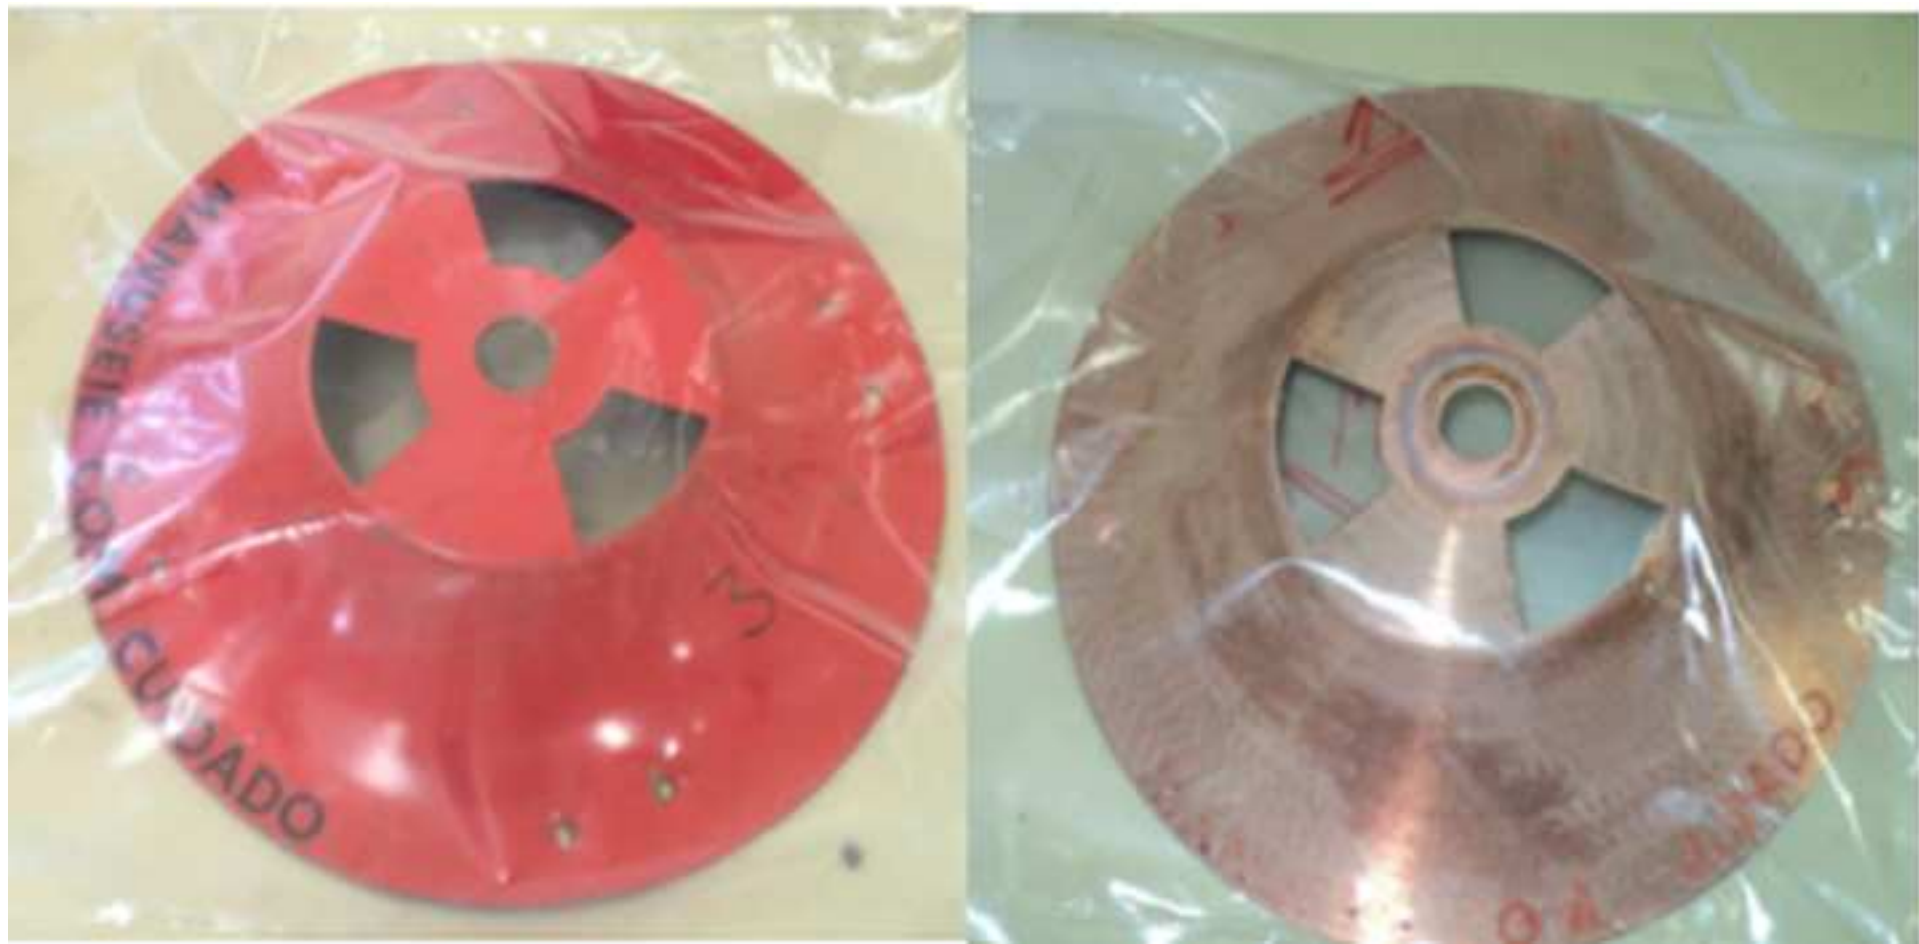
Figure 3
[Click here to download high resolution image](#)

Figure 3 - A RLR plate, before (left) and after (right) laser cleaning and decontamination.

22 One RLR plate is shown in Figure 3 before and after the laser cleaning process almost
23 completely stripped of the painting. The scanning of each surface lasted 25 minutes.
