Deformation and fracture of an alpha/beta titanium alloy

A. Andrade; A. Morcelli; R. Lobo

Scientific Research / Nuclear and Energy Research Institute (IPEN-CNEN/SP) Center for Materials Science and Technology (CCTM) São Paulo - Brazil

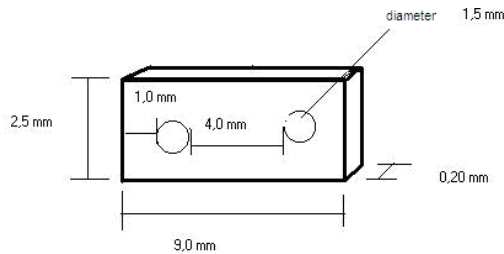
A scheme of the sample prepared for analysis of in situ tensile loading in TEM is shown in Figure 1. Tensile tests of Ti-6Al-4V heat treated at 1000°C for one hour and cooled in water have been performed at room temperature with a Gatan straining holder and TEM observations were made with a Jeol 200C electron microscope.

Figure 1: Scheme of specimen for in situ TEM tensile test

The sample after cutting was submitted to the following steps: mechanical thinning, sample grinding with 600 grit emery paper up to a thickness of 0.2 mm, and final thinning and drilling in a twin jet electropolishing device. Samples with thickness of 0.2 mm were coated with amorphous carbon through the system of "sputtering" and the analysis carried out in two electron microscopes JEOL 200C and JEM 2100 HRTEM.

A region of the specimen was chosen which shows the beginning of the deformation experienced by the sample during the in situ tensile test, and 0.05 mm displacements were applied from the initial position, generating cumulative shifts of 0.05 mm, 0.10 mm, 0.15 mm, 0.20 mm and 0.25 mm.

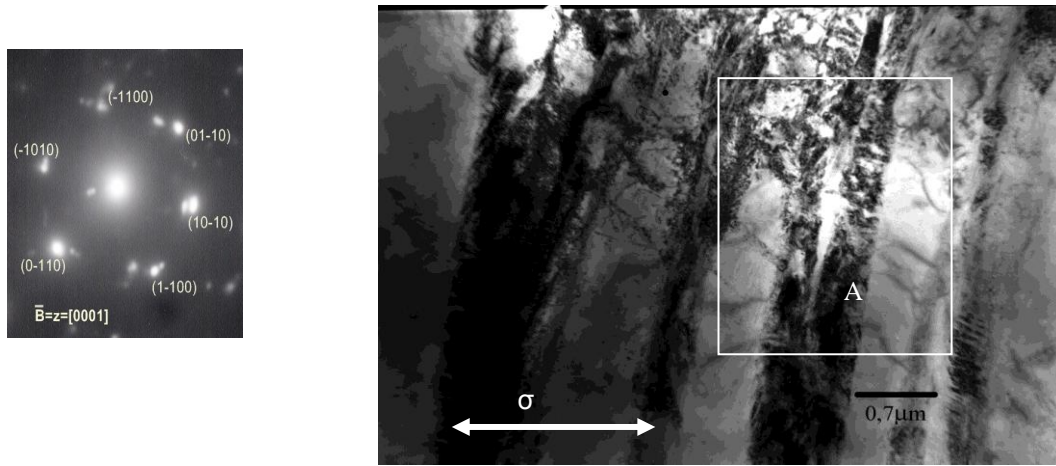
Ti-6Al-4V dislocation substructure and its diffraction pattern are shown in Figure 2. The double ended arrow indicates the applied stress (σ) direction.

Figure 2: Electron micrograph of the sample of Ti-6Al-4V and its diffraction pattern from the region indicated in A

As a result of the diffraction pattern in the region A of the sample on the alpha phase (hcp), it can be observed slip in the hcp alpha phase of prismatic and basal planes $(\bar{1}100)$ and $(10\bar{1}0)$, direction of observation $\bar{B} = [0001]$. Different regions of the alpha phase and beta phase can be observed in the vertical lamellae in Figure 2.

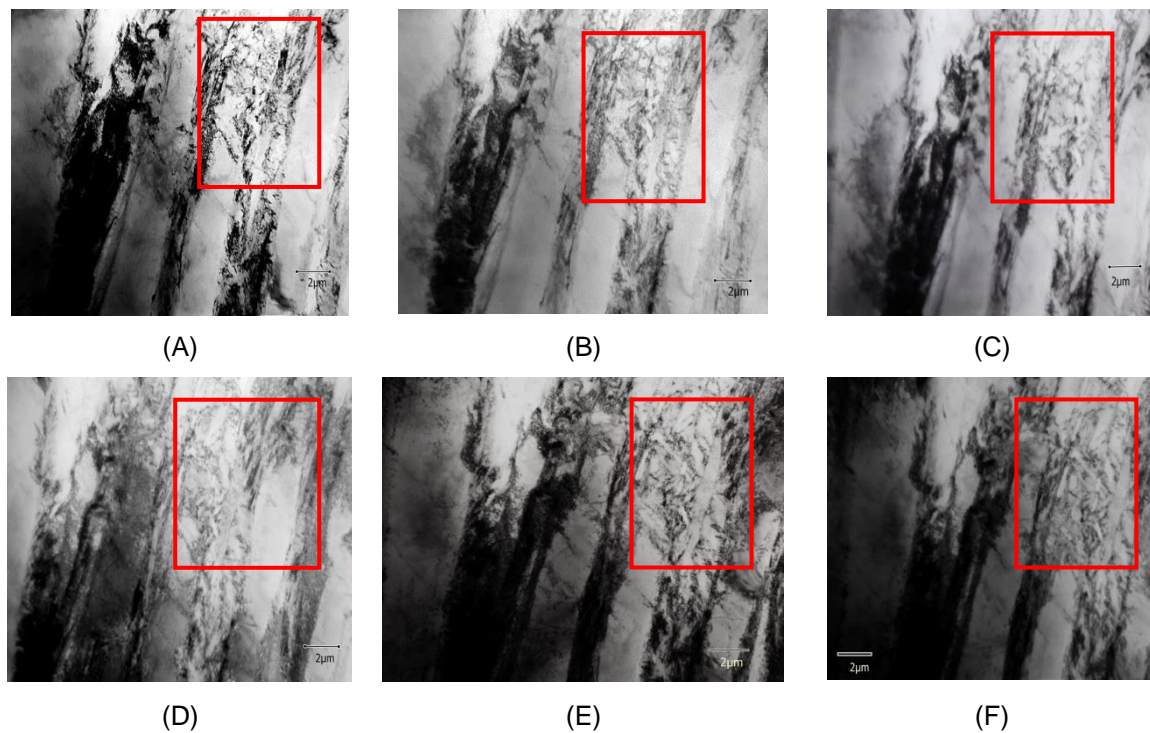
Figure 3 (A-F) shows that after applying the displacement, the density of dislocations become more intense as the applied stress increases. It was noted that in addition to the slipping of planes, deformation of grains also occurred.

Figure 3: Electronic micrographs of Ti-6Al-4V sample on the analysis of in situ traction for different shifts: (A) 0.05mm, (B) 0.10 mm, (C) 0.15 mm, (D) 0.20 mm, (E) and (F) 0.25 mm.

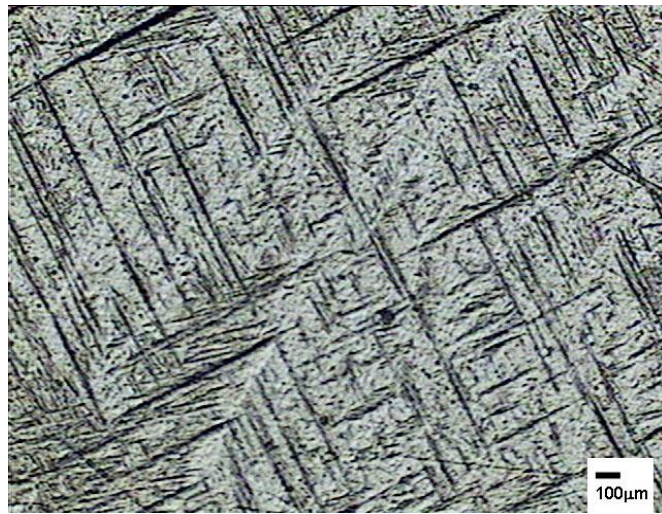
In analysis of the specimen surface by optical microscopy the presence of two phases was observed. The microstructure is a mixture of ($\alpha + \beta$) and β phase evenly distributed in the α matrix. An acicular martensitic microstructure was revealed, ie, the structure shows the presence of thin lamellae resembling needles, characteristic of alpha structure, as can be seen in Figure 4.

Figure 4. Optical micrograph of the sample of Ti-6Al-4V heat treated at 1000 °C for two hours and cooled in water submitted to surface chemical attack

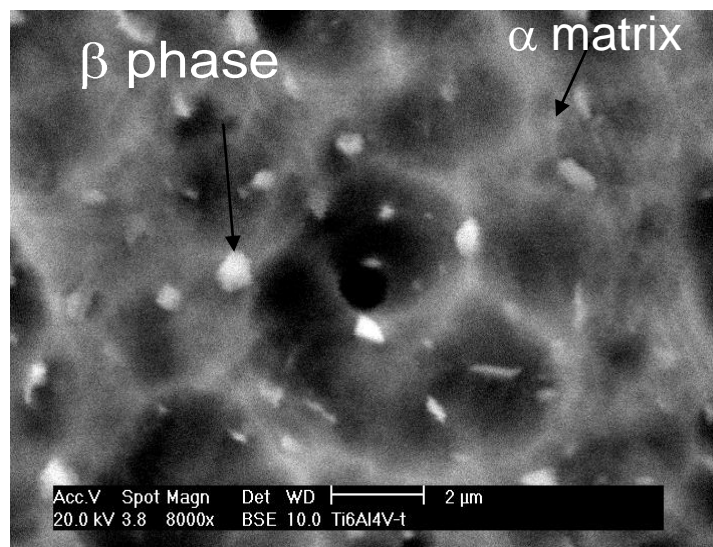
The presence of the β phase homogeneously distributed in the α matrix is shown Figure 5 for Ti-6Al-4V annealed at 800°C for two hours.

Figure 5: SEM image of microstructure of the sample Ti-6Al-4V annealed at 800°C for two hours

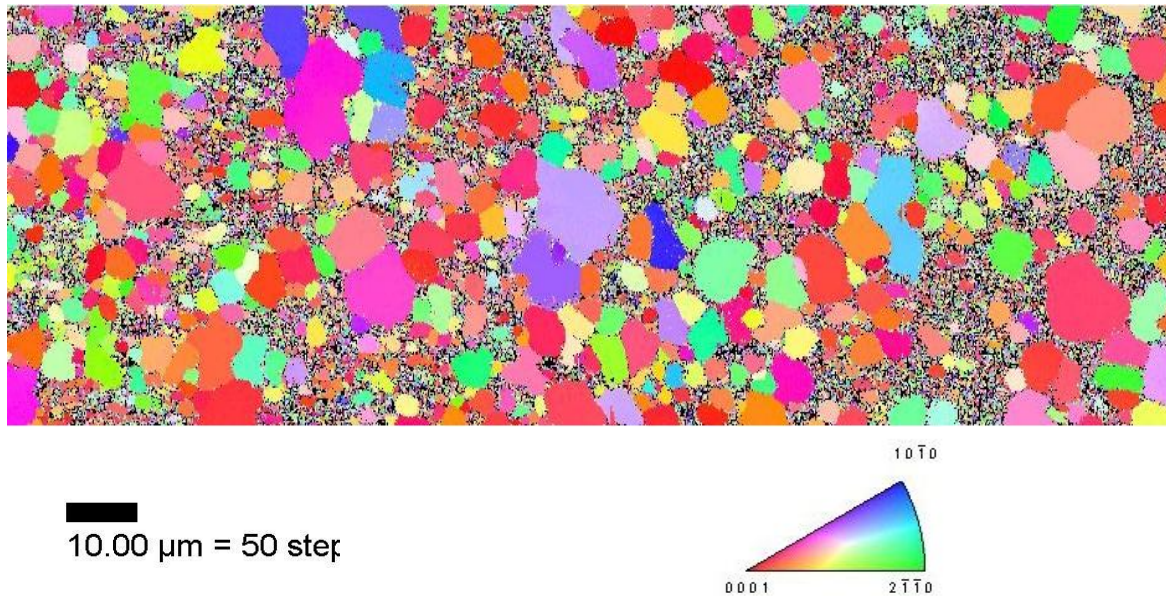
Figure 6 shows the α phase and its crystallographic orientation distribution in Ti-6Al-4V. This analysis is obtained by electron backscattered diffraction (EBSD) in the SEM, and the basal planes (0001) are indicated by red color.

Figure 6: SEM/EBSD image of Ti-6Al-4V microstructure annealed at 800°C for two hours.

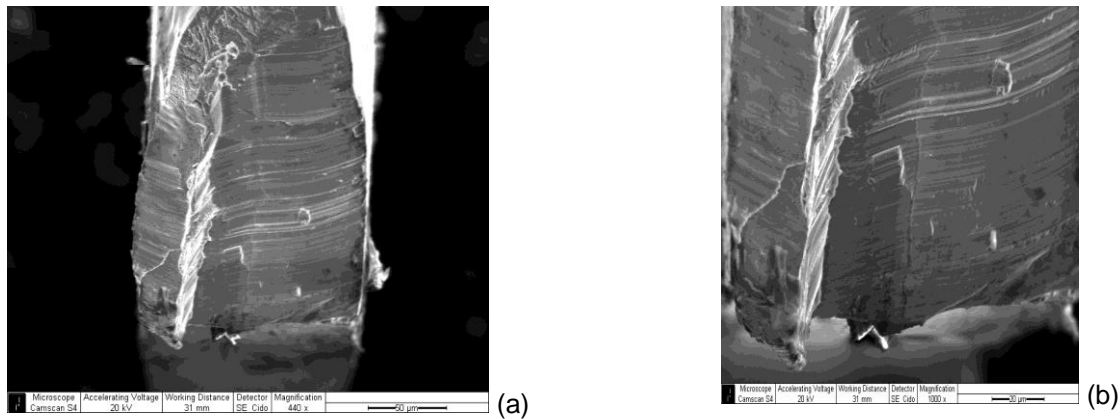
The presence of large areas with steps of the same orientations on the fracture surface of the alloy, as seen in Figure 7, reveals the heterogeneously grain structure (a few large grains across the sample thickness) and the failure mode associated with the tensile loading.

Figure 7: SEM micrograph of Ti-6Al-4V, after heat treatment at 1000 °C/1h and rapid cooling in water at two different magnifications

The morphology of steps on the surface of fracture depends on the loading orientation, the effectiveness of the slip process in the grains and the texture of titanium alloy [7].

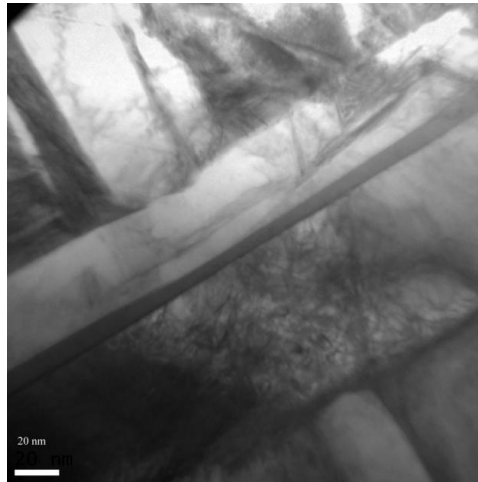
Figure 8 shows overlapping planes with the presence of dislocation areas. This behavior can be attributed to the cooling rate imposed on the sample.

Figure 8: Electron micrograph of the sample of Ti-6Al-4V, after heat treatment 1000 ° C/1h and rapid cooling in water.

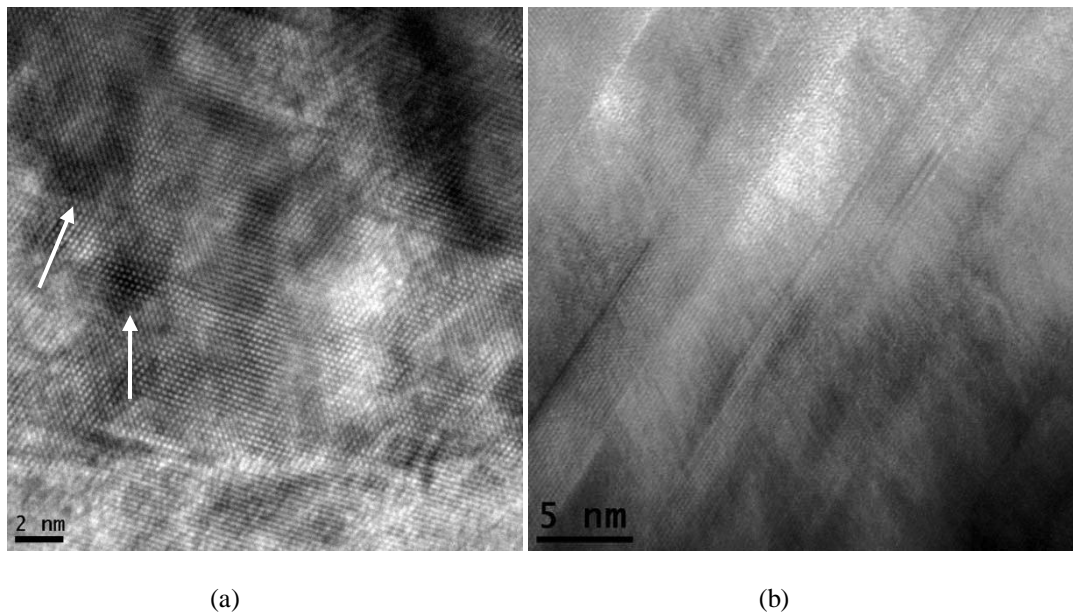
In Figure 9a, observed by high resolution TEM, it is clear the orientation of crystal planes of Ti-6Al-4V. Note the presence of sub-grains in the dark regions (indicated by arrows). By measuring the angles between the planes, values ranging from 60o to 70o are found. This variation can be explained by the proximity to regions where there is the presence of sub-grains. Some example of twinning in the α phase is shown in Figure9b.

Figure 9: Electron micrograph of the sample of Ti-6Al-4V, after heat treatment 1000 ° C/1h and rapid cooling in water.

In the case of Ti-6Al-4V exists factors, in the martensitic structure such as the prior existence of dislocations and α'/α' interfaces which can reduce the activation energy required for nucleation of (1011) twins [2]. It is believed that this observation can not be done in tests with pure titanium.
