Hydrotalcite coatings to protect spent aluminum-clad nuclear fuels during long term wet storage

S.M.C.Fernandes¹, O.V.Correa¹, J.A.De Souza¹, R. A. Antunes², M.C.L. De Oliveira³
L.V.Ramanathan¹

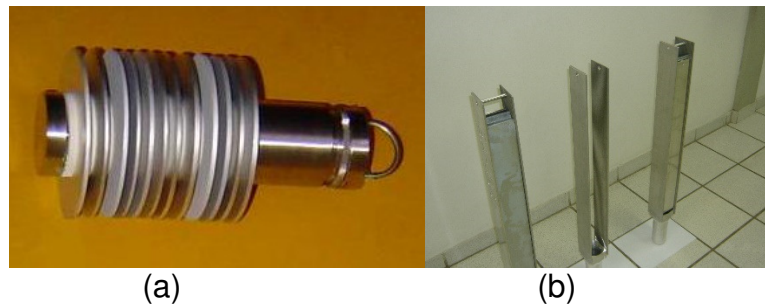
Figure 1: Photographs of: (a) coupons stacked in a rack; (b) plates assembled to form dummy fuel elements.

The field test procedure consisted of: (a) preparing uncoated and coated coupons and plates; (b) stacking of the coupons in racks (Figure 1 a); (c) assembling the plates to form a full size dummy fuel element (Figure 1 b); (d) immersion of the racks and the dummy fuel elements in the spent fuel section of the IEA-R1 reactor in IPEN, Brazil, for different duration; (e) removal of the racks or dummy fuel elements, rinsing

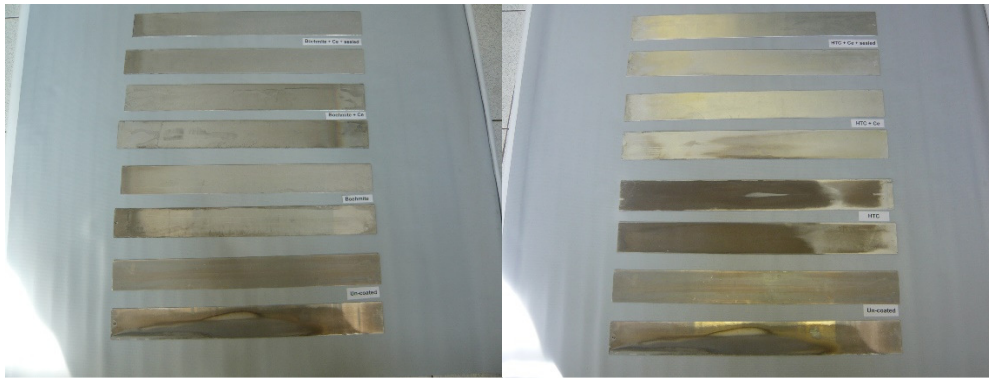
Figure 4: Photographs of full-size plate surfaces. (a) Boehmite coated and (b) HTC coated. The plates above the identification mark were exposed for 8 months and the plates below, for 14 months.

Figure 4 shows photographs of the uncoated and coated plates exposed to the IEA-R1 reactor spent fuel section. The plates stained to different extent, depending on the duration of exposure and the nature of surface treatment. The HTC coated plates were stained very dark compared with the boehmite coated and the uncoated plates. These plates however did not reveal pits. All these plates were examined visually and with an optical microscope and the main surface features are summarized in Table 7.

The uncoated plate exposed for 14 months was more stained than that exposed for 8 months. The boehmite coated plates, with or without cerium treatment and/or sealing,

were stained to the same extent after 8 and 14 months. The HTC coated plates exposed for 8 and 14 months were heavily stained. The HTC + Ce coated plates did not reveal stains after 8 months but were slightly stained after 14 months. The plates that were HTC coated, cerium treated and sealed did not reveal any stains or pits after 8 and 14 months, indicating marked increase in the corrosion resistance imparted by the HTC coating followed by cerium incorporation and sealing.
