EFFECT OF COUPON ORIENTATION ON CORROSION BEHAVIOR OF ALUMINIUM ALLOY COUPONS IN THE SPENT FUEL STORAGE SECTION OF THE IEA-R1 RESEARCH REACTOR

O.V.Correa, R.M.Lobo, S.M.C.Fernandes, G.Marcondes and L.V.Ramanathan
Materials Science and Technology Center,
Instituto de Pesquisas Energéticas e Nucleares (IPEN),
Av. Prof. Lineu Prestes, 2242, Cidade Universitária
05508-000 – São Paulo – Brazil
lalgudi@ipen.br

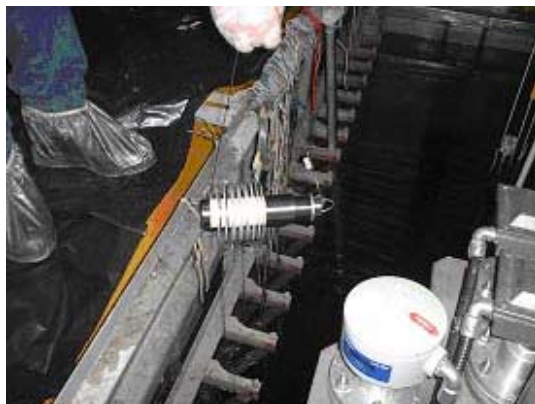
Figure 1. Photograph of rack with vertically oriented coupons being withdrawn from the storage section of the reactor pool.
