TECHNICAL REPORTS SERIES NO. 418

Corrosion of Research Reactor Aluminium Clad Spent Fuel in Water

International Atomic Energy Agency

This report documents the work performed in the IAEA Co-ordinated Research Project (CRP) on Corrosion of Research Reactor Aluminium Clad Spent Fuel in Water. The project consisted of the exposure of standard racks of corrosion coupons in the spent fuel pools of the participating research reactor laboratories and the evaluation of the coupons after predetermined exposure times, along with periodic monitoring of the storage water. The project was overseen by a supervisory group consisting of experts in the field, who also contributed a state of the art review that is included in this report.

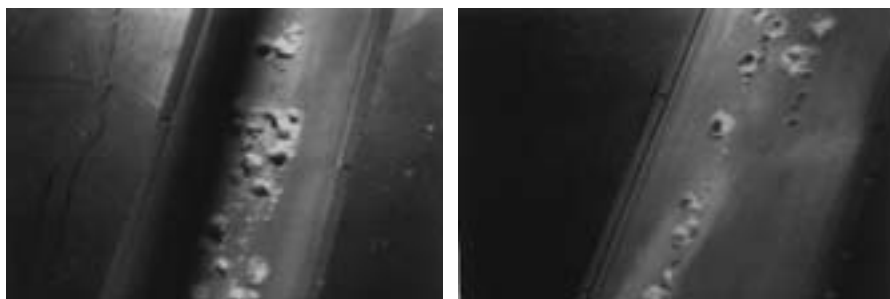
FIG. 1.2. Nodular corrosion products and exposed pits on MTR type spent nuclear fuel.

mechanical damage [1.4]. Over 1700 aluminium clad assemblies were individually examined using video and underwater cameras to record their condition at the fuel storage sites. A wide range of physical conditions of these spent nuclear fuel assemblies were observed. Many of the assemblies after 20 years of storage were in pristine condition. Other fuel assemblies had extensive nodular corrosion products clearly visible on the outer fuel plates, as seen in Fig. 1.2.

Removal of the nodules revealed extensive pitting corrosion that had breached the 0.375 mm aluminium cladding. Pitting corrosion that had penetrated the aluminium cladding to the fuel meat was found on approximately 7% of the total number of assemblies inspected by SRS.

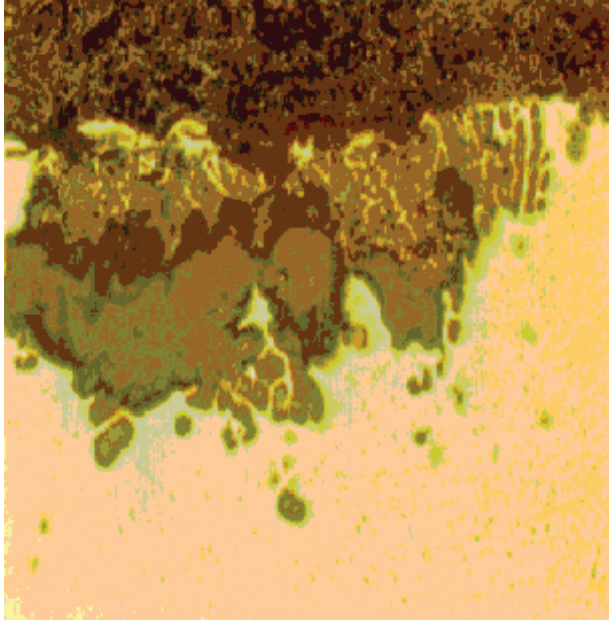
FIG. 5.9. Higher magnification of Fig. 5.8 (100 ×).

Figures 5.6–5.9 correspond to coupon 1100/77. Figure 5.6 shows the corrosion produced inside the square zone covered by a Teflon separator. Figure 5.7 shows the massive pitting that can be encountered inside, at a higher magnification. Figures 5.8 and 5.9 show the cross-section metallography of one of the isolated pits encountered that were associated with dust particles. Figures 5.10–5.12 show the attack affecting sample 6063/64 inside the artificial crevice between coupons 6063/63 and 64, at three different

None of the effects described in the previous paragraph seem to be relevant to the containment of the fissile material, because the penetration they promote is very small. In no case was a relevant amount of weight loss measured. What does matter is the probability of cladding perforation due to pitting. Two main types of pitting were found: the type that takes place inside the sandwiches, together with general attack, and that produced by particles deposited on the surface of the coupons. Pits of the first type appear to be smaller, open and shallow, whereas the particle pitting is more extensive and tunnels underneath the surface, propagating over distances of the order of a millimetre or more. They are seen to grow with time, when metallography performed in the first stage of the work is compared with that in the final stages (Figs 5.8 and 5.9 compared with Figs 5.35 and 5.36).

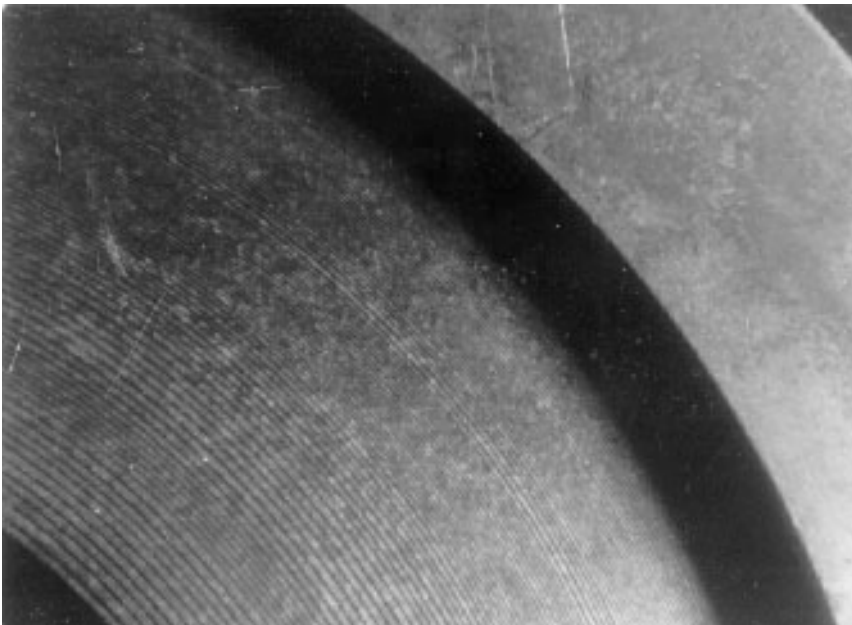
FIG. 5.16. Coupon 6061/08, outside of galvanic couple (6 ×).

magnifications, whereas Fig. 5.13 shows the outer surface of the same sample, which is virtually clean. In Figs 5.14 and 5.15, massive pitting produced on sample 6061/08 at the inner side of the galvanic couple can be seen at two magnifications, whereas in Fig. 5.16 the clean outer surface of the same coupon can be seen.

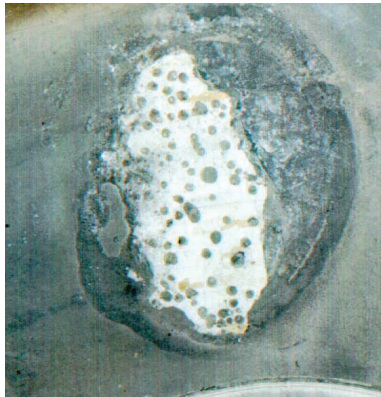
FIG. 5.30. Magnification of island (2 ×).

Figs 5.26–5.28. In Fig. 5.29 a type of pitting can be seen that consists of a cluster of pits covering an isolated region. Figures 5.30–5.32 show this feature in detail.

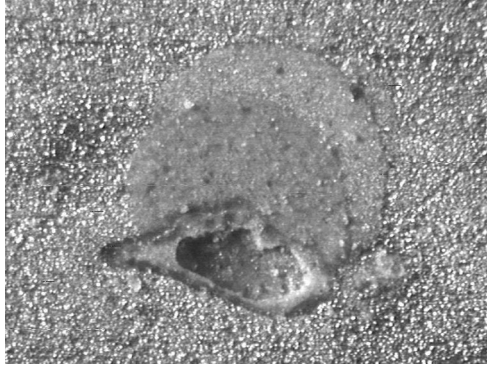
FIG. 5.31. Detailed view of one pit inside the island (20 ×).

Figures 5.37 and 5.38 present side views of pits in sample 45, which also sustained some particle pitting where it was immersed in the RA6 DP. The pits seem to be between 100 and 200 μm deep. Unfortunately, the precise location of the pit shown in Fig. 5.31 could not be found.

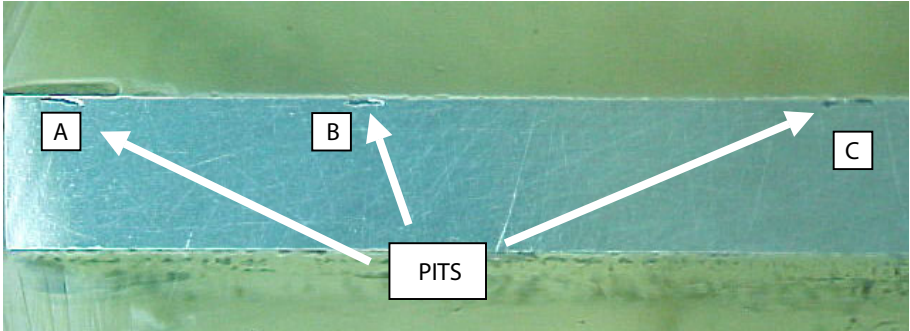
FIG. 5.34. Cross-section metallography showing pits. Coupon thickness 3 mm.

Figure 5.33 shows a top view of the large pits encountered on coupon 15 (belonging to rack 3, which was immersed in channel 113 of the CSF), onto which particles had fallen. The size of the pits appears to be less than 0.3 mm in diameter. However, when a cross-section metallography was performed, it became clear that the attack had propagated underneath the exposed surface, extending over regions as wide as 1 mm, as seen in Figs 5.34–5.36. In Fig. 5.34 three pits can be seen that were found in the same line of the cross-section. Magnifications of two of them are shown in Figs 5.35 and 5.36.

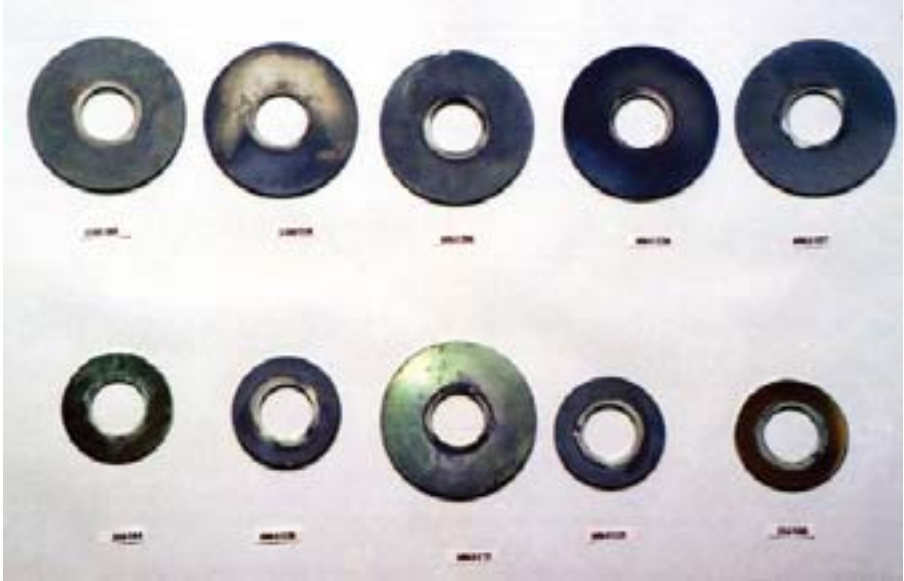
FIG. 7.2. Surfaces of coupons from rack 2.

The front and back of each coupon, as well as the overall assembled rack, were photographed. A photograph of the coupons of rack 2 is shown in Fig. 7.2. Comparative examination of these photographs revealed the following:

- (a) There were stains and spots on the immersed coupons. These were inhomogeneously distributed.

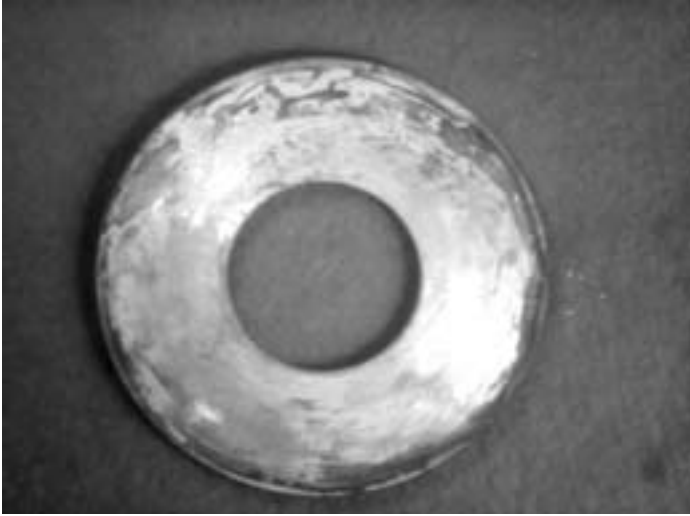
FIG. 8.4. A 6063 coupon from rack 3 after exposure to the basin water for two years.

Rack 3 was in the pool for two years. The rack was immersed on 1998-05-25 and taken out on 2000-05-30. A photograph of a 6063 coupon from rack 3 following exposure to the basin water for two years is shown in Fig. 8.4. The deposit (surface layer) on the coupon surface could be easily removed by simple washing.

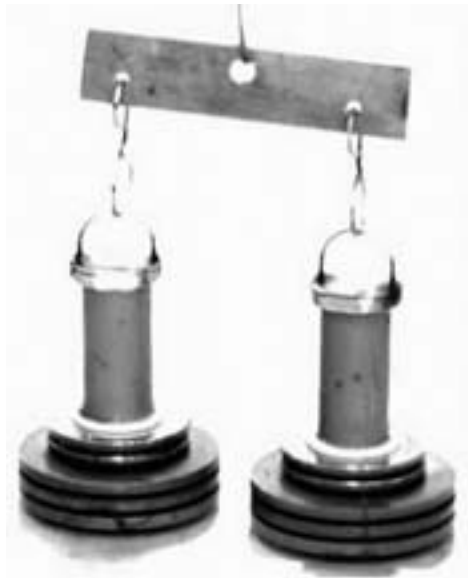
FIG. 9.2. Racks after removal from the basin.

After removal from the pool, the rack and the coupons were extensively photographed to record the surface features. In addition, the pH within the crevices was measured. Figure 9.1 shows the first set of coupons just prior to the second immersion. Figure 9.2 shows racks soon after removal from the pool after 550 days of exposure. Some pits were seen on the coupon surfaces. All the

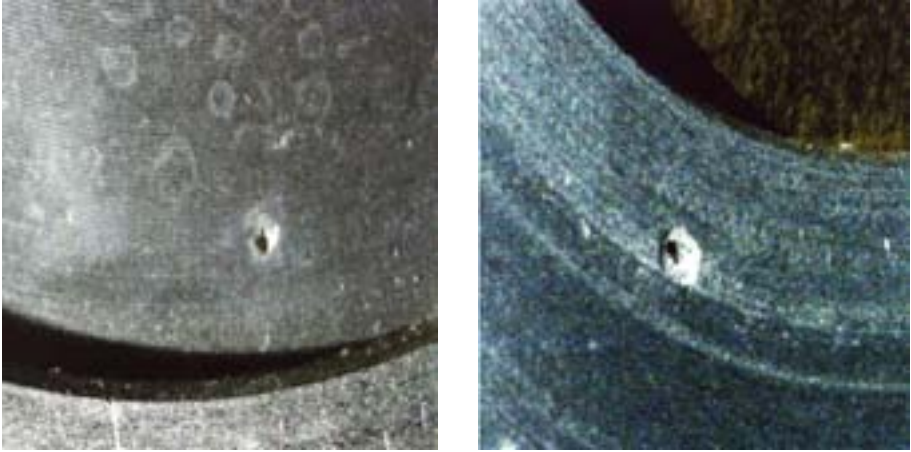
FIG. 9.3. Surface features on coupons after decontamination.

coupons were decontaminated in a 50% phosphoric acid solution and then examined. Figure 9.3 shows the surface features after decontamination. Pits and machining marks are clearly visible. One of the coupons was sectioned close to a pit and the coupon cross-section was polished to measure the depth of the pit.

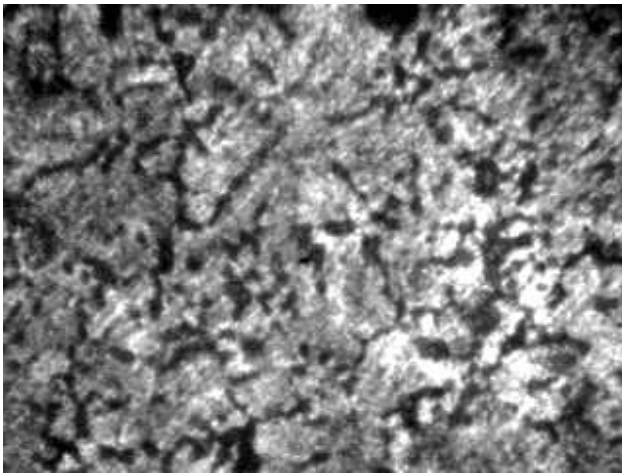
FIG. 9.5. Surface of coupon from rack 2 showing grain boundaries after decontamination.

As mentioned above, the two racks received in São Paulo were exposed in the same pool for 742 days. The coupons were inspected before and after decontamination. The chloride ion content was maintained at <2 ppm and the conductivity at <16 $\mu\text{S}/\text{cm}$. There were no deposits or corrosion products on the coupon surfaces and the pH values within the crevices were near neutral. Neither crevice corrosion nor galvanic corrosion was observed (Fig. 9.5). After

decontamination, the crevice surfaces had a bright silvery appearance. The outer surfaces of the coupons exhibited some roughening. The extent of roughness was greatest for 1100 and least for 6061 coupons. Microscopic examination revealed grain boundaries (Fig. 9.5). The deepest pit was found on the exposed surface of 1100 and the maximum pit depth was only 7.2 μm . No crevice or galvanic attack was observed. In general, the surfaces of the coupons of racks 2 and 3 were significantly better than those of rack 1.

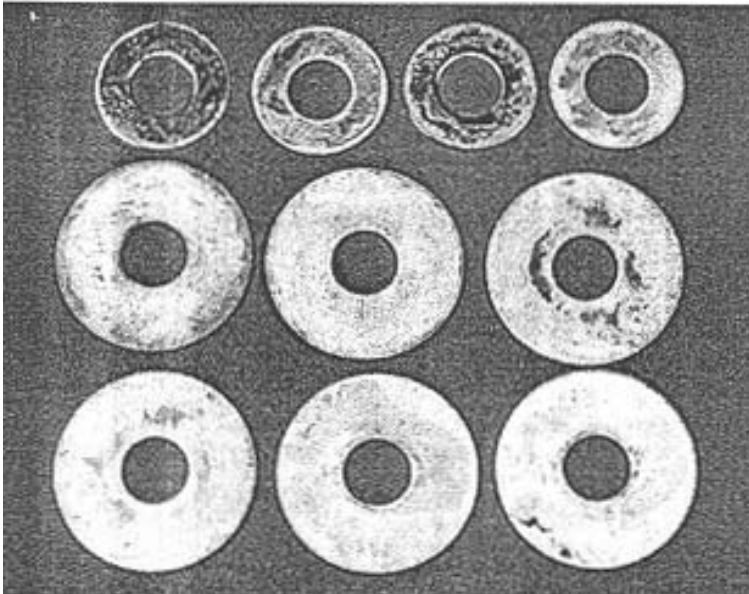
Rack 3 was permanently withdrawn from the basin water in October 2000. The same procedures as described above were used to disassemble and investigate the coupons. Photographs of the front (exposed to water) and back (coupling side) are shown in Fig. 10.1.

FIG. 10.1. Photographs of rack 3 coupons. (a) Fronts (exposed to water) and (b) backs (coupling side).

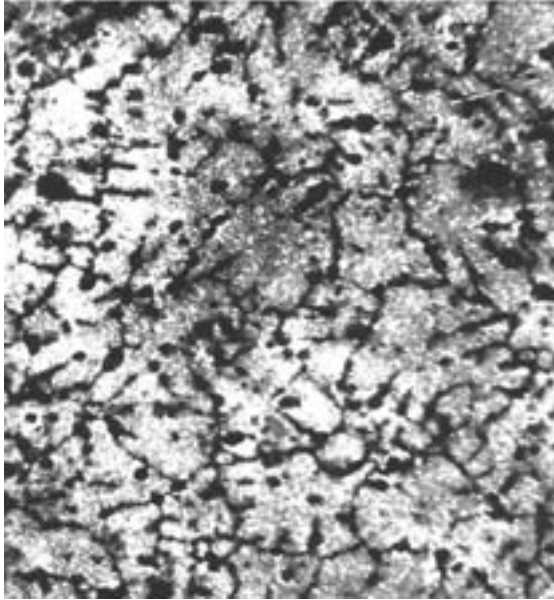
(11.3(b))

FIG. 11.3. Washed surfaces of coupons in racks 1, 2 and 3. (a) Region with red and brown particles (racks 2 and 3); (b) typical failure in racks 2 and 3; (c) unpolished coupon from rack 1. All photographs at 100 × magnification.

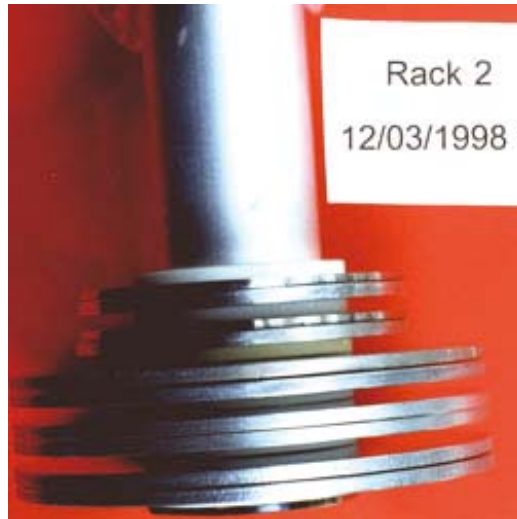
FIG. 13.2. Rack 2 before immersion.

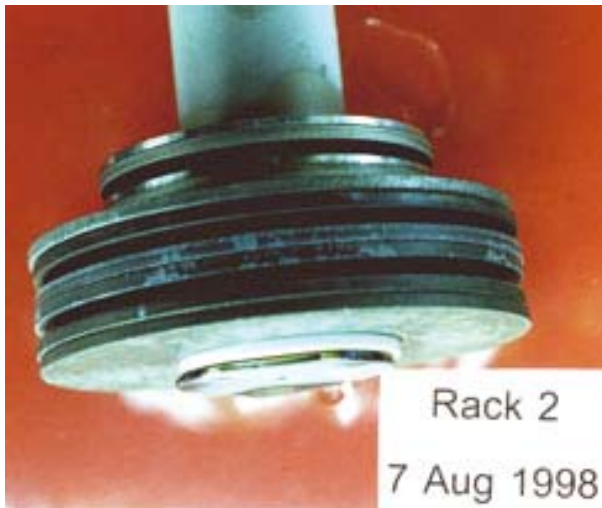
Racks 2 and 3 were examined visually every month for any signs of corrosion, and photographs were taken at regular intervals. Figures 13.2–13.4 show photographs of rack 2. Some edge corrosion was observed on some of the coupons, but after this, no significant corrosion was observed during the periodic examination of the assembled rack. On 2000-10-12, rack 2 was removed and disassembled. The pH on the contact surface of crevice and galvanic couples was measured and found to be 5.5, equal to that of the pool water. Table 13.3 catalogues the observations made visually on the coupons of rack 2 after 33 months of exposure. The coupons were taken for pit measurement without removing any oxide film.

FIG. 13.3. Rack 2 after six months of immersion.
