Analysis of the criticality of flaws found in trunnion of grinding ball mills used in mining plants

M.D.M. Neves*, A.H.P. Andrade, D.N. Silva

IPEN – Instituto de Pesquisas Energéticas e Nucleares, São Paulo, Brazil

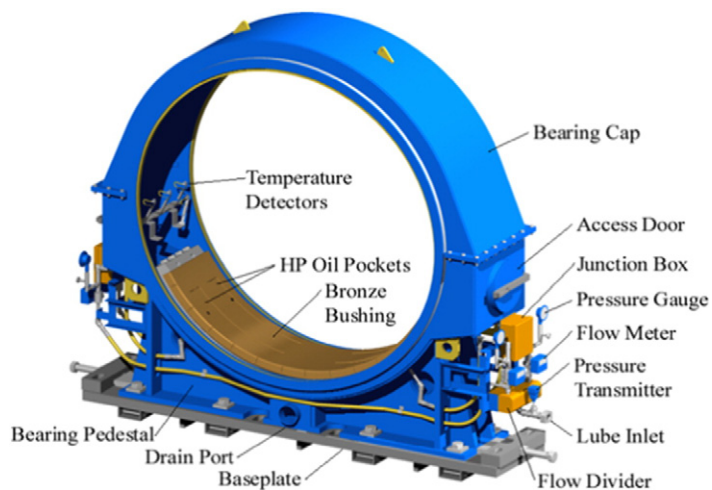
The cracks to be analyzed in this study appeared in a trunnion of a ball mill in the region of axial and radial contact with the bearing bushing of the mill. Those cracks were caused by a lack of lubrication, which allowed the metal to metal contact between the trunnion and the bushing. This contact led to a heating in the trunnion, inducing thermal stresses that culminated in the appearance of cracks in various regions of the trunnion.

Fig. 2. Trunnion bearing components, including bronze bushing.

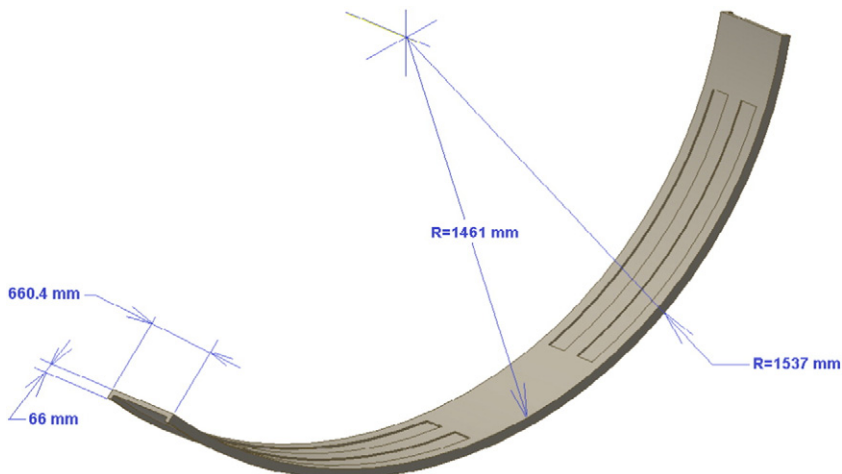
This paper was based on a $\text{Ø} 7.315 \text{ m}$ (24 ft) \times 12.192 m (40 ft) ball mill used in a typical mining plant. Some basic dimension of the studied trunnion is shown in Fig. 3. The approximate weight is 28 metric tons. The trunnion material was nodular cast iron per DIN 1693 grade GGG-50 [4] equivalent to EN-1563-GJS-500-7 [5]. The bronze bushing dimension is noted in Fig. 4.

Fig. 4. Bronze bushing dimension.
