# RETRIEVAL AND CONDITIONING OF RADIUM SOURCES-CONTAINING PACKAGE IN PANAMA

A team of CNEN experts successfully conducted an operation in Panama to recover and condition disused radioactive sources stored in an unsafe condition. The sources, containing the Ra-226 isotope, were used in the past to treat tumors using the technique known as brachytherapy and were immobilized in a complex package buried in an old hospital wing destined for demolition. The compartment where the package stayed for decades, built under the floor of a hospital laboratory, was contaminated with radon and daughters, including Pb-210, responsible for the contamination found. The operation consisted of extracting the package from this compartment, placing it in a cylindrical metal overpack, transporting it to the temporary storage site and carry out site decontamination. Besides the package with the sources, three 200L drums containing contaminated debris from the demolition of walls and floor were generated. No relevant event of radiological protection, such as occupational dose above the established limits, contamination of personnel or place, etc, was observed. The package produced, together with those con

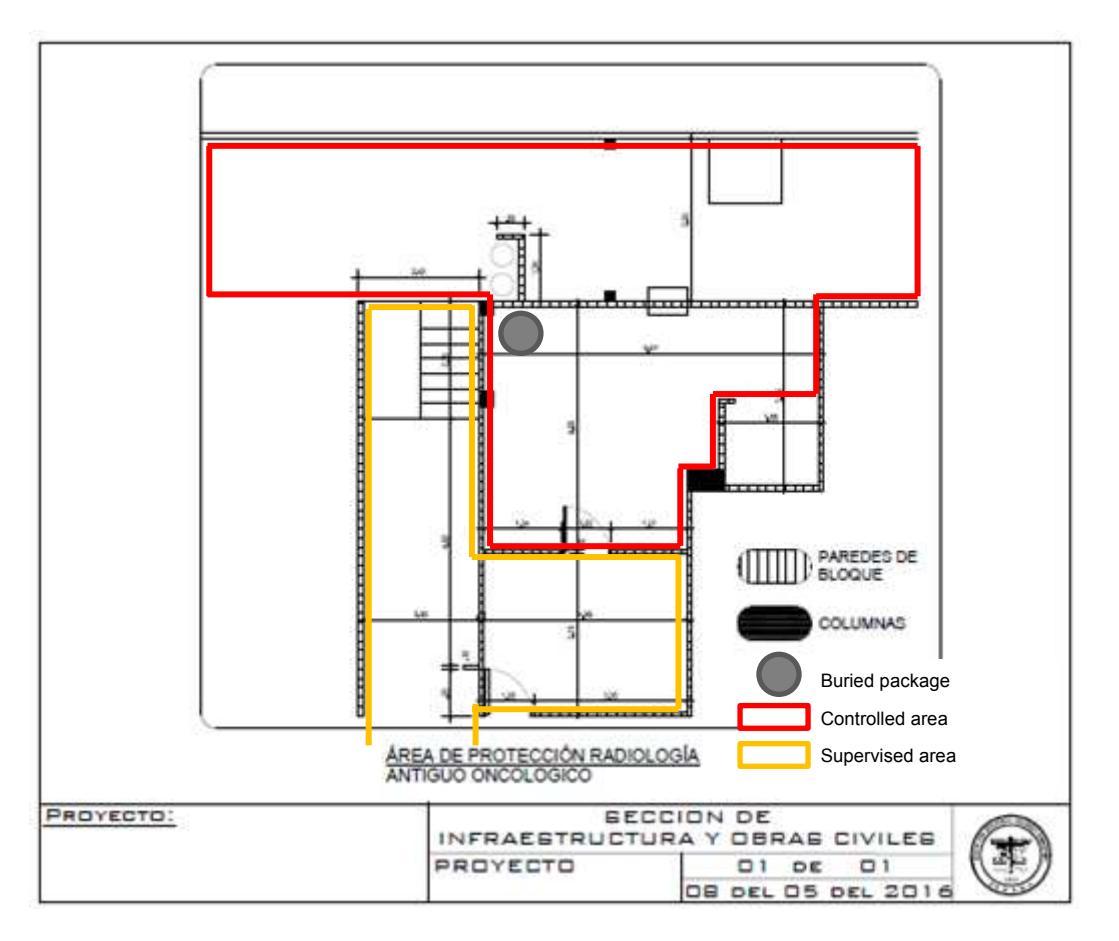
Figure 1: Work areas and access control [1]

As a measure to manage possible contamination and to keep exposures as low as reasonably achievable, work areas and access control were established (Figure 1). A more strictly controlled area was designed encompassing the room where the package was buried and the open area behind this room. Access to this site was only to carry out defined tasks, with mandatory use of PPE and appropriate dosimetry. A less strict supervised area was established covering all rooms, aisles and open areas adjacent to the controlled area up to the control point. The adequate personal preparation before access to the controlled area and the monitoring of personnel leaving for the free area were performed at the entrance to the supervised area. Only the personnel involved in the work and the staff of the regulatory agency had access to the site.

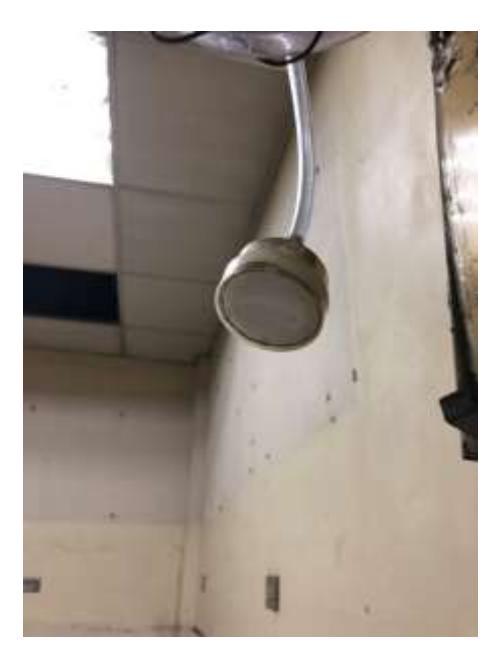
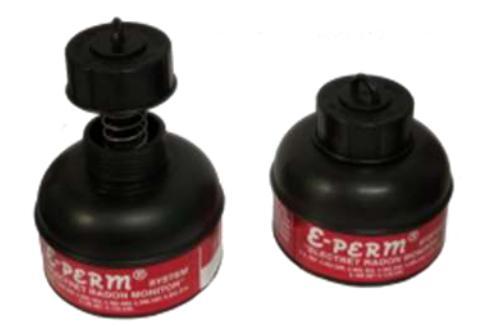
Figure 3: Air samplers

Sampling of ambient air was performed using a continuous air sampler and radon samplers (Figure 3). The first was installed in the operating room at a height of approximately 1.20 m, and its filter was read and changed every day, while the radon samplers were installed at floor level, also changed in a daily basis.
