EXPERIENCE ON WET STORAGE SPENT FUEL SIPPING AT IEA-R1 BRAZILIAN RESEARCH REACTOR*

J. A. PERROTTA, L. A. A. TERREMOTO and C. A. ZEITUNI

Instituto de Pesquisas Energéticas e Nucleares (IPEN/CNEN-SP), Divisão de Engenharia do Núcleo (REN), Travessa R, 400, Cidade Universitária, Caixa Postal 11.049, CEP 05422-970, São Paulo-SP, Brazil

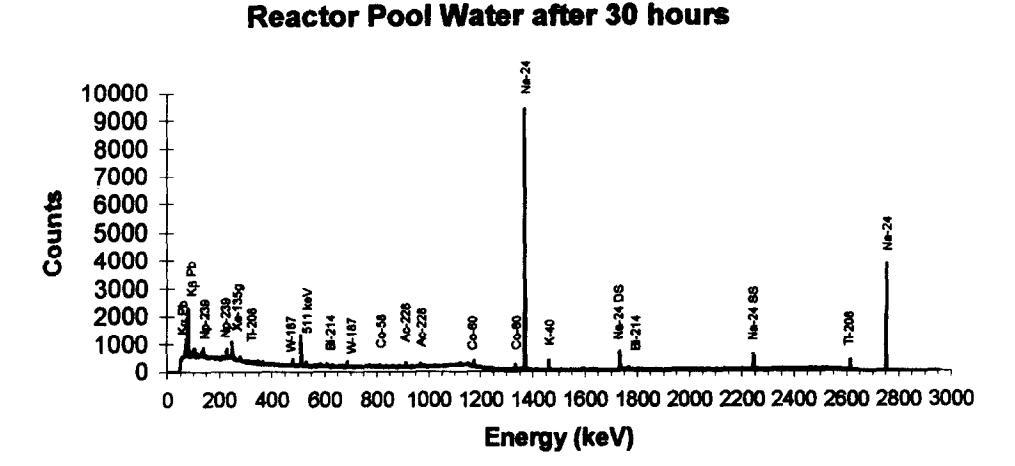
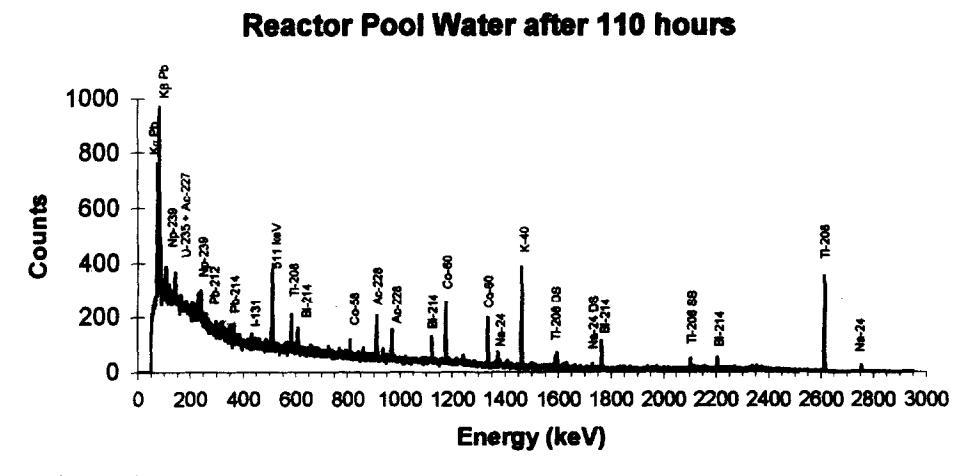
Fig. 4. Gamma-ray spectrum of the pool water sample, recorded 30 h after sampling.

Fig. 5. Gamma-ray spectrum of the pool water sample, recorded 110 h after sampling.

- 4. The analysis date influences the measured specific activity. This is due to the activation of the pool water that gives a high background level in the gamma-ray spectrum. The sipping tests were done with the reactor in operation and the activity of ²⁴Na (half-life of 15.02 h) in the water was high enough to increase background due to Compton continuum. Table 5 shows the pool water background and it is observed that the number of counts at the channel related to the energy of 661.6 keV decreases with the time of the analysis after sampling. Figs 4 and 5 show the gamma-ray spectra for the pool water, where one can see the influence of ²⁴Na in the background due to Compton continuum.
