# The Behavior of ANGRA 2 Nuclear Power Plant Core for a Small Break LOCA Simulated with RELAP5 Code

**Abstract.** This work discusses the behavior of Angra 2 nuclear power plant core, for a postulate Loss of Coolant Accident (LOCA) in the primary circuit for Small Break Loss Of Coolant Accident (SBLOCA). A pipe break of the hot leg Emergency Core Cooling System (ECCS) was simulated with RELAP 5 code. The considered rupture area is  $380 \text{ cm}^2$ , which represents 100% of the ECCS pipe flow area. Results showed that the cooling is enough to guarantee the integrity of the reactor core.

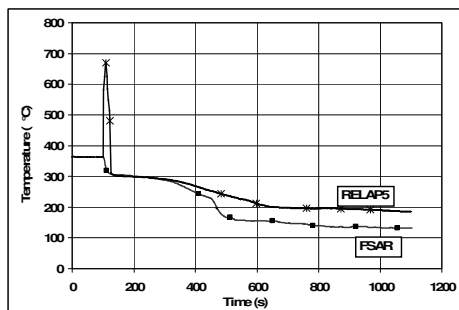
**FIGURE 4.** Maximum Temperature in the hot fuel rod (RELAP5 and FSAR)

FIGURE 4 shows that the core cooling by ECCS was enough to keep the fuel cladding below its melting temperature (1200 °C). Although the results were not as expected when compared to the FSAR, the ECCS efficiency was verified for this accident.
