# The Behavior of ANGRA 2 Nuclear Power Plant Core for a Small Break LOCA Simulated with RELAP5 Code

**Abstract.** This work discusses the nuclear behavior of Angra 2 nuclear power plant core, for a postulate Loss of Coolant Accident (LOCA) in the primary circuit for Small Break Loss Of Coolant Accident (SBLOCA). A pipe break of the hot leg Emergency Core Cooling System (ECCS) was simulated with RELAP 5 code. The considered rupture area is 380 cm<sup>2</sup>, which represents 100% of the ECCS pipe flow area. Results showed that the cooling is enough to guarantee the integrity of the reactor core.

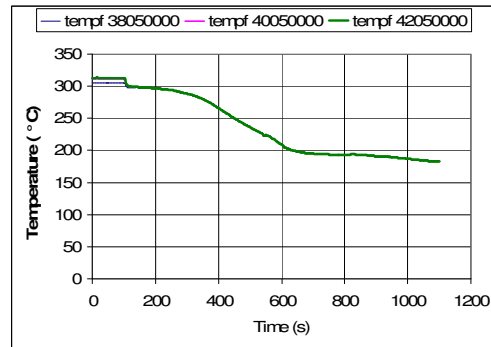
**FIGURE 3.** Temperature in the reactor core RELAP5

FIGURES 2 and 3 show the pressure and the temperature in the core cooling channels obtained with RELAP5 code. FIGURE 2 also compares the pressures obtained from the simulation with RELAP5 and FSAR, that showed to be in a reasonable agreement.
