Fukumori, N. T. O.; Martins, P. A.; Osso Jr, J. A.; Matsuda, M. M. N.

Centro de Radiofarmácia, IPEN-CNEN/SP – Brasil

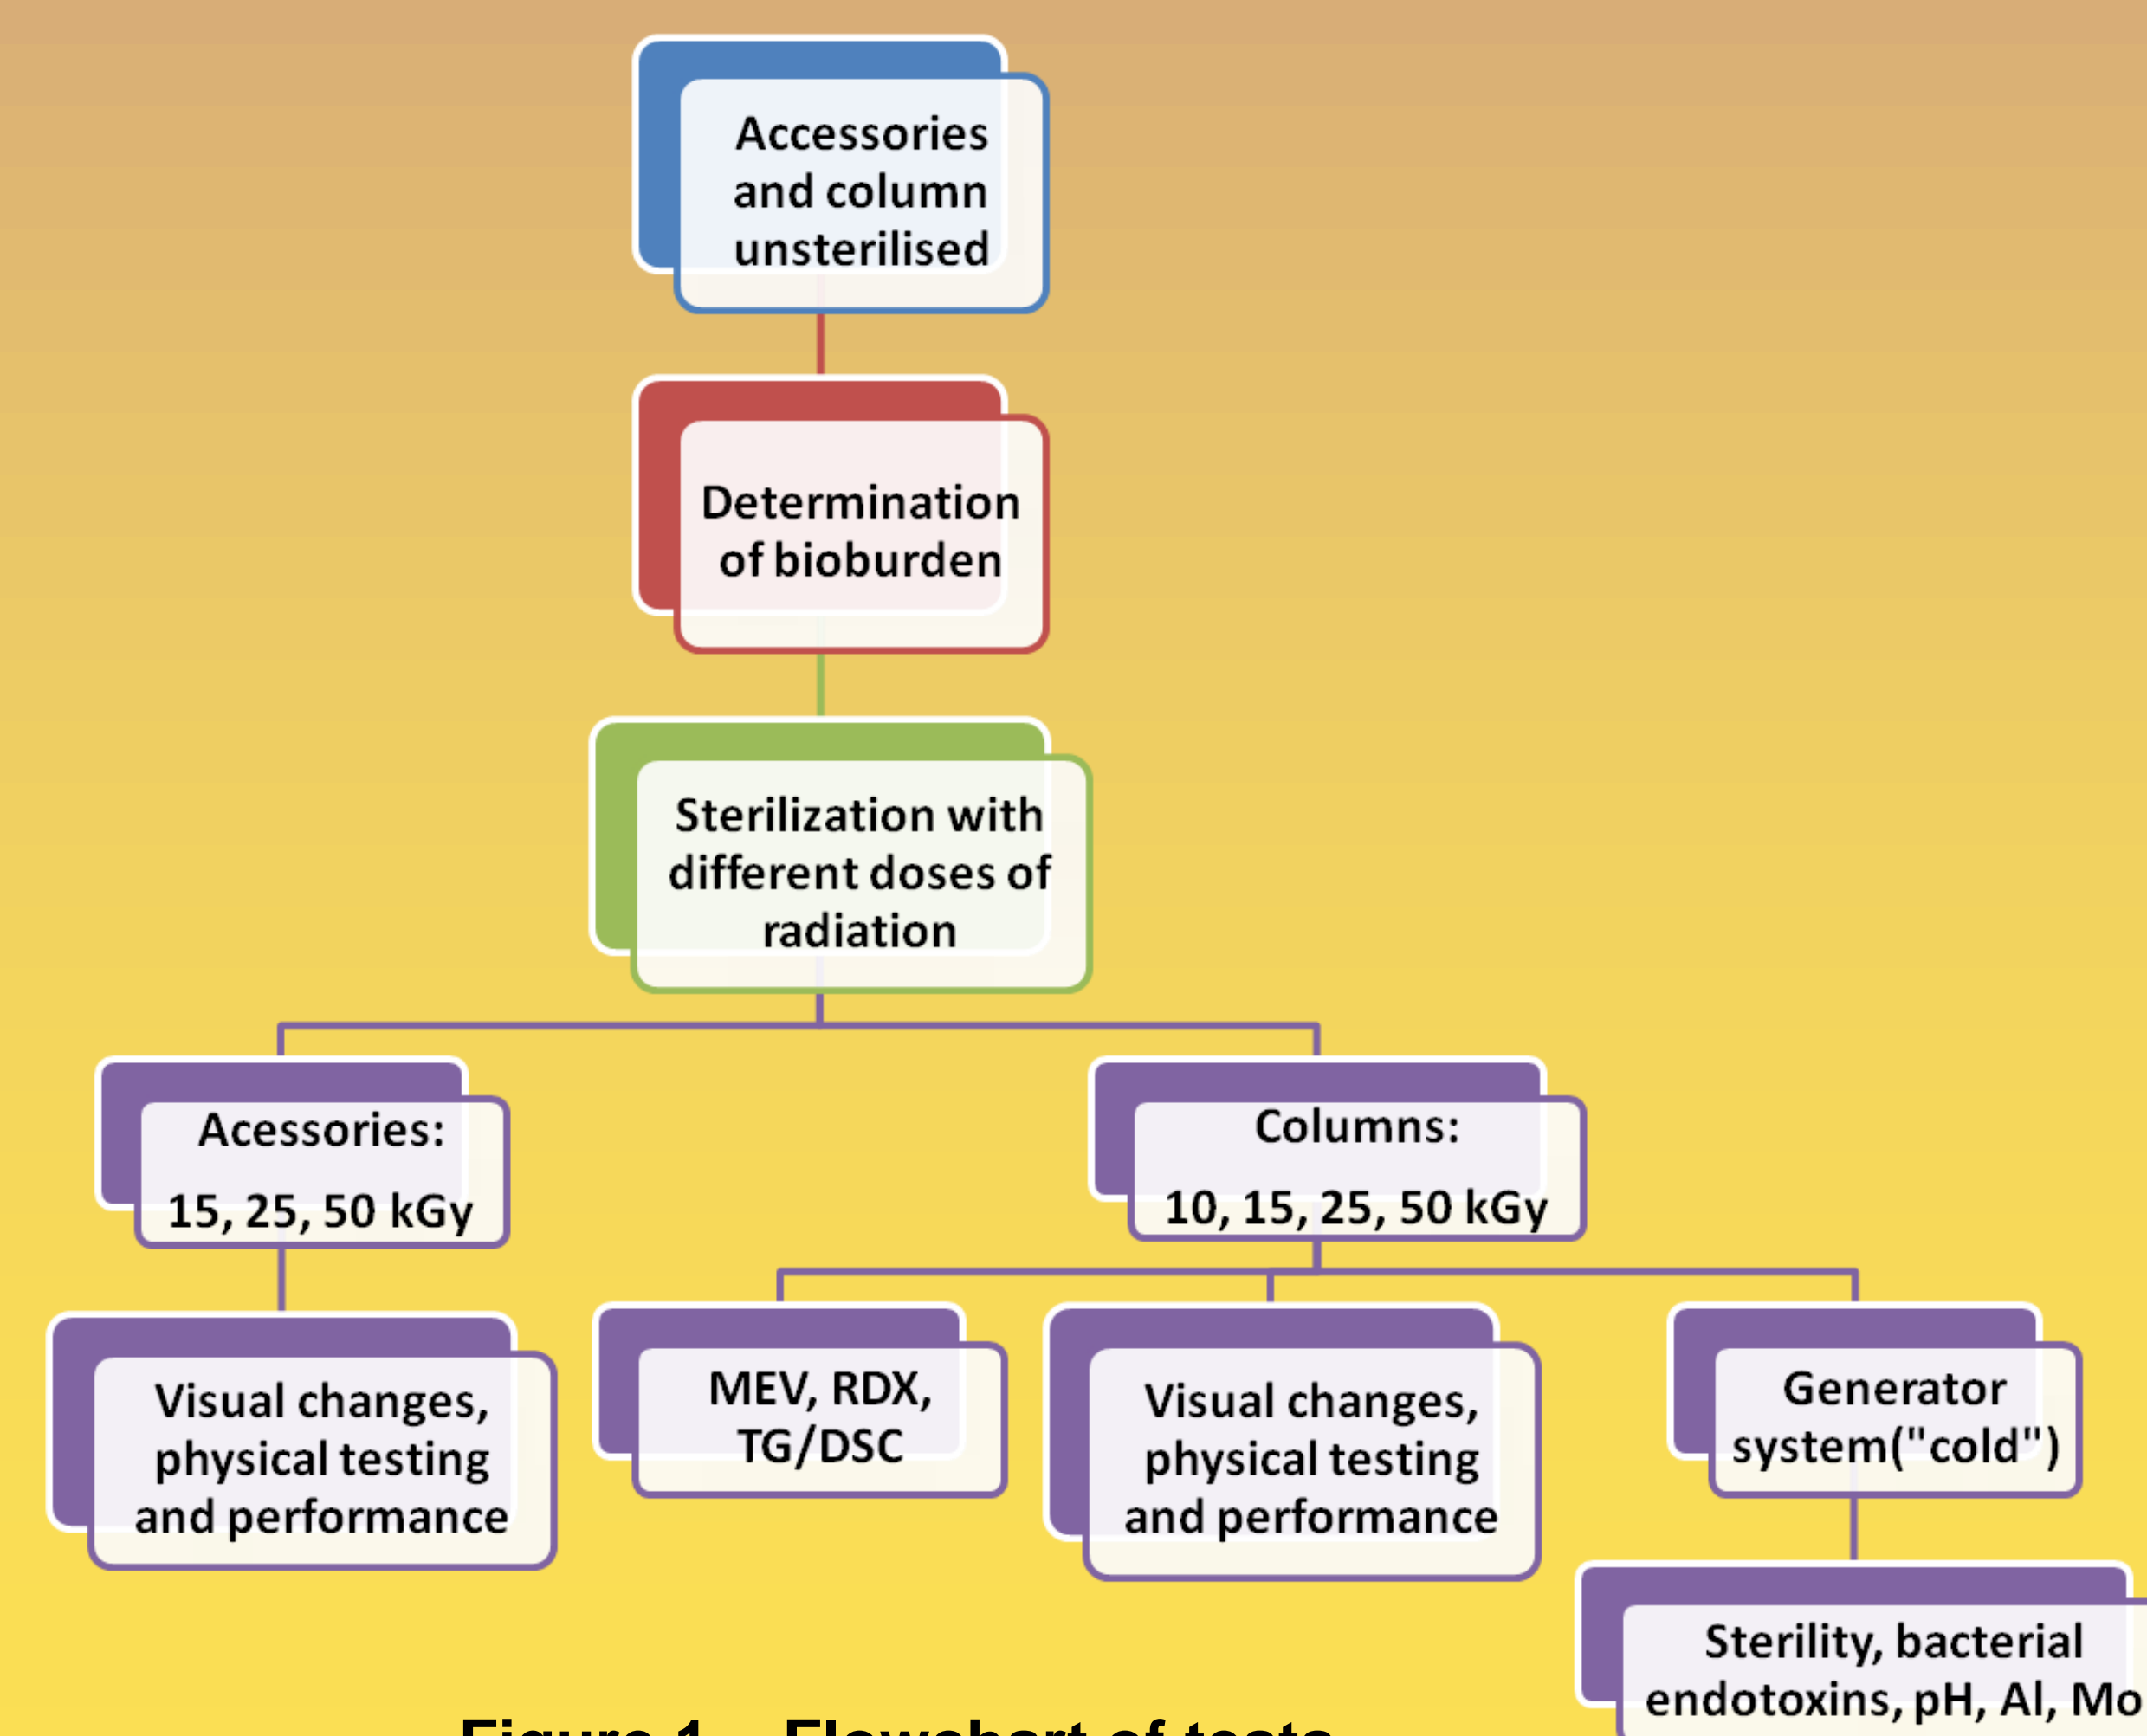
Figure 1 – Flowchart of tests

Thirty columns were irradiated at 10, 15, 25 and 50 kGy absorbed doses and examined for: changes due to the action of gamma radiation on the glass column; the crystal structure of alumina by scanning electron microscopy (SEM), elemental analysis by EDS and X-ray diffraction; weight change in tetrafluoroethylene (Teflon®) by TGA and DSC; visual changes and mechanical resistance of accessories for  $^{99}\text{Mo}/^{99\text{m}}\text{Tc}$  generator; measuring time and elution volume in "cold" systems for elution, as well as sterility, bacterial endotoxins, pH, Al and Mo concentration in the eluates. For confirmation of the  $^{60}\text{Co}$  dose applied to the column generator polymethylmethacrylate (PMMA) dosimeters were placed in empty glass columns exposed to 10 and 25 kGy doses. Figure 1 summarizes the tests.

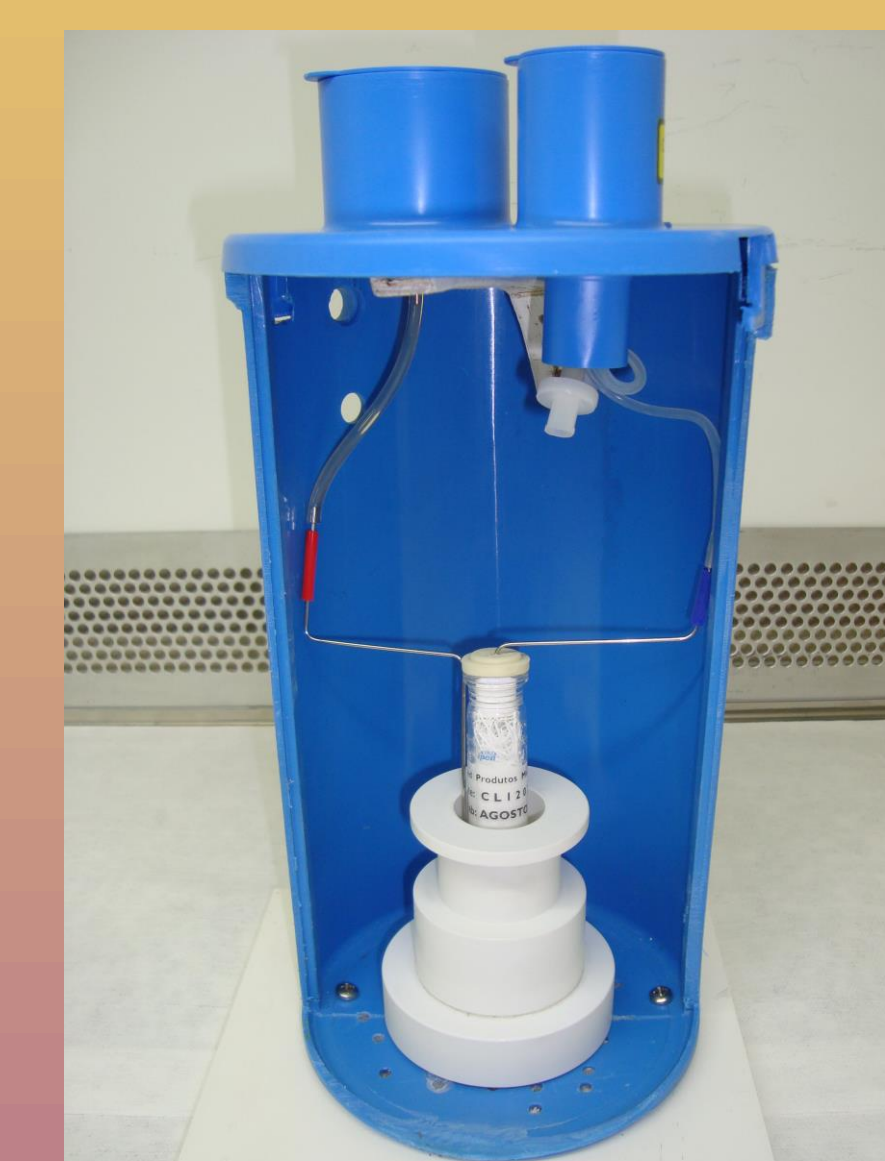
Figure 3 - Non-radioactive generator systems

The performance tests in non-radioactive generator systems (Figure 3) showed increased presence of aluminum in the eluates of columns irradiated with lower absorbed doses whilst in all cases the  $\text{MoO}_4^{2-}$  adsorption yield was above 99.97%.
