# Effect of Anodization on the Stress Corrosion Cracking Behavior of The AZ61 Magnesium Alloy in 0.1 M NaCl Solution

In the present work, the AZ61 alloy, one of the most important commercial structural magnesium alloys, was anodized in three different alkaline electrolytes consisting of 3 M KOH + 0.15 M Na<sub>2</sub>SiO<sub>3</sub> + 0.1 M Na<sub>2</sub>B<sub>4</sub>O<sub>7</sub>·10H<sub>2</sub>O, 3 M KOH + 0.5 M Na<sub>3</sub>PO<sub>4</sub> and 3 M KOH + 0.50 M Na<sub>2</sub>SiO<sub>3</sub>. The treatment was conducted at two different current densities, 20 and 30 mA·cm<sup>-2</sup> for 10 minutes. The anodized layers were characterized by scanning electron microscopy, X-ray diffractometry and X-ray photoelectron spectroscopy. The corrosion resistance was assessed by potentiodynamic polarization tests. The SCC behavior was studied using slow strain rate tests in 0.1 M NaCl solution at room temperature. Conventional tensile tests were also conducted in air. The susceptibility to SCC was dependent on the morphology of the anodized film. The composition of the electrolyte and the current density of the anodization treatment affected the SCC susceptibility of the AZ61 alloy. The bes

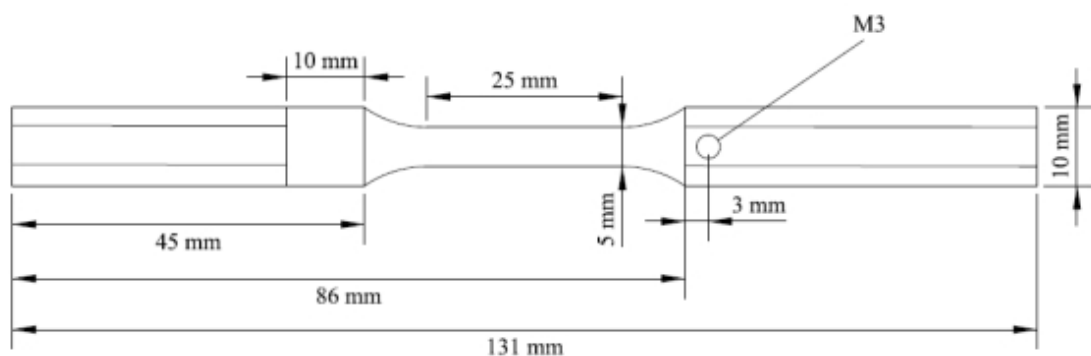
**Figure 1.** Schematic drawing of the SSRT specimens.

Specimens for the SSRT tests were prepared using a CNC machine (Romi D600). A schematic drawing of the machined specimens is displayed in Figure 1. The dimensions (mm) were based on the ASTM B107/B107M, ASTM B557 and ASTM E8/E8M standards<sup>28-30</sup>. After machining, surface finishing was comprised of grinding with silicon carbide waterproof sandpapers up to grit #2000, rinsed with ethanol and distilled water.

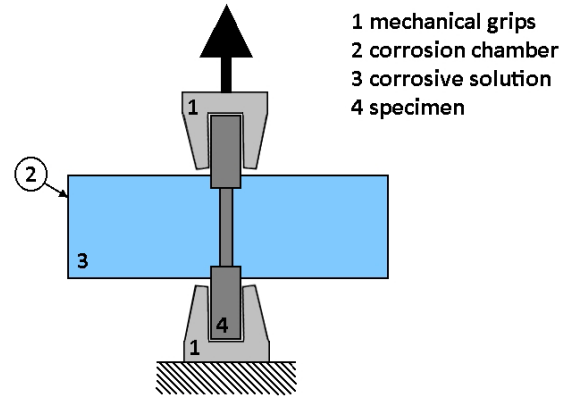
Figure 2. Schematic representation of the SSRT set up.

SSRT tests were conducted in 0.1 M NaCl at room temperature. The specimens were subject to uniaxial tensile tests at a deformation rate of  $10^{-6} \text{ s}^{-1}$  in a universal testing machine (MTS, Exceed 45), according to the ASTM G129 standard<sup>31</sup>. The machine was equipped with a homemade acrylic cell to hold the electrolyte, as schematically shown in Figure 2. The tests were conducted in triplicate. The elongation (EL) at break and ultimate tensile strength (UTS) of the specimens were determined from the engineering stress-strain curves. The tests were also conducted in air for comparison. After failure, the fracture surfaces were cleaned in  $10 \text{ g L}^{-1} \text{ CrO}_3$  solution at room temperature for 5 minutes, according to ASTM G1-90 to remove the corrosion products. Next, after rinsing in deionized water and drying in a warm air stream, fractographic analysis was carried out in a Leica/LEO 440i scanning electron microscope.

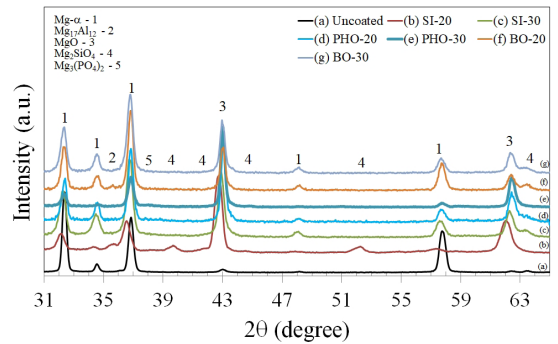
Figure 3. XRD patterns of the uncoated and anodized AZ61 alloy.

The crystalline phases formed on the anodized layers were identified by X-ray diffractometry. Figure 3 displays the XRD patterns of the as-received and anodized AZ61 alloy. The Mg- $\alpha$  and Mg<sub>17</sub>Al<sub>12</sub> peaks originated from the AZ61 alloy substrate are clearly seen for all samples. The main phase in the anodized films is MgO. According to Bai and Chen<sup>34</sup>, MgO forms by the migration of Mg<sup>2+</sup> ions from the substrate to the film/electrolyte interface, and also by the migration of O<sup>2-</sup> from the electrolyte to the substrate/film interface, following reaction (3).

In addition to MgO, Mg<sub>2</sub>SiO<sub>4</sub> peaks were also observed in the XRD patterns of the samples anodized in the silicate and borate-based electrolytes. This phase is frequently reported for anodized layers obtained in silicate-based electrolytes<sup>35,36</sup>. The formation of Mg<sub>2</sub>SiO<sub>4</sub> proceeds according to Equations 4 and 5<sup>15</sup>.

In the phosphate-based electrolyte the dominant crystalline phase is also MgO, as also displayed in Figure 3. Peaks from the substrate were also observed (Mg-*α* and Mg<sub>17</sub>-Al<sub>12</sub>). In addition to MgO, a weak magnesium phosphate (Mg<sub>3</sub>(PO<sub>4</sub>)<sub>2</sub>) peak was observed at 37.8°. This phase is also reported in the literature in the oxide film obtained from electrolytic oxidation processes of magnesium alloys in sodium phosphate-based electrolytes<sup>41,42</sup>.

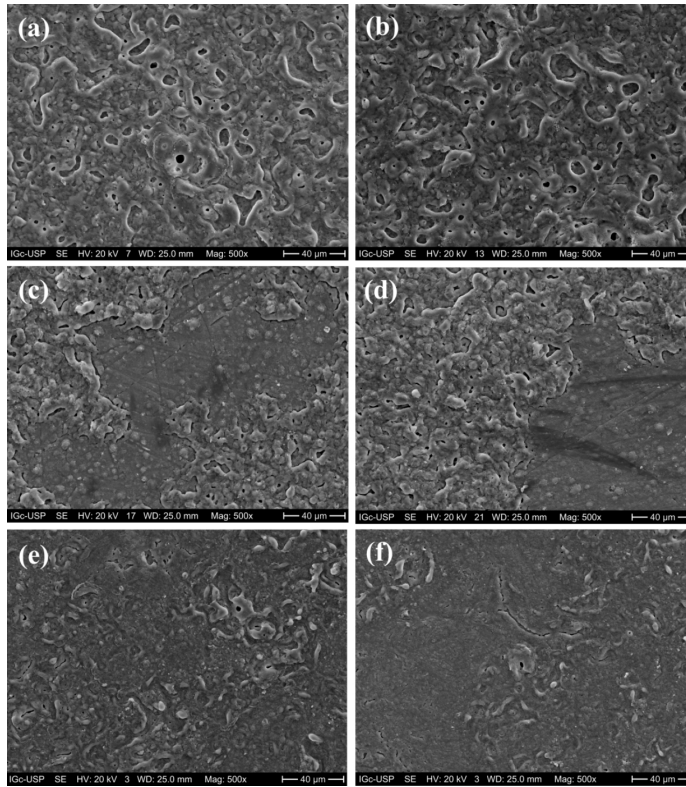
**Figure 4.** SEM micrographs (secondary electrons mode) showing the surface morphologies of the anodized layers: a) SI-20; b) SI-30; c) PHO-20; d) PHO-30; e) BO-20; e) BO-30.

Figure 4 shows SEM micrographs of the top surfaces of the anodized layers. The films obtained in the 3 M KOH + 0.5 M Na<sub>2</sub>SiO<sub>3</sub> electrolyte display pores and cracks that are typically formed during anodization of magnesium alloys<sup>43,44</sup>. The morphological features of the SI-20 (Figure 4a) and SI-30 (Figure 4b) samples are nearly the same, suggesting the increase of the anodizing current density did not change the surface topography of the anodic film. EDS maps (Supplementary Files – Figures S1 and S2) confirm that

The films obtained in the 3 M KOH + 0.5 M Na<sub>3</sub>PO<sub>4</sub>, in turn, display a distinct surface aspect. As seen in Figure 4c, the anodized layer formed on the PHO-20 sample exhibits a duplex character. Part of the surface displays a rough topography permeated by pores and cracks, whereas other regions are smoother (central region of Figure 4c). EDS mapping (Supplementary File – Figure S3) revealed that the smooth region does not contain phosphorus, being the magnesium signal much more intense at this site than at the rougher peripheral sites. The same features were observed for the PHO-30 sample (Figure 4d and Figure S4 – Supplementary File), with the difference that the smooth area is smaller than for PHO-20, suggesting the phosphate-rich anodized layer have grown faster when the current density increased from 20 to 30 mA·cm<sup>-2</sup>. In fact, the applied current density may trigger the growth of the anodized layer, as reported by Chai et al.<sup>45</sup>.

When anodization was carried out in the 3 M KOH + 0.15 M Na<sub>2</sub>SiO<sub>3</sub> + 0.1 M Na<sub>2</sub>B<sub>4</sub>O<sub>7</sub>·10H<sub>2</sub>O electrolyte, the surface aspect became smoother. As seen in Figure 4e, the BO-20 layer covers the whole surface and displays fewer pores and cracks when compared to the SI-20 (Figure 4a) and PHO-20 (Figure 4c) anodic films. The topography became even more compact for the BO-30 sample (Figure 4f). EDS maps reveal that magnesium is evenly distributed on the anodic films of these samples (Supplementary files – Figures S5 and S6), being the major constituent of these layers.

In order to confirm the visual indications of the SEM micrographs displayed in Figure 4, confocal laser scanning microscopy was employed to measure the surface roughness of the anodized layers. The results are expressed as average roughness (Ra) and mean roughness depth (Rz), as displayed in Table 3. The measurements were made along ten different lines on the sample surface. The anodizing treatment conducted in the borate-containing electrolyte led to the formation of a smoother oxide layer (samples BO-20 and BO-30), as seen in Table 3, confirming the visual aspect shown in Figure 4. The roughness values of the SI-20 and SI-30 samples were the highest, whereas the samples anodized in the phosphate-based electrolyte (PHO-20 and PHO-30) displayed intermediate values. The increase of the applied current density led to an increment of the Ra and Rz values. This effect was less pronounced for the BO-20 and BO-30 samples. Hence, based on the SEM micrographs (Fig 4) and roughness parameters (Table 3), as reported in the literature<sup>38</sup>, the anodized layers were more homogeneous and compact for the borate-containing electrolyte.

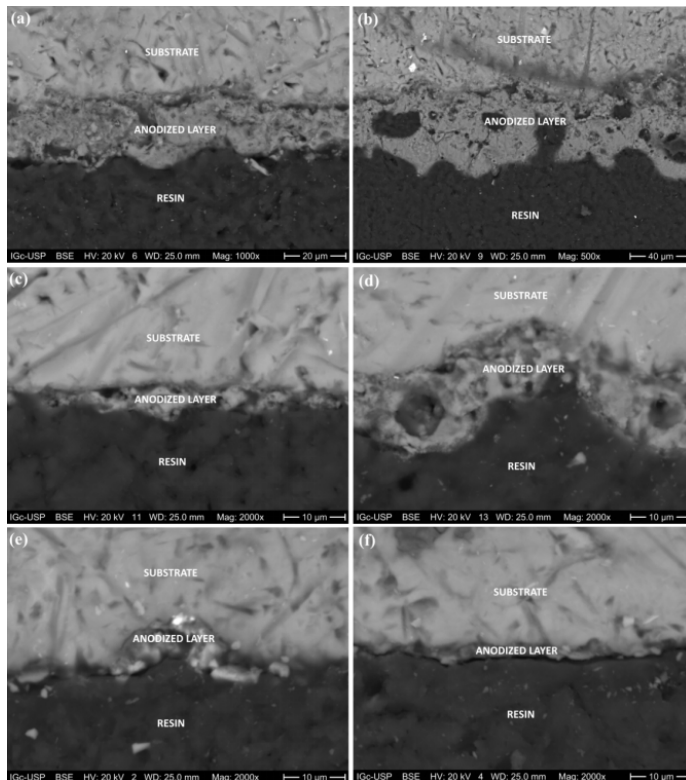
**Figure 5.** SEM micrographs (backscattered electrons mode) showing the cross-section morphologies of the anodized layers: a) SI-20; b) SI-30; c) PHO-20; d) PHO-30; e) BO-20; f) BO-30.

Complementary information on the morphology and compactness of the anodized layers was obtained from the cross-sectional SEM micrographs displayed in Figure 5.

The thickness of the anodized film increased with the applied current density, as observed for the SI-20 (Figure 5a) and SI-30 samples (Figure 5b). Another noticeable feature is that the compactness of the anodic film was also affected by the current density. Figure 5b clearly exhibits discontinuities and an irregular growth of the anodized layer, when compared to Figure 5a. Similar observations are also valid for the PHO-20 (Figure 5c) and PHO-30 (Figure 5d) samples. By increasing the applied current density, the anodic film has grown faster, but showing more defective sites.

A different situation took place when the anodizing treatment was conducted in the borate-containing electrolyte. As observed in Figure 5e and 5f, by increasing the applied current density, the BO-30 sample (Figure 5f) displayed an anodic film more homogeneous and compact with respect to the film obtained for the BO-20 sample (Figure 5e). Furthermore, as mentioned in section 3.1.1, borate ions are associated with a decrease of the electrical conductivity of the anodizing electrolyte, thus leading to the formation of a thinner anodic film, as confirmed by the SEM micrographs displayed in Figure 5e and 5f.

From the cross-sectional SEM micrographs shown in Figure 5a and 5b, one could expect the defective and irregular morphology of the anodized layer formed on the SI-30 would facilitate electrolyte penetration. This, in turn, could increase the susceptibility of the AZ61 alloy to SCC by intensifying pitting formation at the interface substrate/anodic film. However, such effect was not observed. A possible explanation may be related to the fact that SI-30 sample displayed the lowest values of UTS, and a low elongation at break (the second lowest among all anodized samples). Hence, as the defective anodized layer had already greatly decreased its tensile properties in air, the presence of the corrosive environment did not lead to a significant deterioration of these properties with respect to SI-20. This effect also manifests if one looks at the values of  $I_{SCC}$  (susceptibility index for the UTS). The value of  $I_{SCC}$  decreased for SI-30 with respect to SI-20. For the samples anodized in the phosphate-based electrolyte (PHO-20 and PHO-30) the  $I_{SCC}$  was not significantly altered when the anodizing current density increased. The major influence of the current density on  $I_{SCC}$  was observed for the samples anodized in the borate-containing electrolyte. As shown in Table 5, the  $I_{SCC}$  of BO-30 reduced almost three times with respect to BO-20. Such lower susceptibility to SCC may be related to the compactness of the anodic film formed on this sample (section 3.1.2). Pores and cracks of the anodic layer, as well as the intrinsic brittleness of this ceramic layer, are associated with its limited ability to enhance the SCC behavior of anodized metallic substrates<sup>54</sup>.

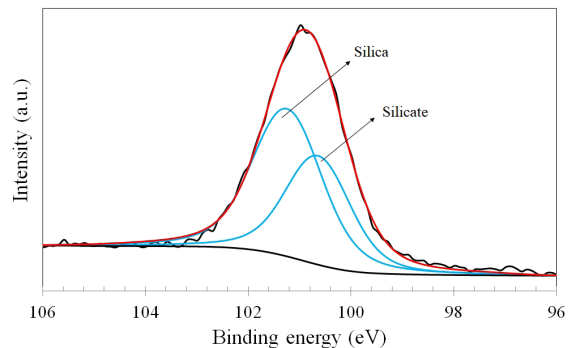
**Figure 7.** XPS Si 2p high resolution spectrum of the BO-20 sample.

The Si 2p high resolution spectra were acquired for the samples anodized in silicate-containing electrolytes (SI-20, SI-30, BO-20 and BO-30). One representative Si 2p spectrum is shown in Figure 7 for the BO-20 sample. The Si 2p spectra of the other samples presented the same features, and are displayed as Supplementary files (Figure S8). The spectra were deconvoluted with two components. The low binding energy component was assigned to silicate bonds such as those found in  $\text{Mg}_2\text{SiO}_4$ . The high binding energy component was assigned to silica-type bonds, as observed by other authors<sup>49</sup>.

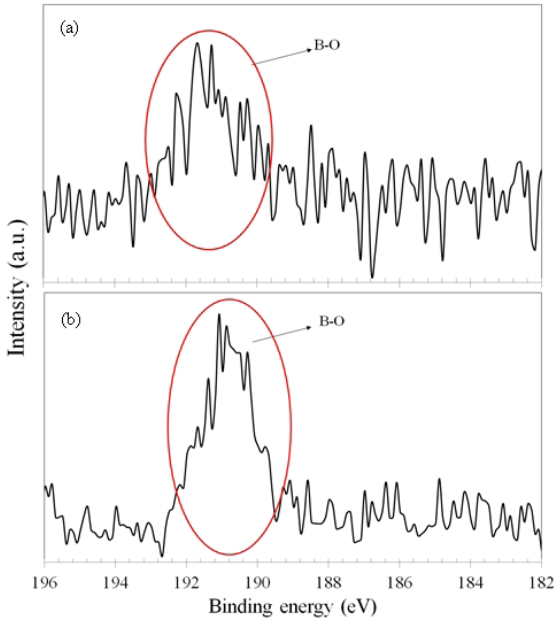
**Figure 8.** XPS B 1s high resolution spectra of the AZ61 alloy anodized in the borate-containing electrolyte: (a) BO-20; b) BO-30.

A weak B 1s signal was observed in the AZ61 samples anodized in the borate-containing electrolyte. As shown in Figure 8, the B 1s peak appears at approximately 191.6 eV for the BO-20 (Figure 8a) and BO-30 (Figure 8b) samples. This peak is assigned to B-O bonds in the anodized layer, as observed by Ardelean et al.<sup>50</sup>. Oxidation treatments of magnesium alloys in borate-containing electrolytes may lead to the formation of compounds such as  $\text{Mg}_2\text{B}_2\text{O}_5$  or  $\text{Mg}_3\text{B}_2\text{O}_6$ <sup>40,51</sup>. Although not detected by XRD (Figure 3), XPS analysis unequivocally shows that a small amount of borate-containing species is incorporated into the anodic films of BO-20 and BO-30.

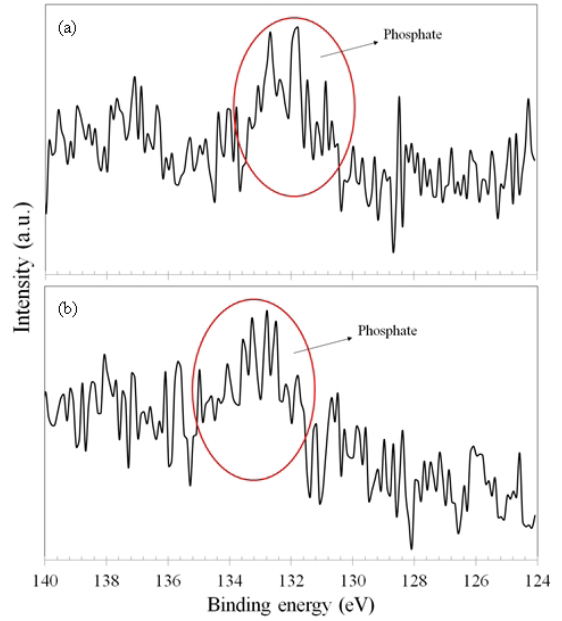
**Figure 9.** XPS P 2p high resolution spectra of the AZ61 alloy anodized in the phosphate-containing electrolyte: (a) PHO-20; b) PHO-30.

The XPS P 2p high resolution spectra of the PHO-20 and PHO-30 samples are shown in Figure 9. For both samples the small peak at approximately 133 eV is assigned to phosphate bonds, in accordance with the literature<sup>52</sup>. The formation of  $\text{Mg}_3(\text{PO}_4)_2$  is expected in this type of process<sup>47,48</sup>. The XPS results confirm the presence of this phase, as also observed in the XRD patterns displayed in Figure 3. The anodized layers on the PHO-20 and PHO-30 samples consist of a mixture of MgO and  $\text{Mg}_3(\text{PO}_4)_2$ , with predominance of MgO, as suggested by the weak XPS signal of the phosphate phase. The presence of amorphous  $\text{Mg}(\text{OH})_2$  cannot be ruled out too.

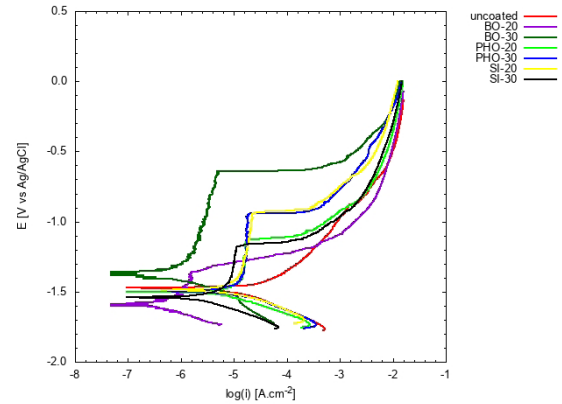
**Figure 10.** Potentiodynamic polarization curves of the uncoated and anodized AZ61 alloy in 0.1 M NaCl solution at room temperature.

Potentiodynamic polarization curves of the uncoated and anodized AZ61 alloy are shown in Figure 10. The tests were conducted in 0.1 M NaCl solution at room temperature. Corrosion potential ( $E_{\text{corr}}$ ), corrosion current density ( $i_{\text{corr}}$ ), passive current density ( $i_{\text{pass}}$ ), breakdown potential ( $E_b$ ) and passive range ( $\Delta E = E_b - E_{\text{corr}}$ ) were determined from these curves, as displayed in Table 4. The corrosion current density was determined using the Tafel extrapolation method. Since it is formally valid if both the anodic and cathodic branches are under activation control,  $i_{\text{corr}}$  was determined only for the uncoated AZ61 alloy, as it was the only sample that did not display passivation in the anodic branch of its polarization curve. Conversely, as all anodized samples displayed a passive region,  $i_{\text{pass}}$  was determined instead of  $i_{\text{corr}}$ . It was taken at the middle of the passive range, as proposed by other authors<sup>53</sup>.

The oxide layers could effectively slow down the corrosion kinetics of the AZ61 alloy, depending on the anodizing conditions, as shown in Figure 10 by the remarkable reduction of the anodic currents with respect to the uncoated substrate. Conversely, the mechanical strength was reduced after anodizing, as denoted by the values of UTS and elongation at break in the tensile tests conducted in air. Thus, the anodic films play two distinct roles, if one considers the electrochemical and mechanical effects separately. The decrease of the anodic currents indicates that the oxide films act as a barrier against electrolyte penetration, even though they are intrinsically permeated by pores and cracks (Figure 4 and 5). Simultaneously, it is accompanied by the stress riser effect that decreased both the tensile strength and ductility. Additionally, the susceptibility to SCC ( $I_{SCC}$  values shown in Table 5) can be correlated with the electrochemical behavior described in section 3.2. As discussed above, the  $I_{SCC}$  values were affected by the morphological aspects of the anodic films, being reduced for the most compact anodized layers (BO-30). In the same regard, the passive range and breakdown potentials were also dependent on the compactness of the anodized layer, being maximized for the BO-30 sample. Hence, there is an evident correlation between the SCC susceptibility and the electrochemical stability of the oxide film, and the compactness of the anodizing layer play a central role in this scenario.

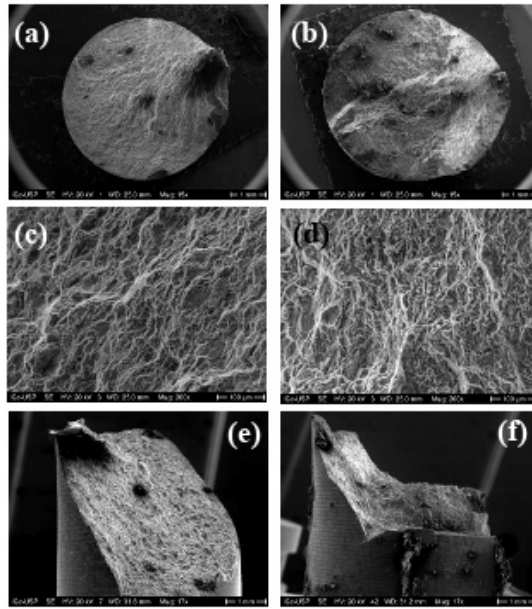
**Figure 12.** SE-SEM micrographs of the fracture surfaces of the as-received AZ61 alloy: a) cross-section; specimen tested in air; b) cross section; specimen tested in 0.1 M NaCl solution; c) high magnification view of (a); d) high magnification view of (b); e) side view; specimen tested in air; f) side view; specimen tested in 0.1 M NaCl.

SEM micrographs of the fracture surfaces of the uncoated AZ61 alloy after the tensile tests in air and 0.1 M NaCl solution are shown in Figure 12. For the test conducted in air (Figure 12a) there is a long crack propagation region, typically associated with ductile behavior, as also indicated in the stress-strain curve of this sample (Figure 11). The SEM micrograph shown in Figure 12c confirms the ductile character of the fracture surface by the unequivocal presence of dimples on the crack propagation region, as also reported by Srinivasan et al.<sup>55</sup> for the AZ61 alloy. The side view of the fractured specimen (Figure 12e) shows a slant fracture with a slope of approximately 45°, typical of ductile specimens subjected to tensile tests<sup>56</sup>. Some distinct aspects may be seen in the case of the specimen fractured in the 0.1 M NaCl solution. The general aspect of the fracture surface (Figure 12b) displays smoother sites when compared to the specimen fractured in the air (Figure 12a), suggesting a mixed ductile-brittle fracture mode. In fact, the microfractographic features of this sample (Figure 12d) indicate the coexistence of ductile (dimpled fracture) and brittle (cleavage regions at the right side of the micrograph) features, characterizing the mixed fracture mode. By comparing the side view (Figure 12f) with that of the specimen fractured in the air (Figure 12e), the reduction of the ductile character of the fracture surface is also evident, as indicated by the relatively flat fracture. Hence, Figure 12 shows the susceptibility of the AZ61 alloy to SCC, as also inferred from the values of  $I_{SCC}$  and  $I_e$  (Table 5) for the uncoated substrate, corroborating literature reports<sup>57</sup>.

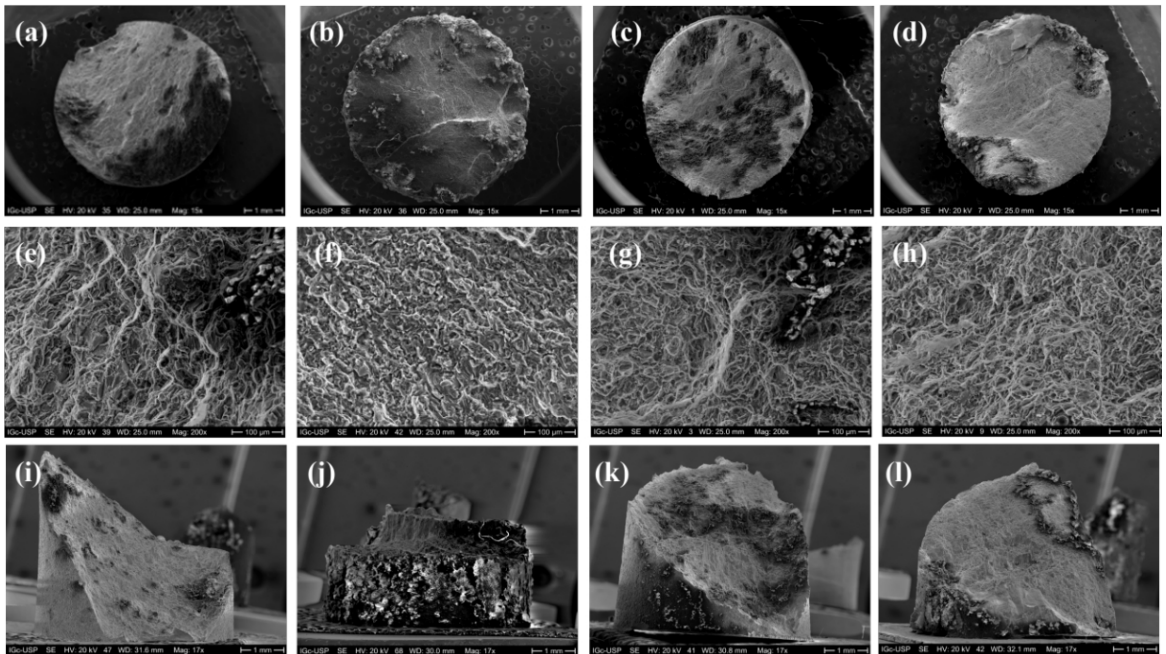
**Figure 13.** SE-SEM micrographs of the fracture surfaces of the SI-20 and SI-30 samples: a) SI-20 cross-section; specimen tested in air; b) SI-20 cross section; specimen tested in 0.1 M NaCl solution; c) SI-30 cross-section; specimen tested in air; d) SI-30 cross section; specimen tested in 0.1 M NaCl solution; e) high magnification view of (a); f) high magnification view of (b); g) high magnification view of (c); h) high magnification view of (d); i) SI-20 side view; specimen tested in air; j) SI-20 side view; specimen tested in 0.1 M NaCl; k) SI-30 side view; specimen tested in air; l) SI-30 side view; specimen tested in 0.1 M NaCl.

The fracture surfaces of the SI-20 and SI-30 samples are shown in Figure 13. The general aspect of the fracture surface of the SI-20 sample tested in the air (Figure 13a) displays a wide crack propagation region, indicating the ductile character of this sample, as also confirmed by the

dimpled fracture observed in Figure 13e. Its side view (Figure 13i) also displays the slant fracture typical of ductile behavior. When this sample was fractured in 0.1 M NaCl solution the fracture surface exhibits different aspects. As seen in Figure 13b (general fracture surface) and 13f

(microfractographic features), smooth regions and a granular aspect, typical of brittle fractures were observed for the SI-20 sample in 0.1 M NaCl solution. The side view displayed in Figure 13j clearly indicates an intense deterioration of the fractured specimen and the flat fracture associated with brittle failure, differently from what was observed for the specimen fractured in the air (Figure 13i).

Similar features could be found in the fracture surfaces of the SI-30 sample. The general view (Figure 13c) and microfractographic features (Figure 13g) typically show a wide crack propagation region and a dimpled fracture, respectively. The side view (Figure 13k) also shows a slant fracture associated with a ductile fracture mode. When the tests were conducted in 0.1 M NaCl solution, some localized cleavage sites could be seen, as displayed in the left side of Figure 13h. The side view of the SI-30 sample tested in the NaCl solution (Figure 13l) still shows a predominant slant fracture, suggesting the increase of the anodizing current density did not alter the fracture mode with respect to the SI-20 condition. This result is in agreement with the  $I_{SCC}$  and  $I_g$  values of the SI-20 and SI-30 samples (Table 5), that indicated a reduction of the susceptibility to SCC of SI-30 with respect to SI-20.

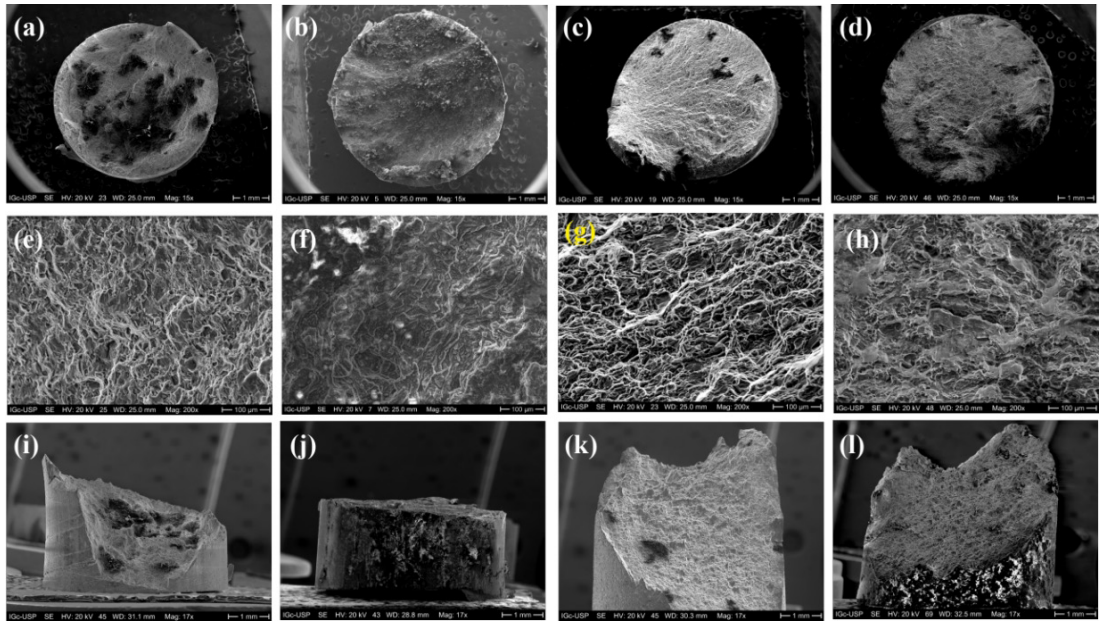
**Figure 14.** SE-SEM micrographs of the fracture surfaces of the PHO-20 and PHO-30 samples: a) PHO-20 cross-section; specimen tested in air; b) PHO-20 cross section; specimen tested in 0.1 M NaCl solution; c) PHO-30 cross-section; specimen tested in air; d) PHO-30 cross section; specimen tested in 0.1 M NaCl solution; e) high magnification view of (a); f) high magnification view of (b); g) high magnification view of (c); h) high magnification view of (d); i) PHO-20 side view; specimen tested in air; j) PHO-20 side view; specimen tested in 0.1 M NaCl; k) PHO-30 side view; specimen tested in air; l) PHO-30 side view; specimen tested in 0.1 M NaCl.

The corrosive environment had a remarkable effect on the mechanical behavior of the samples anodized in the 3 M KOH + 0.5 M  $\text{Na}_3\text{PO}_4$  solution (PHO-20 and PHO-30). This can be inferred from the SEM micrographs shown in Figure 14.

By examining the fracture surface of the PHO-20 sample in the air (Figure 14e) and in 0.1 M NaCl solution (Figure 14f), the microfractographic features changed from dimpled to cleavage fracture, indicating the susceptibility of this sample to SCC.

The general aspects of the fracture surface (Figure 14a and 14b) point to this direction too, as seen by the presence of granular regions on the specimen fractured in the sodium chloride solution (Figure 14b). Furthermore, ductility loss of the PHO-20 sample in the corrosive environment is also evident from the side views displayed in Figure 14i and 14j. Fracture exhibited a flat character for the test conducted in the sodium chloride solution (Figure 14j). Sample PHO-30 also exhibits a trend of increasing the cleavage character of the fracture surface when the test was conducted in the sodium chloride solution. Nonetheless, some distinct aspects can be highlighted with respect to PHO-20. The most striking difference seems to be associated with the ductility level, either for the test conducted in the air or in the 0.1 M NaCl electrolyte. The dimples formed on the fracture surface of the PHO-30 sample tested in air (Figure 14g) are more pronounced than those on the surface of the PHO-20 sample in the same environment (Figure 14c). Similarly, for the tests conducted in the corrosive environment, PHO-30 still shows some dimples on the fracture surface (Figure 14h), while it was mainly flat for the PHO-20 sample (Figure 14f), losing the dimpled fracture mode. Thus, as the anodizing current density increased, the susceptibility to SCC decreased for the samples treated in the phosphate electrolyte. This is also confirmed by the slant fracture of the PHO-30 sample either in the air or in the sodium chloride solution (Figure 14k and 14l, respectively) with respect to the predominantly flat fracture of the PHO-20 sample in both conditions (Figure 14i and 14j). The increase of the localized corrosion protection ability of PHO-30 when compared to PHO-20, as indicated by its larger values of breakdown potential and passive range (Table 4), may be related to its enhanced SCC behavior.

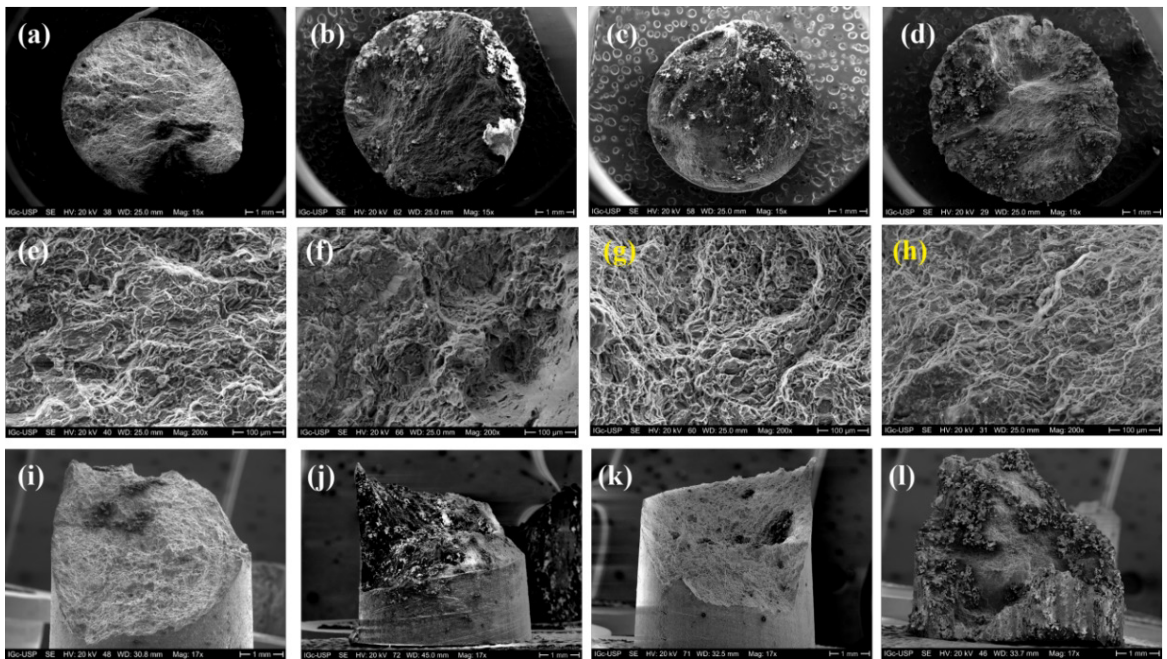
**Figure 15.** SE-SEM micrographs of the fracture surfaces of the BO-20 and BO-30 samples: a) BO-20 cross-section; specimen tested in air; b) BO-20 cross section; specimen tested in 0.1 M NaCl solution; c) BO-30 cross-section; specimen tested in air; d) BO-30 cross section; specimen tested in 0.1 M NaCl solution; e) high magnification view of (a); f) high magnification view of (b); g) high magnification view of (c); h) high magnification view of (d); i) BO-20 side view; specimen tested in air; j) BO-20 side view; specimen tested in 0.1 M NaCl; k) BO-30 side view; specimen tested in air; j) BO-30 side view; specimen tested in 0.1 M NaCl.

Figure 15 shows the fracture surfaces of the BO-20 and BO-30 samples for the tests conducted in the air and 0.1 M NaCl solution. The general aspect of the fracture surface of the BO-20 sample tested in air (Figure 15a) and the microfractographic features (Figure 15e) reveal a mixed fracture mode, with the concomitant presence of dimples and cleavage sites. The same features can be observed for the BO-30 sample tested in air (Figure 15c and 15g), although the dimples occupy a bigger area. The side views displayed in Figure 15i and 15k show the slant fracture typical of ductile behavior. The corrosive environment had a remarkable effect on the fractographic aspects of the BO-20 sample, as well as for the samples anodized in the phosphate-based electrolyte, as suggested by the micrographs displayed in Figure 15b and 15f. The fracture surface has several craters originated from alloy dissolution upon exposure to the sodium chloride solution. The side view displayed in Figure 15j suggests a strong degradation when the BO-20 sample was tested in the sodium chloride solution. By examining the fracture surface of the BO-30 sample, its general aspect (Figure 15d) and microfractographic features (Figure 15h) reveal loss of ductility in comparison with the sample tested in air (Figure 15c and 15g). The dimpled aspect of the fracture surface is less pronounced for the sample tested in the sodium chloride solution. The presence of smooth regions, typical of brittle fracture (cleavage mode), is observed, although some dimples can still be seen (Figure 15g). The side view shown in Figure 15l also indicates intense deterioration, as well as observed for the BO-20 sample (Figure 15j). Such behavior reflects what was inferred from the results displayed in Table 5 that

indicated larger susceptibility of the BO-20 sample to SCC ( $I_{SCC}$  and  $I_e$  values) with respect to BO-30. Furthermore, the ductility loss of the AZ61 alloy, as observed from the stress-strain curves in Figure 11, is also reflected on the fractographic features, with a predominance of cleavage areas over dimpled fracture. Hence, by increasing the anodizing current density in the borate-containing electrolyte, the AZ61 alloy became less prone to SCC. This behavior can be explained by the SEM micrographs shown in section 3.1.2, which revealed the formation of a thin, compact and homogeneously distributed anodic film for the BO-30 sample. This morphology favored both the corrosion resistance (Figure 10) and SCC behavior of the AZ61 substrate.
