Heat Treatment Effect on Spray Formed Al/SiC Composite

E.G. Gomes and J.L. Rossi

Powder Processing Center CCP, Instituto de Pesquisas Energéticas e Nucleares, IPEN,
CEP 05422-970 São Paulo, Brazil

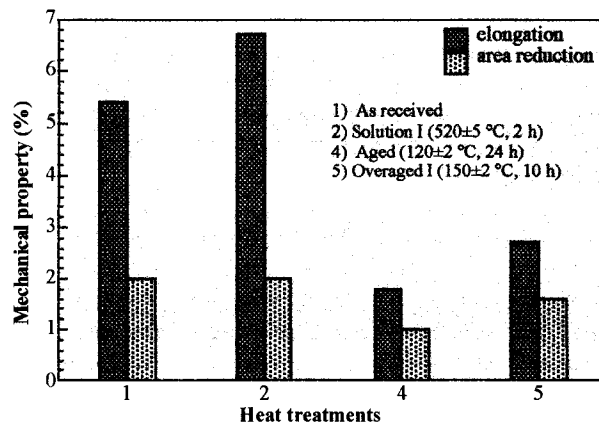
Fig. 4. Change of the elongation and the reduction of area at the fracture of the composite material in function of the heat treatments.

There was a narrow change in ductility of the solution treated composite, 520 °C for 2 hours, in relation to the as received material, see Fig. 4. This ductility increase was due to the uniform strain since there was a small reduction of area. For the composite aged at 120 °C for 24 hours and overaged at 150 °C for 10 hours, the increase in the mechanical strength and in the hardness, caused a decrease in the ductility when compared to the composite material in both, as received and solution treated condition.
